## Message of the President Görün Arun

### Disasters and Heritage

# Iscarsah

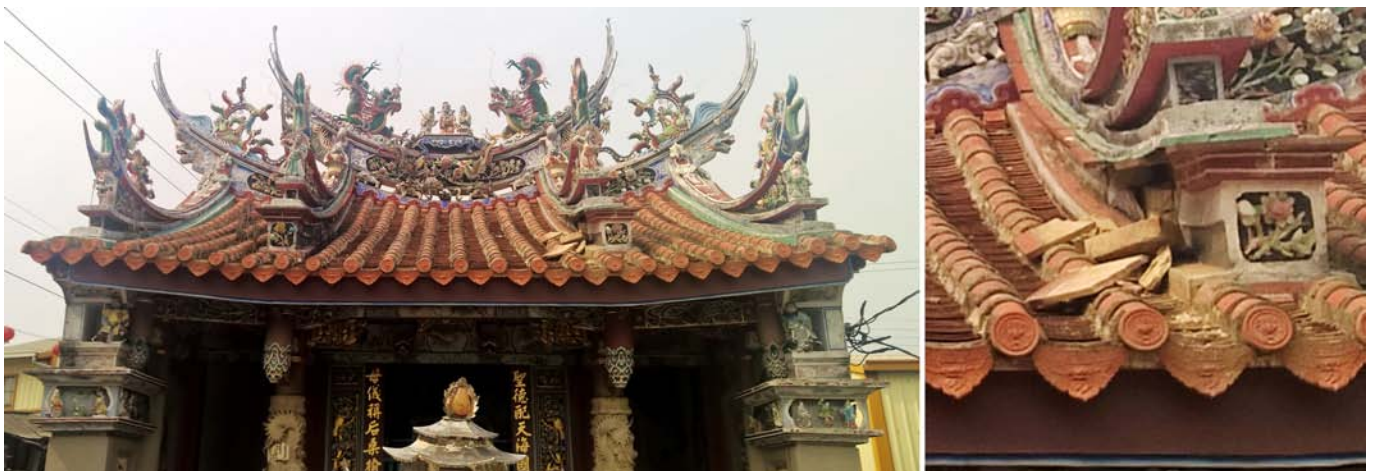
Figure 4: Tie-Xian-Qiao Tungi Temple (Tiexian Village, 1692, Municipality level listing): damaged acroterion (Photo: Tainan Municipal Administration of Cultural Heritage).

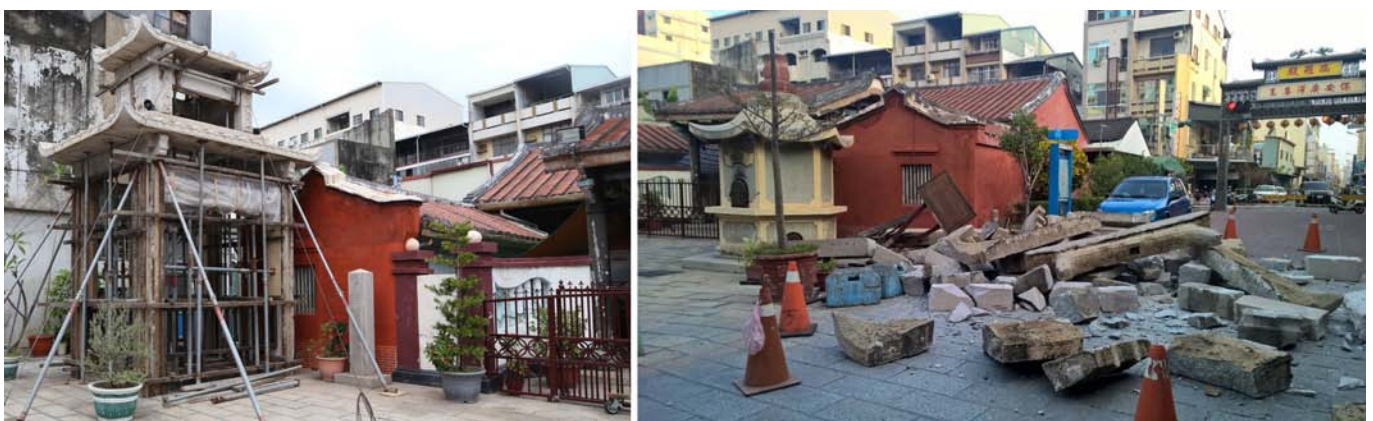
Figure 5: Wind God Temple. Left: Drum Tower (Photo: <http://www.fingermedia.tw/>). Right: Collapsed Bell Tower. The furnace is also damaged. (Photo: Tainan Municipal Administration of Cultural Heritage).

Only one construction collapsed: a stone tower belonging to the complex of the Wind God Temple, a temple founded in the 18 c. (and rebuilt in 1927 after the original temple was demolished for urbanistic reasons by order of the Japanese administration). Three stone constructions stood in front of the temple: a gate of three bays and two towers (a bell and a drum tower). The higher and slender gate did not suffer damages but the top heavy towers did. The bell tower collapsed (figure 5-right) and the drum tower, heavily damaged (figure 5-left), was dismantled a few days later. Both of them were not experiencing their first misfortune. The bell tower already collapsed in 1930, following the M 6.5 Xinying earthquake (Tainan municipality), was rebuilt in 1967 and displaced in 1995. And the drum tower collapsed in 1946, following the M 6.1 Xinhua earthquake (Tainan municipality) and was only rebuilt in 1995. Possibly the most common damage pattern observed in historical buildings is cracks appearing between structural elements imperfectly connected, especially stone elements (columns, slabs) and

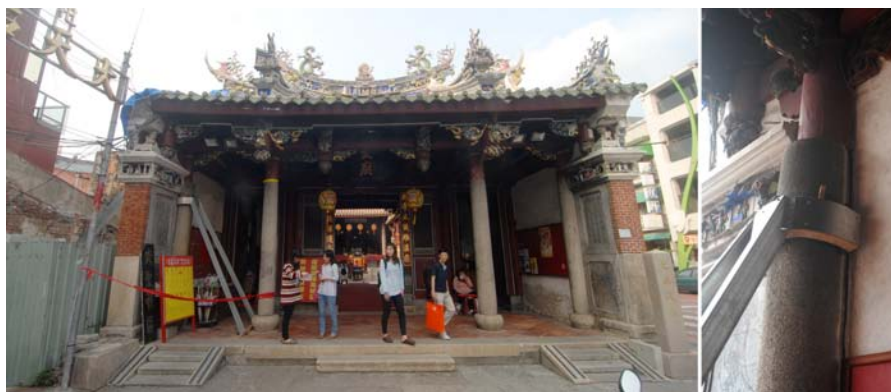
Figure 6: Official God of War Temple (Photos: P. Smars, 2016).

walls. In the Official God of War Temple significant displacements of columns were observed, in the entrance (figure 6) and inside the temple complex. Provisional strengthening structures were installed there, in the courtyard (figure 8) and on the outside wall of the temple (figure 7). Cracks in between structural elements are also observed in the Singi Temple (figure 10) and in the Confucius Temple (figures 9-left).

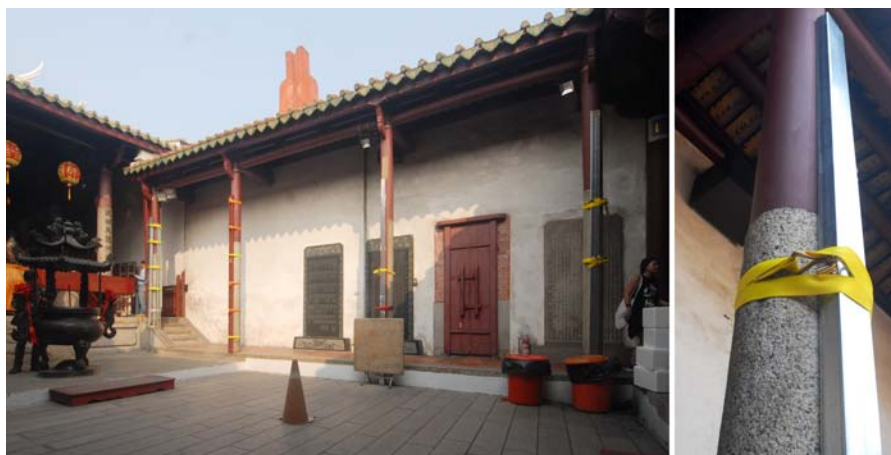
Figure 8: Courtyard of the Official God of War Temple (Photos: P. Smars, 2016).

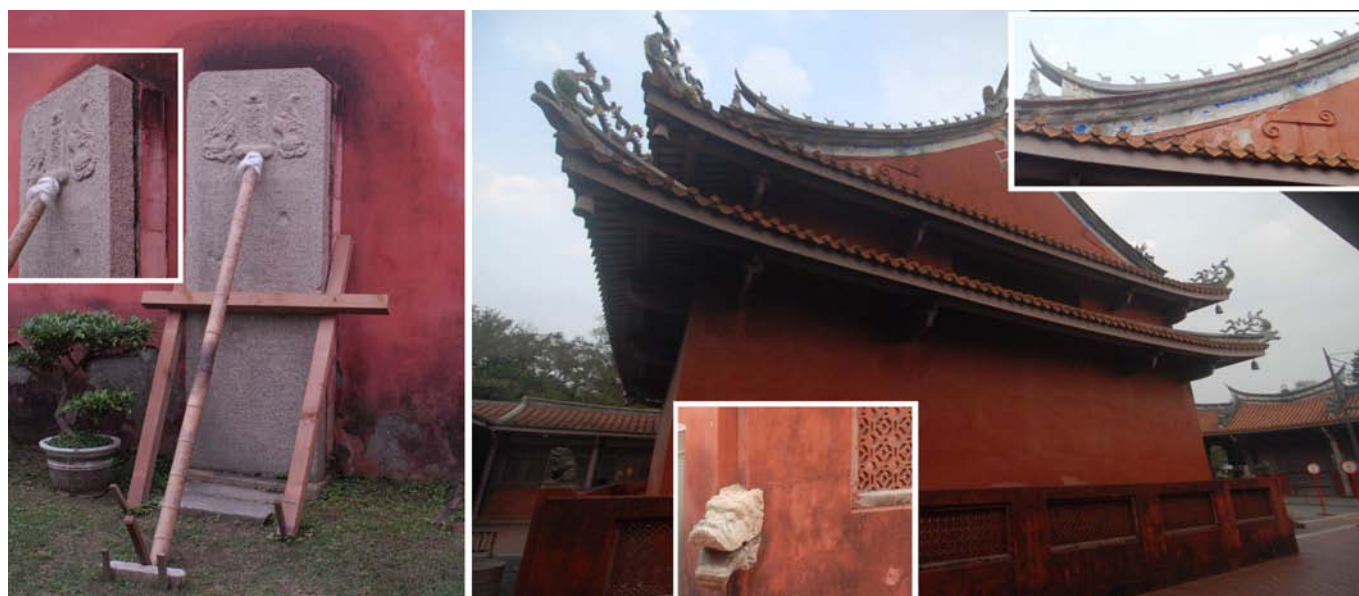
Figure 9: Temple of Confucius. Left: Stele. Right: Hall of Great Achievement (Photos: P. Smars, 2016).

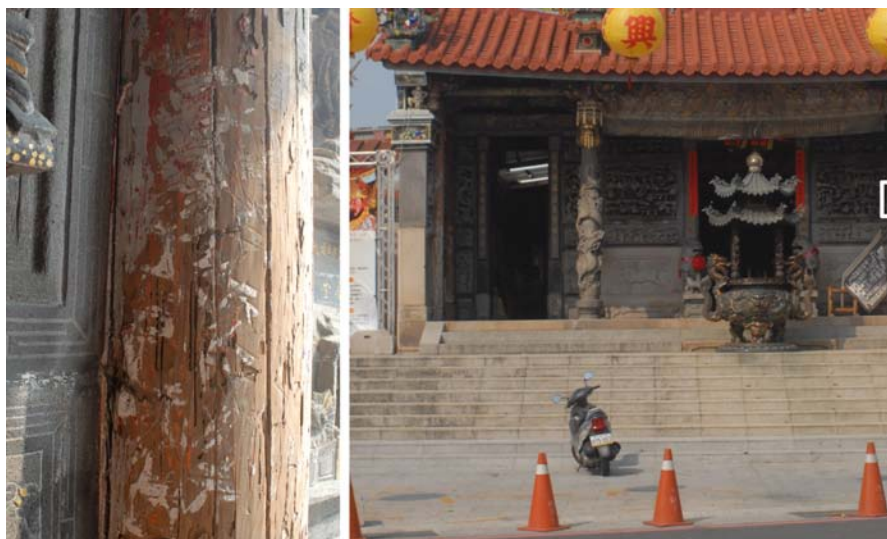
Figure 10: Sing-Ji Temple (Photos: P. Smars, 2016).

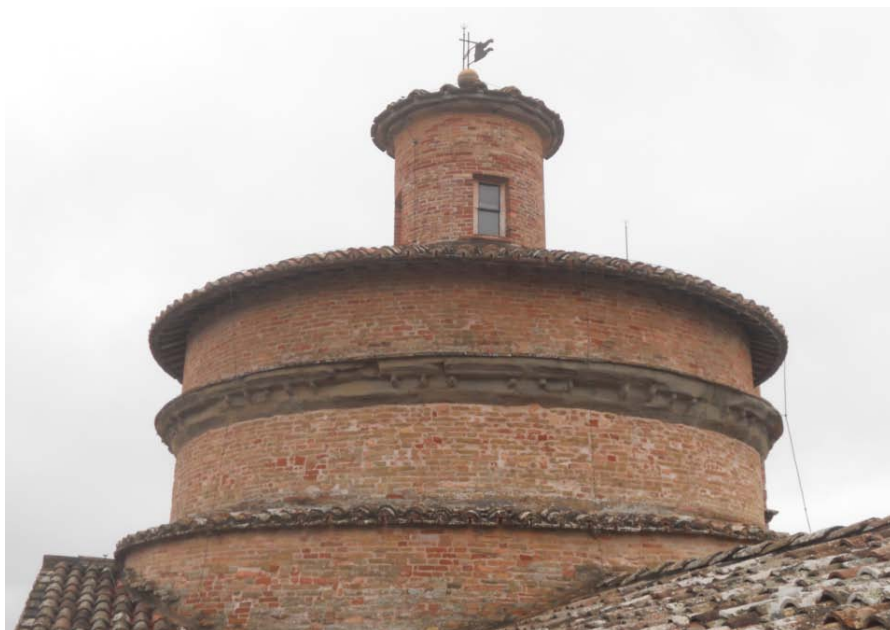
Tambor con evidente deterioro de las cornisas en piedra arenisca.

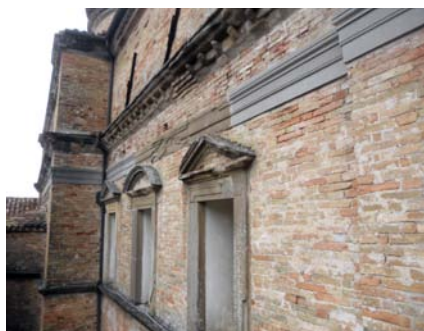
Deterioro de las cornisas del frente noroeste (Foto S. Gizzi, 2015).

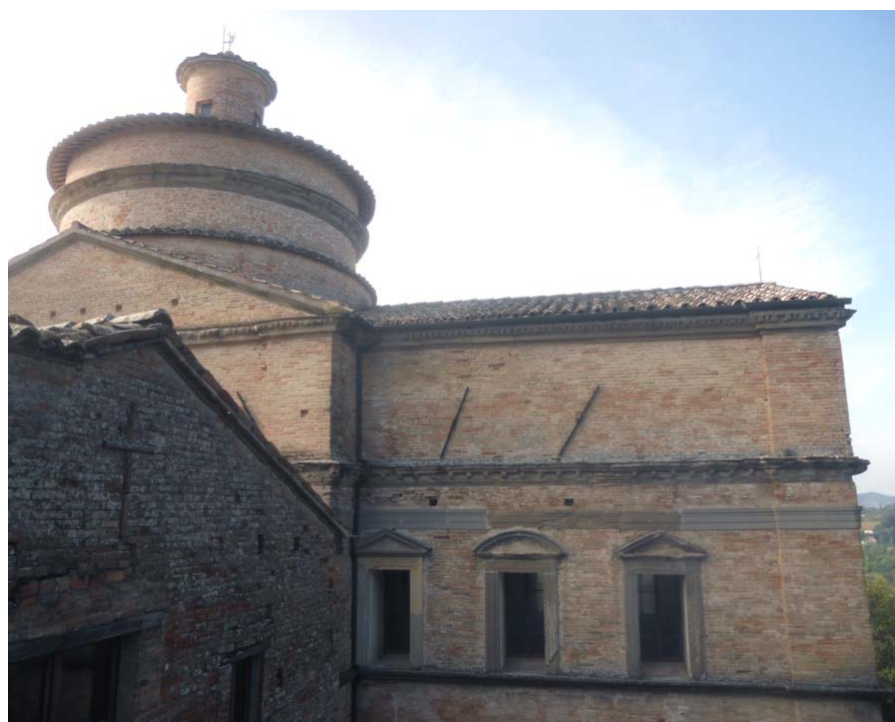
Deterioro de las cornisas del frente noroeste. Nótese las partes reintegradas con piedra arenisca (Foto S. Gizzi, 2012).

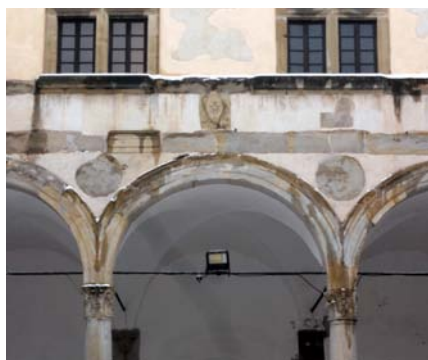
Deterioro de la piedra arenisca en el Palacio Papal de Camerino (Foto S. Gizzi, 2012).

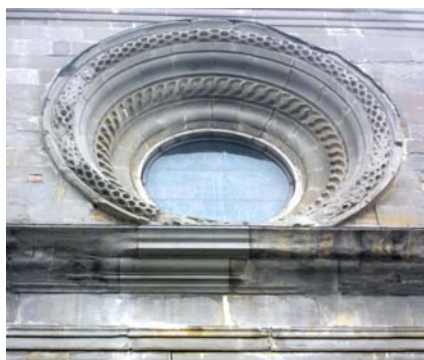
Deterioro y reintegraciones de la piedra arenisca de la iglesia de Santa María de las Gracias al Calcinato en Cortona (Foto S. Gizzi, 2012).

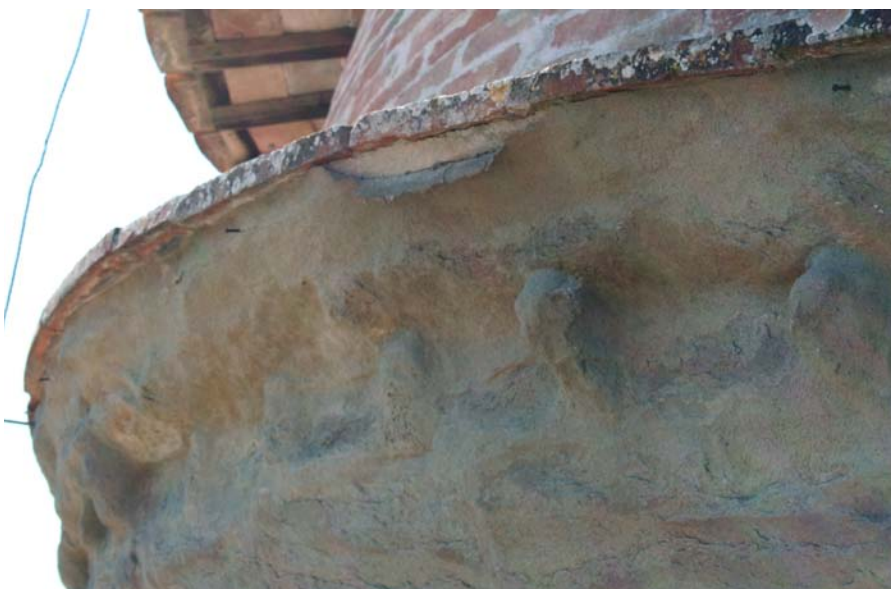
Efectos negativos de la consolidación efectuada con resinas sintéticas en los años Noventa del siglo XX (Foto F. Lanari, 2013).

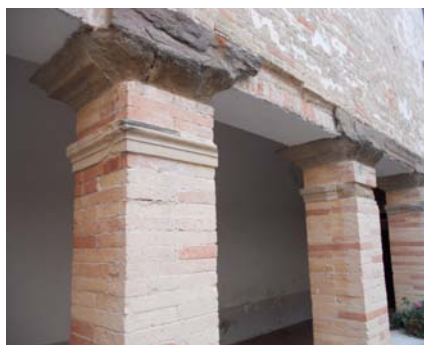
Tipos de ladrillo y deterioro de los capiteles en el claustro del Convento (Foto S. Gizzi, 2013).

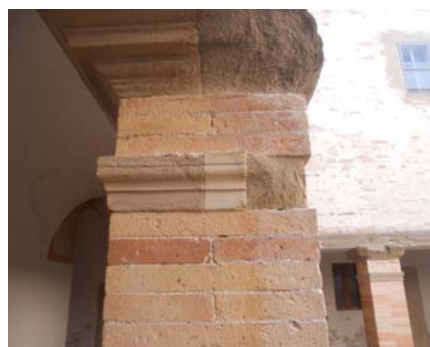
Tipos de los ladrillos y deterioro de los capiteles en el claustro del Convento de San Bernardino (Foto S. Gizzi, 2013).

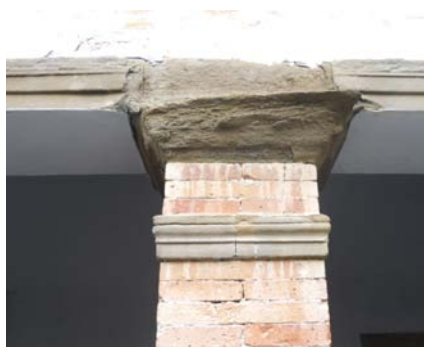
Detalle del deterioro del capitel en piedra arenisca en el claustro (Foto S. Gizzi, 2013).

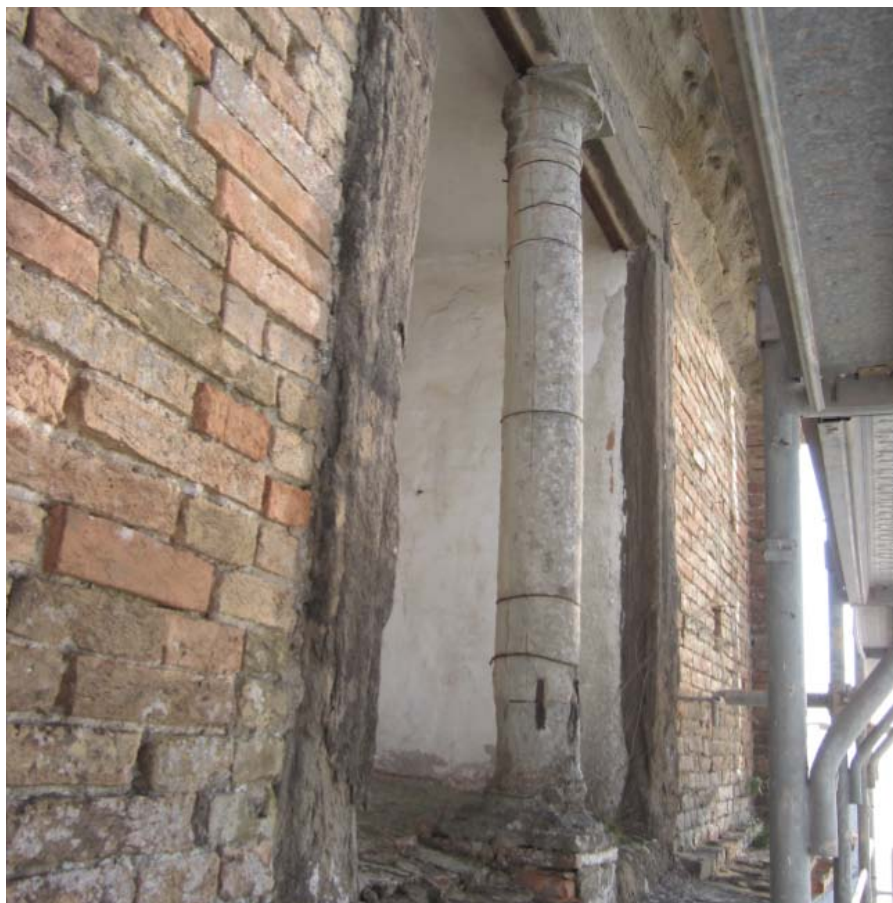
Estado de deterioro de la columnilla de la ventana bifora del frente principal antes de la intervención (Foto S. Gizzi, 2014).

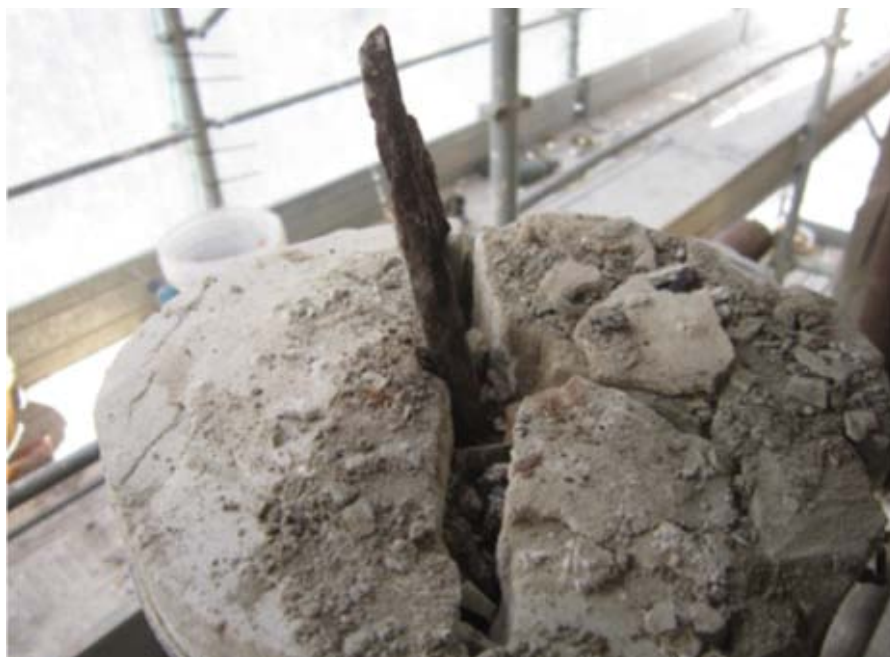
Detalle de la fisura de la columna (Foto Gamma s.r.l. Fano, 2015).
