BULLETIN

September 2025

Message from the President	1 - 2
Thoughts from Afar on the Recent Myanmar Earthquake Stephen J. Kelley	3 - 4
ISCARSAH Webinar Series Tim Michiels	5
Seismic Analysis and Structural Assessment of Typical Stone Masonry Building in the Historic Core of Dubrovnik Mario Uros	6 - 8
Seismic Isolation Applications in Romania on Heritage Buildings Andreea Dutu	9 - 10

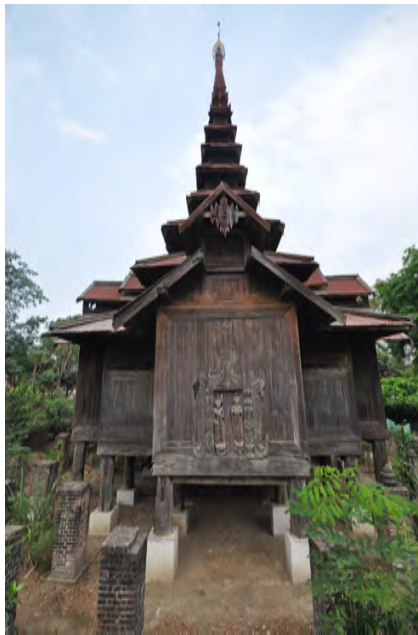
Figure 3: The monastery of Thin-gaza has its teak posts replaced above grade with square concrete piers due to rot and termite damage (S. Kelley photo).

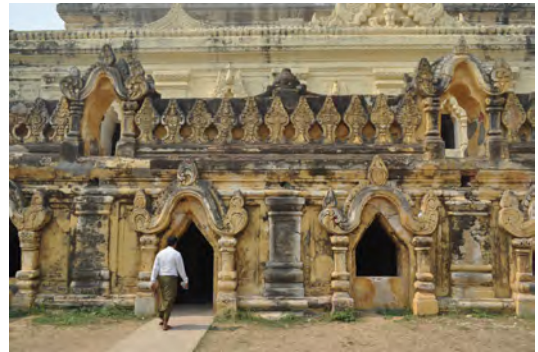
Figure 4: View of the Maha Aungmye Bonzan Kyaung from the south revealing the intricate ornamentation rendered in stucco over brick masonry (S. Kelley photo).

I was also asked to survey several unreinforced masonry structures that, not surprisingly, did not perform well during the earthquake. The obvious example is the Maha Aungmye Bonzan Kyaung (Figure 4). The Monastery is a fine example of early 19th century Burmese monastery architecture. As it was customary during this period for monasteries to be built of teak, this monastery was built in the same style with stucco ornamentation that looks like wood carving (Figure 4). The encircling hallways and chambers were covered with barrel vaults (Figure 5). At the time I observed the cracking within the vaults most likely from an 1838 earthquake and the outward spread of the encircling galleries. I am sorry to report the collapse of this monument (Figure 6).

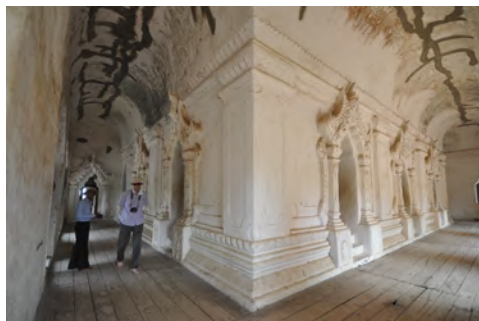
Figure 5: View of the lower gallery from the southwest showing the cracks along the apex of the vaults (S. Kelley photo).

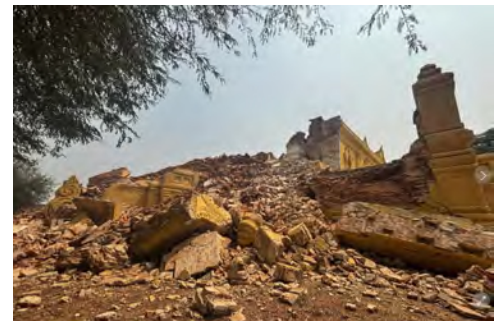
Figure 6: The collapse of the Maha Aungmye Bonzan Kyaung following the earthquake (photo from the Associated Press)

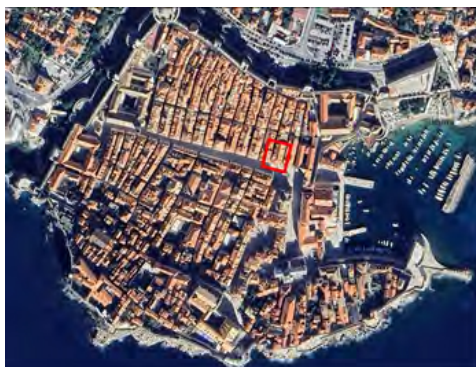
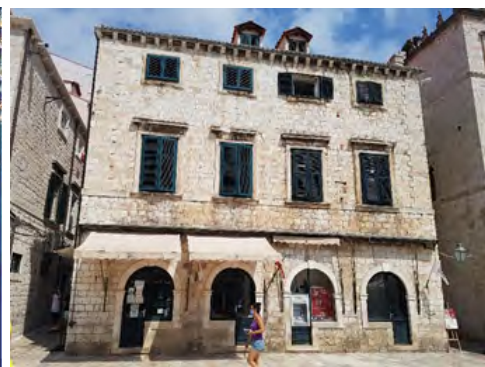
Numerical models of varying complexity were developed for the analyses. The most sophisticated analyses involved non-linear dynamic simulations and advanced constitutive material model to predict the behaviour of the building under the set of real and artificial earthquakes specified for the site. Although these models are complex and rarely used in regular engineering practise, they were necessary to ensure a understanding of the performance of the historic structure. In addition, the global seismic response was assessed by applying an equivalent frame model with a macro-element constitutive law, representing masonry elements as pier and spandrel elements and using a pushover analysis. Finally, representative walls were analysed for possible out-of-plane failure and the corresponding safety factors were calculated.

The analysis was thus conducted in two stages: the first comprising the evaluation of the existing condition of Block B17, that included model calibration based on measurement results and seismic performance assessment; the second involved the structural analysis of the building for different retrofit strategies applied to the structure, ie. considering proven engineering techniques commonly used, such as wall injections, post-tensioning of the wall, installation of ties etc. Results of both global models indicated the critical structural elements that exhibited significant seismic vulnerability. The analysis of potential out-of-plane mechanisms and non-structural elements also revealed structural vulnerabilities that require targeted intervention. Comparison with the upgraded models gave a valuable information on the effectiveness of specific strengthening measures.

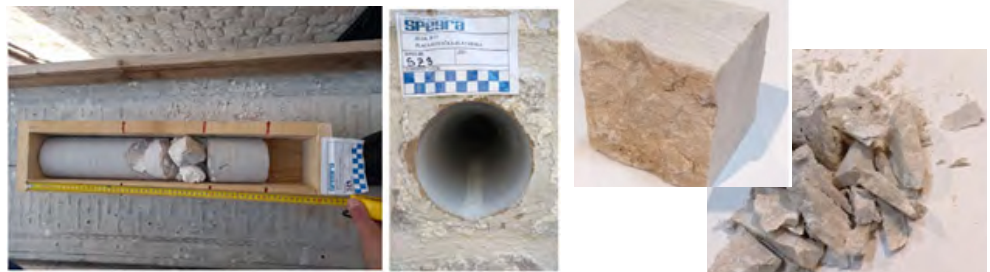
Extraction of wall structure and laboratory testing samples

The research project employed advanced numerical modelling methodologies that were supported by extensive experimental data. Laboratory and in-situ investigations provided important information on the mechanical properties of the traditional three-leaf masonry walls as well as on the global dynamic behaviour determined by the OMA measurements of the existing structure. These findings served as the basis for the creation of numerical models and performing simulations to predict the structure's response.

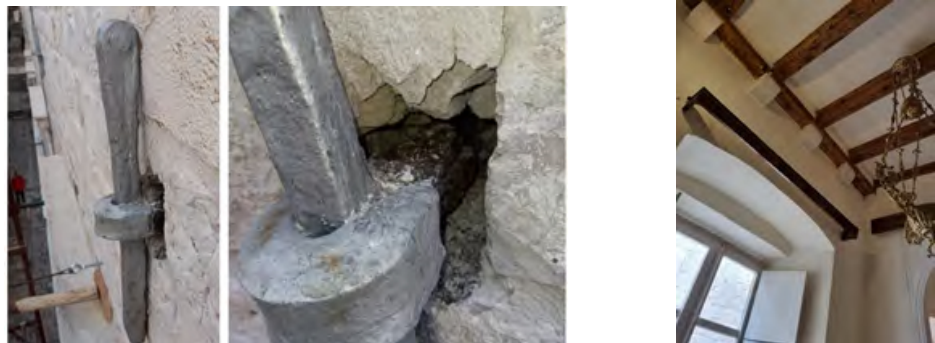
Representative documented structural details
