**The First International  
Workshop on  
Restoration and  
Strengthening of  
Historical Structures**  
*Volume I: Papers*

Iranian Ministry of Cultural Heritage, Tourism and  
Handicrafts (MCTH)  
and  
International Scientific Committee on the Analysis  
and Restoration of Structures of Architectural  
Heritage (ISCARSAH)

# **The First International Workshop on Restoration and Strengthening of Historical Structures**

Ed. María Margarita Segarra Lagunes, Mehrdad Hejazi

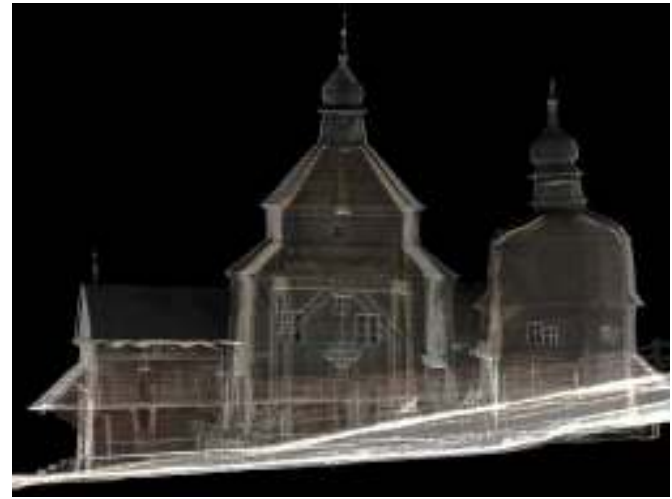
Figure 6. Section through the wooden Tserkva of the Descent of the Holy Spirit in Potelych, Ukraine (1502) taken from a 3D laser scan (scan by Skeiron in Lviv).

**4.8.2.** Geometric documentation of the building (Figure 6).

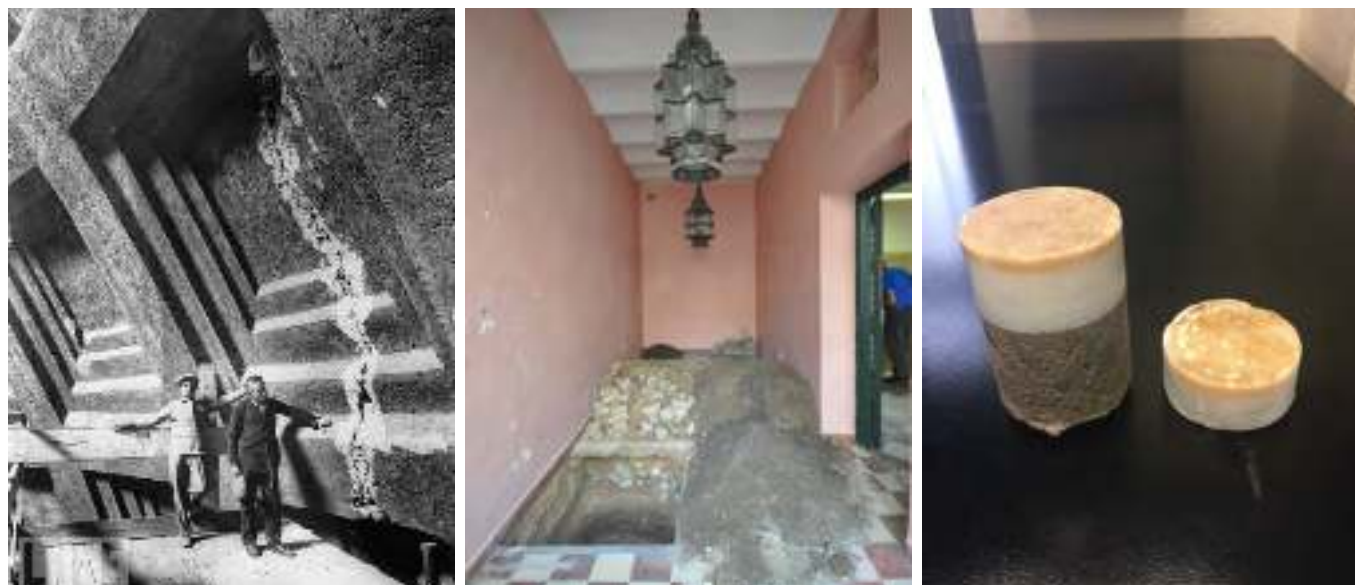
Figure 7. Prof. Giacomo Boni, famed Italian archaeologist, inspects a crack in the concrete vaulting of the dome of the Pantheon during restoration in 1925. Figure 8. Sondage at the Tangier American Legation Museum Pavilion Arabe in Morocco (early 20<sup>th</sup> Century) to determine the makeup of the foundations. Figure 9. Removal of cores through the marble floor of the Oklahoma State Capitol (1914-1918) to determine the depth of the marble staining.

intrusive devices (Figure 7).

**4.8.4.** Invasive survey, i.e. removing components and making inspection openings, is likened to exploratory surgery and may be performed to reveal the nature and condition building systems and components (Figure 8).

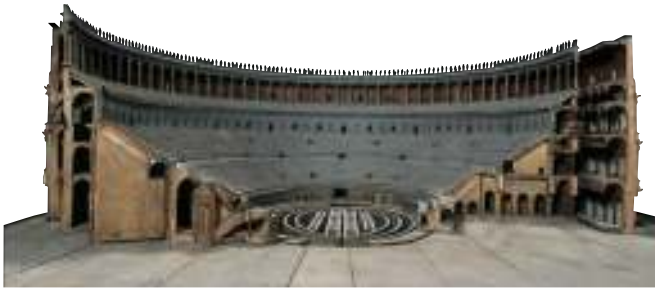
Carlo Lucangeli, Wooden model of the Colosseum (1790 and 1812).

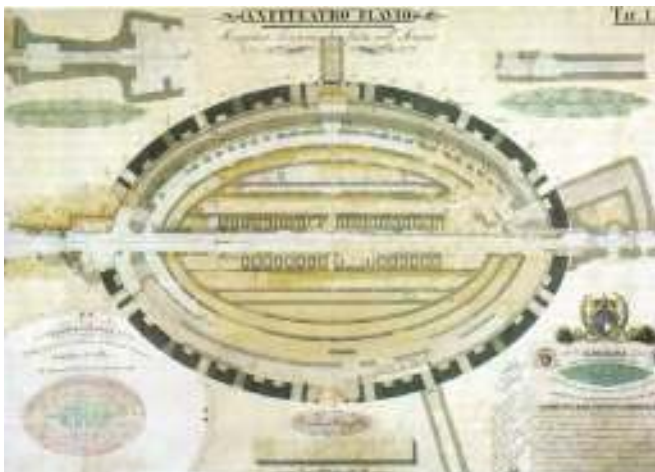
Luigi Maria Valadier, survey of the hypogea of the Colosseum, commissioned by Emperor Napoleon Bonaparte in the early 19<sup>th</sup> century.

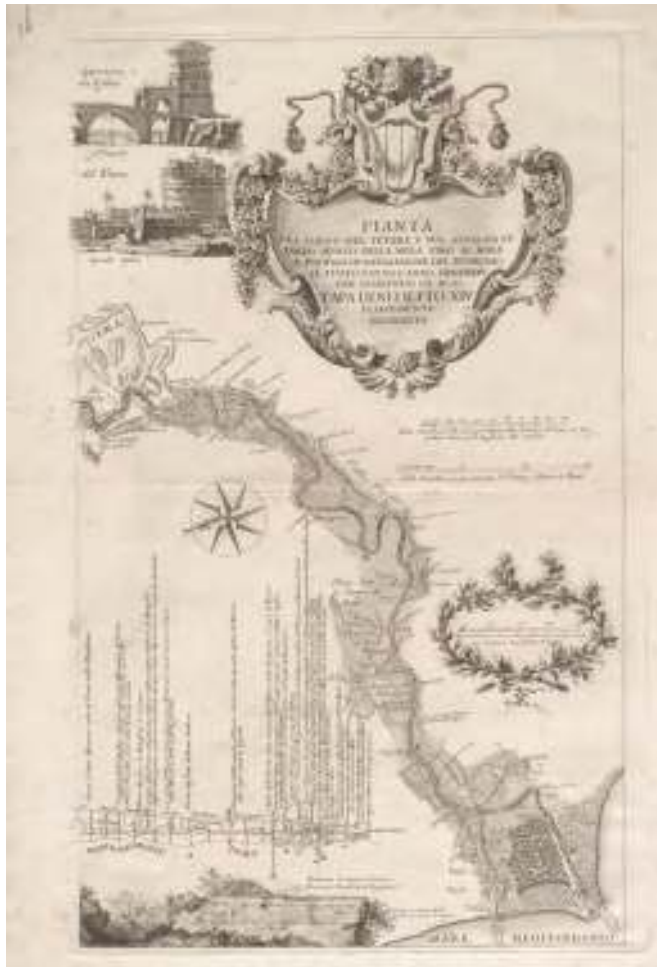
Map of the Tiber River between Rome and its mouth in the Tyrrhenian Sea. The survey, conducted by Bolognese engineers Gambarini and Chiesa in 1744, shows the river's course and the depth of its bed.

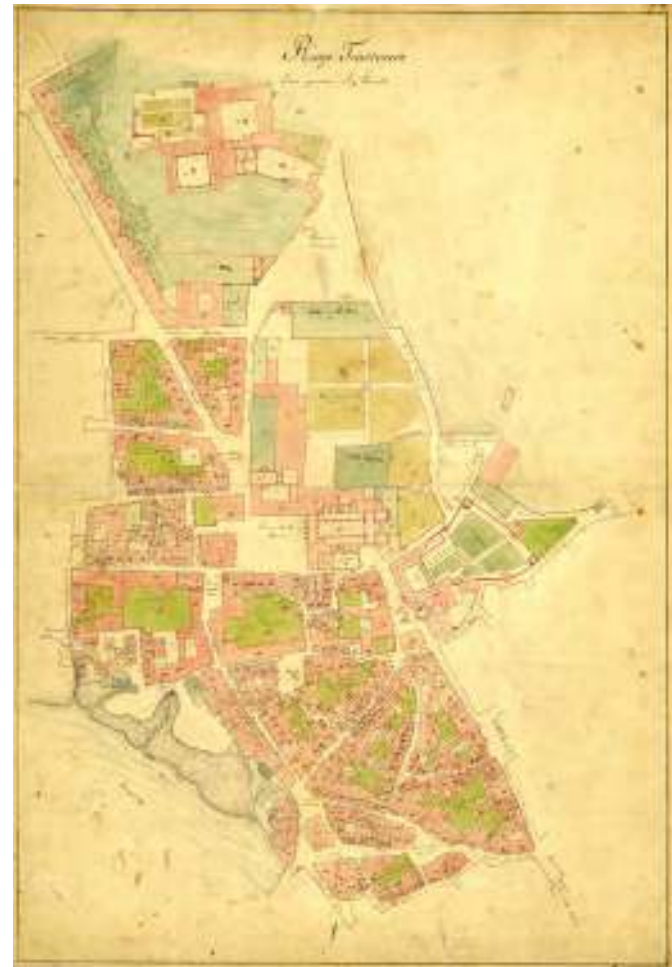
Gregorian cadastre (first half of the 19<sup>th</sup> century), the Trastevere district of Rome. Existing buildings are in red. Courtyards, gardens, and undeveloped spaces are in green.

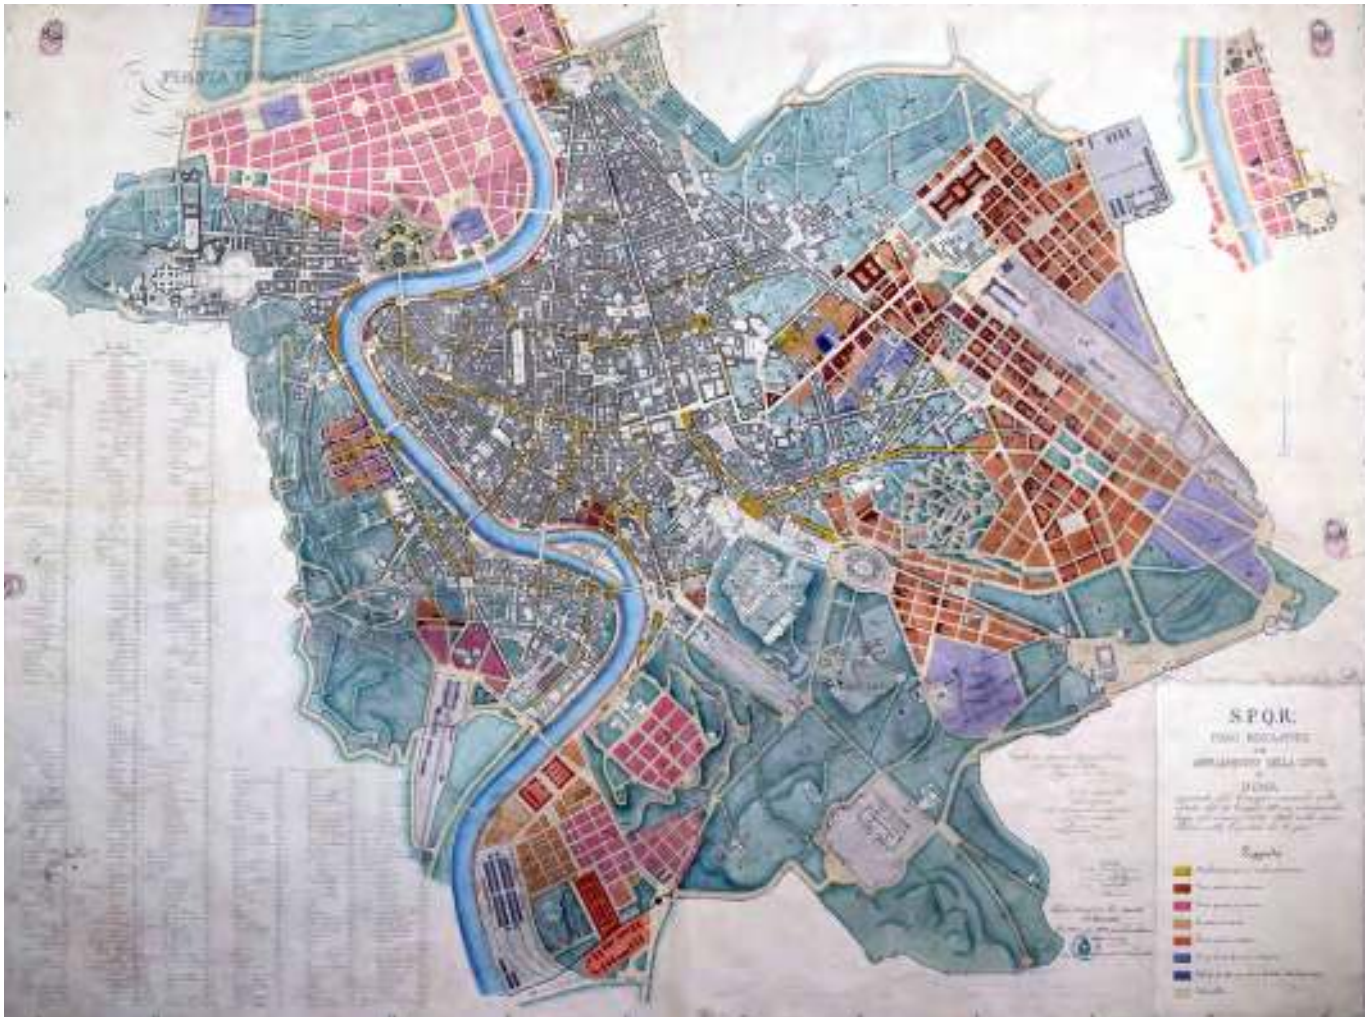
Rome Master Plan, approved by the City Council in 1882. In red and pink, all the new neighborhoods that will arise when Rome becomes the capital of United Italy, for the construction of residential and office buildings.

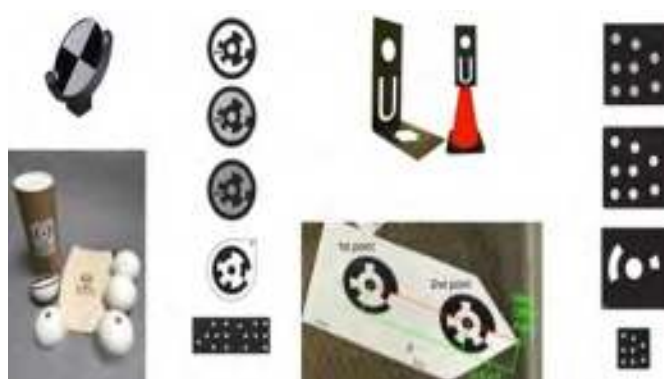
Figure 1. Coded and non-coded targets used in photogrammetry and laser scanning.

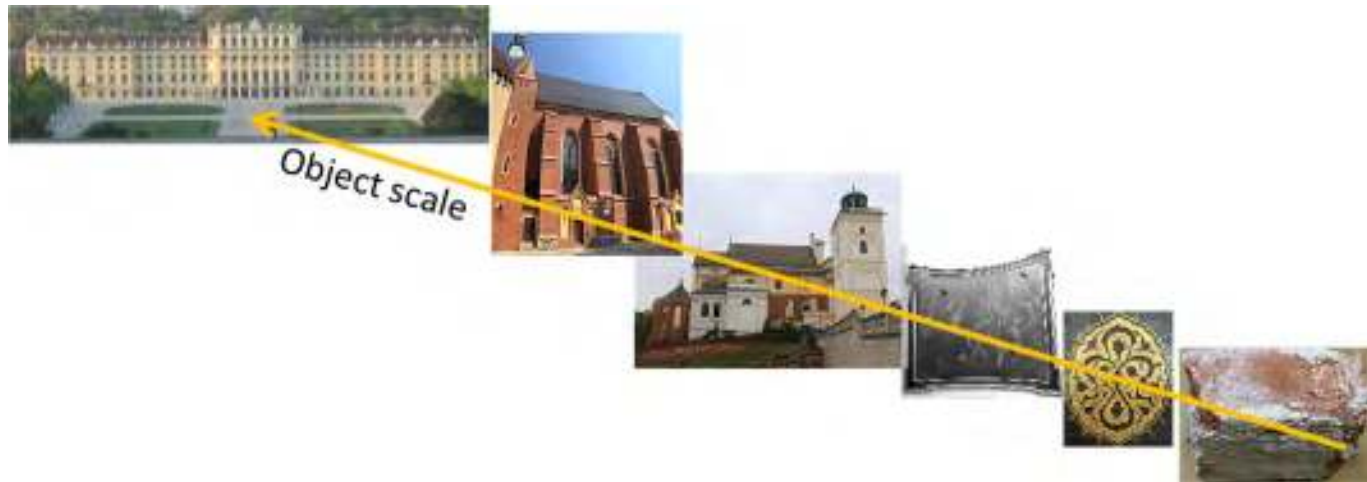
Figure 5. Documentation method depends on the *scale* and the *purpose*.

Examples presented here are selected to cover objects size from  $0.01 \text{ m}^2$  to  $1 \text{ km}^2$  (Figure 5) that is

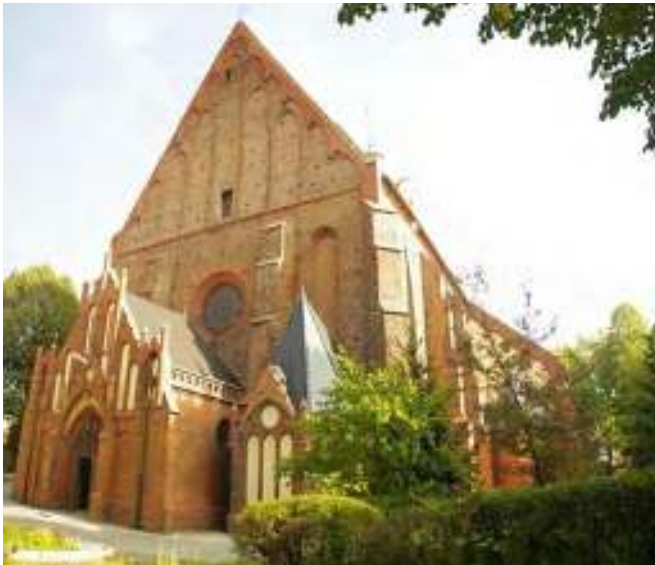
Figure 8. Ząbkowice Śl (courtesy of Łukasz Bednarz, ISCARSAH, Poland).

burning down of its previous timber roof during Hussite's war in 1428. The vault was restored in the neo-Gothic style in the years 1893–95 using machine-made bricks, smaller than the original ones.

Within time brick vaults and walls cracked and repair works became necessary. Prior to the works Finite Element Model analysis was performed on a basis of geometrical models (Figure 9) developed using 3D high resolution laser scan data (in 2009).

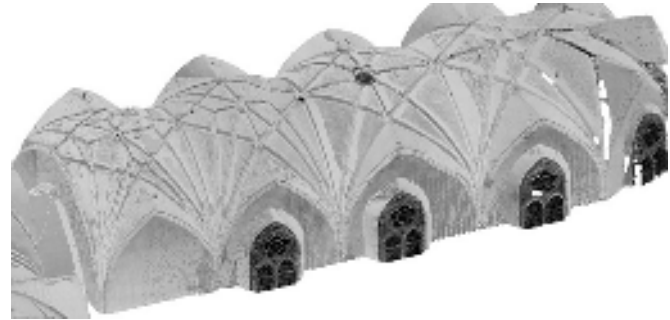
Figure 9. Ząbkowice Śl. Church vault model based on a laser scan (courtesy of Łukasz Bednarz).

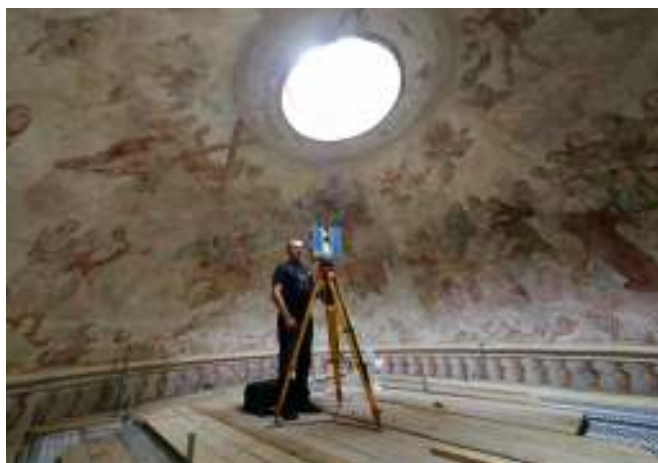
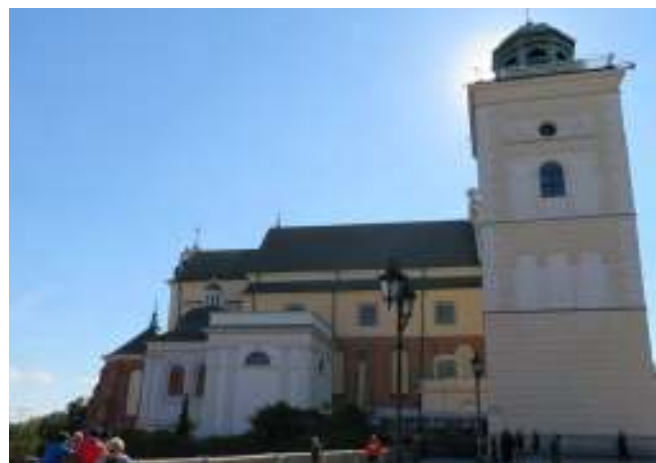
Figure 10. St. Anna's church, scanning of the chapel dome, (left photo courtesy of Katarzyna Górecka, Academy of Fine Arts in Warsaw, Poland).

and decorated in XVIII century. A documentation of the dome of a side chapel (Figure 10) was prepared using laser scanning and two photogrammetric models based on ambient light and artificial light photographs. The 3D model from the laser scan is used for drawing plans and cross-sections and as a reference for photogrammetric models to evaluate their accuracy. The first photogrammetric model based on ambient light and images having 12.8 megapixels has a mean error of 0.036 m when compared to the laser reference scan. The second model based on artificial light and images having 50 megapixels made after the dome conservation has a mean error of 0,0046 m. This is a very good agreement with the reference laser scan model. It shows that photogrammetry of well texturized objects can be used for 3D modelling as a first choice method as it offers high accuracy plus better texture and damage mapping than do laser scans [12].

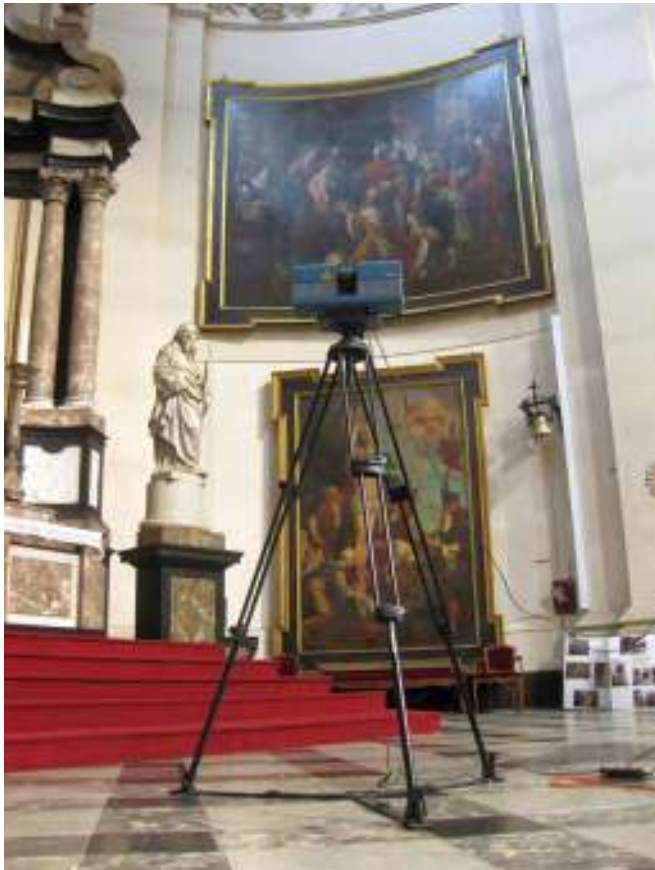
Figure 11. St. Aubain Cathedral in Namur, Belgium. Left, scanning of the curvilinear painting “Adoration of the Magi”. Right, scan preview with visible two holes in the upper part of the painting.

At first three scans were taken in Sept. 2012 to assess modelling accuracy, to document painting before conservation works and to build models of two tables (concave and convex) planned to be used during conservation of painted and reverse sides of the canvas. Histogram presented in left part of Figure 12 shows that points within about 2 Sigma (95,5%) confidence bound have their distance to the reference point-cloud

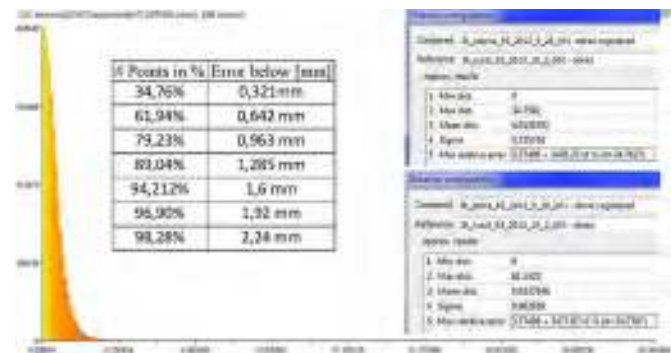
Figure 12. St. Aubain Cathedral in Namur, Belgium. Left, histogram of the point distance differences between two scans. Right, statistics of distance computation for two scans compared with the reference one.

Analysis of the rather low accuracy results supported with statistics of distance computation for two scans compared with the reference one given in right part of the Figure 12 does not explain why maximum differences in measured distance are as large as 34 or even

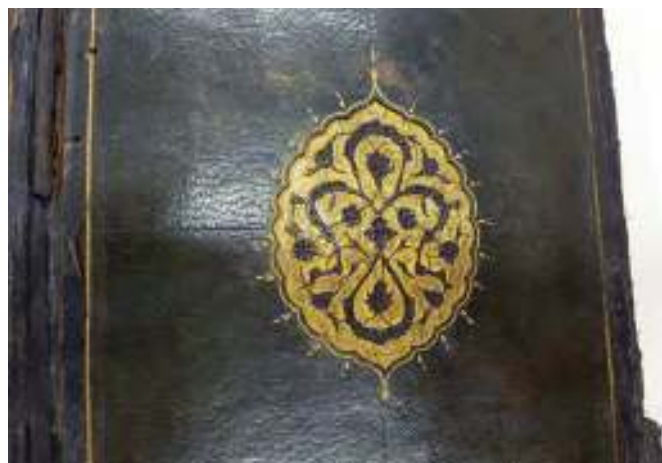
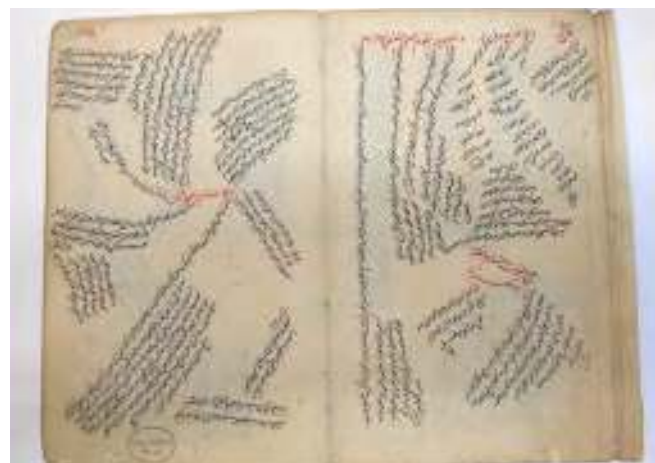
Figure 13. Ornamented leather cover of the Turkish book. Figure 14. Two pages of the Turkish book.

Conservation project undertaken at Faculty of Conservation and Restoration of Works of Art at Academy of Fine Arts in Warsaw included restoration of a missing leather cover of the book. The existing cover had a pressed-in ornament shown in Figure 13. The idea was to copy the ornament on a newly made missing cover replica. For this purpose manufacturing of a stamp being a reverse of the shape of existing ornament was assumed.

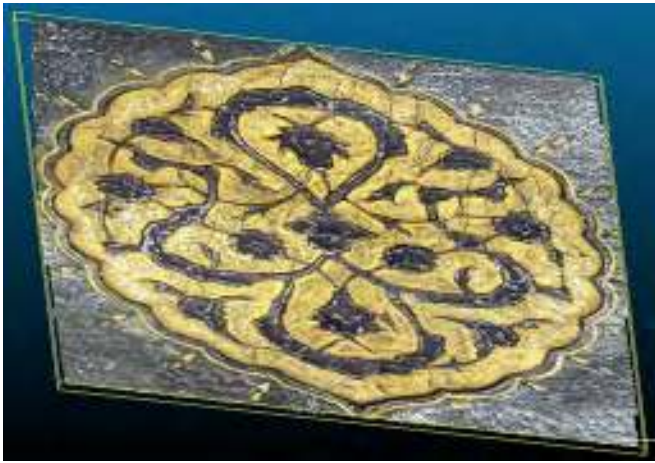
Figure 15. Photogrammetric model of the cover ornament.

Photogrammetry model was built on a basis of free hand images taken ad hoc with smartphone Samsung S-4 camera. It allowed to obtain a point cloud of 34 718 points and a mesh with 68 725 faces. The result is illustrated in Figure 15. Using triangulation scanner EPPM-1 a point cloud of 479 969 points was recorded and a mesh with 959 060 faces generated which gives aver-

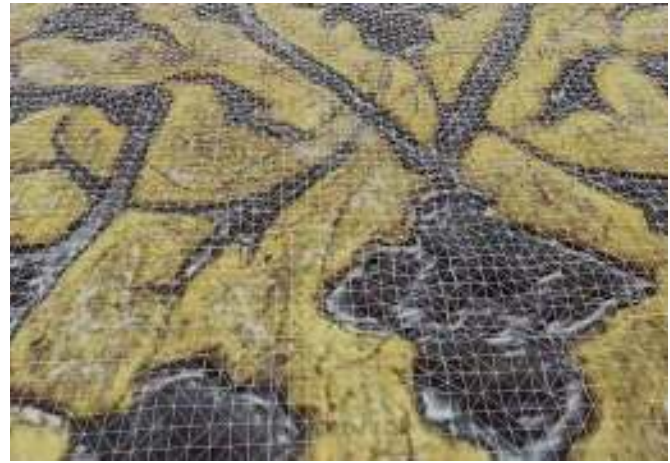
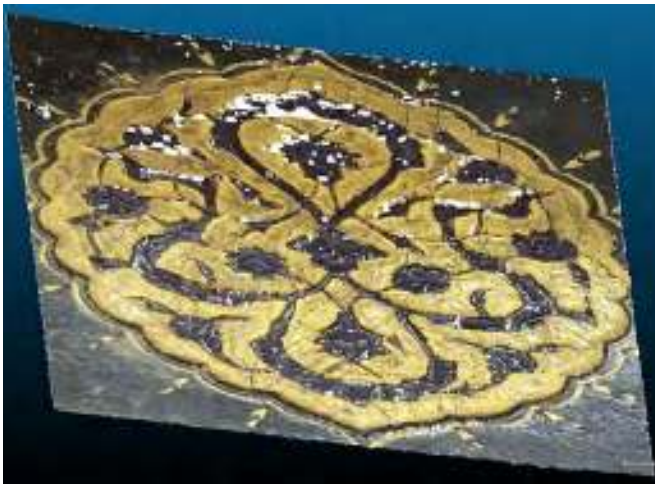
Figure 16. Model of the cover ornament based on the laser triangulation scanning.

age of 120 faces per 1 mm<sup>2</sup>. This demonstrates the technical feasibility of generating highly detailed models of small objects of art. Fitting a normal distribution to point height differences between the scan model and photogrammetry model of the cover ornament gave a remarkably good mean value 0.006 mm but with much higher standard deviation equal to 0.464 mm.

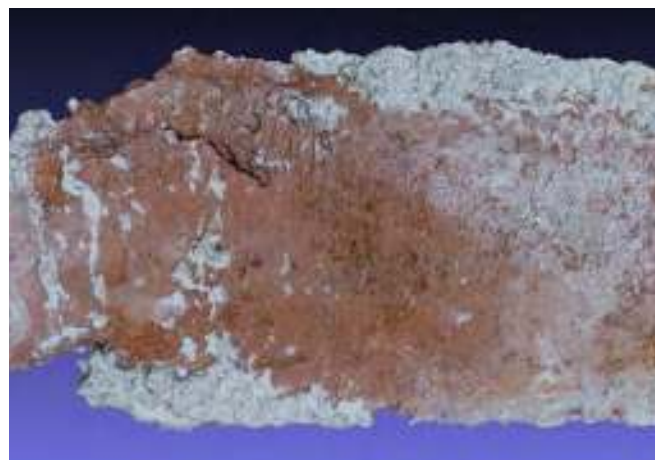
Figure 17. Hand-held camera photogrammetric model of a brick surface (left). Crack points coordinates shown in Cloud Compare (right).

This example (Figure 17) illustrates a feasibility of using the super-close range photogrammetry to surface shape studies but also that a texture applied to a model is extended to the whole model surface, while real 3D information exists in model vertices only. The 3D data apparent continuity is usually obtained through triangulation procedure based on the registered points data. In surface deterioration studies approximation of the surface needs to be carefully analysed as it introduces model smoothing which may screen subtle degradation changes. The same regards canvas painting and tapestry surface documentation.

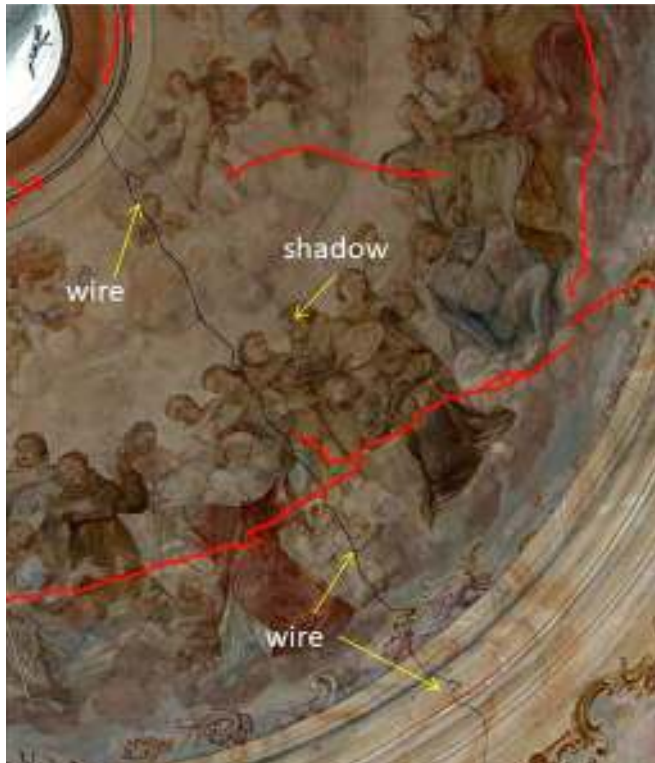
Figure 18. St. Anna's church, mapped real cracks and a crack imitation by a wire, (courtesy of Katarzyna Górecka, Academy of Fine Arts in Warsaw, Poland).

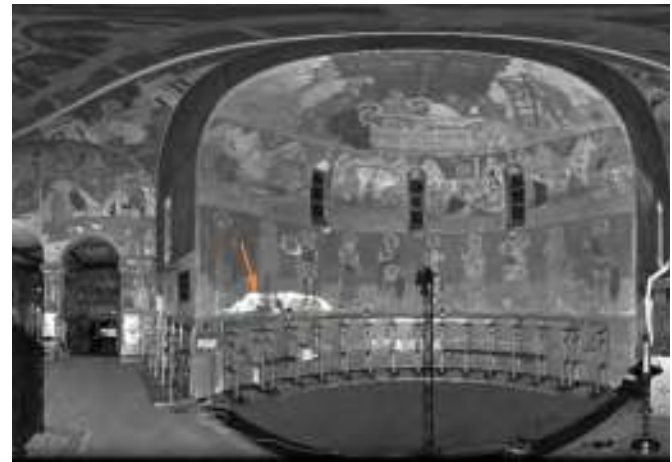
Figure 19. Salt efflorescence recorded by laser scanning in orthodox church in Chevetogne, Belgium (scan author).

*Mapping of 2D damages* (salt efflorescence, fungi, damp) can be documented automatically by laser scanning and photogrammetry thanks to a change in colour or absorption/reflection properties of a surface (Figure 19).

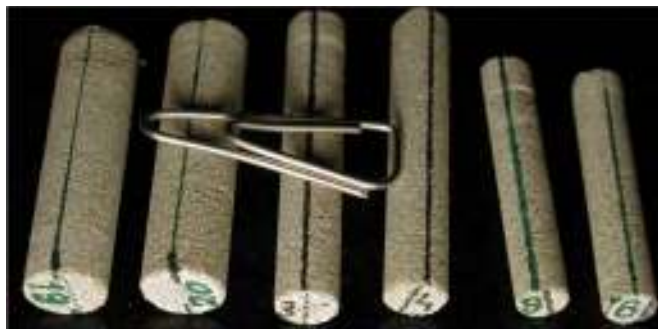
Figure 27. Micro-cores of Schilfsandstein.

Cross-validation tests on Schilfsandstein specimens were done in 2008 together with Bayerisches Landesamt für Denkmalpflege. BLFD [27]. At first CoDiT measurements were performed on sub-sized specimens (Figure 27) without a knowledge about the material properties (a blind test).

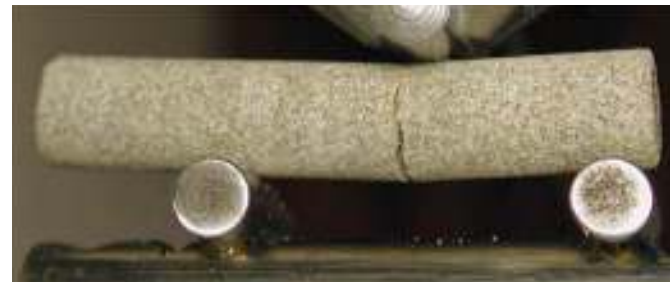
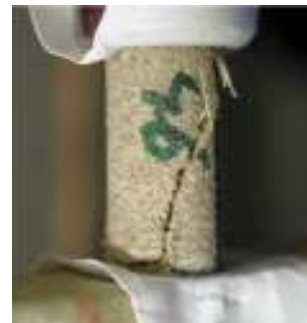
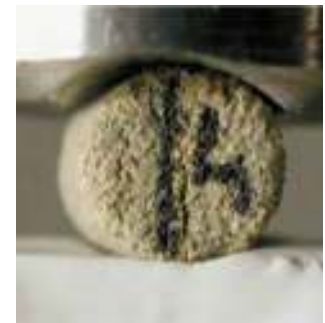
Figure 28. Sequence of the strength tests using a micro-core: left, FS; middle, UCS; right, ITS.

In agreement with the test sequence shown in Figure 26 at first it was performed the measurement of stone flexural strength  $FS$  in three-point bending test (Figure

28, left) in such a way that the specimen cracked into two various length pieces: longer one used to produce specimen of slenderness 2:1 taken for uniaxial compressive strength  $UCS$  measurement (Figure 28, middle) and shorter one, cut for slenderness 1:1, used for indirect tensile strength  $ITS$  measurement in Brazilian test (diametral compression) as shown in Figure 28, right. The acceptance of the result is based on visual inspection of the correctness of the observed failure mech-

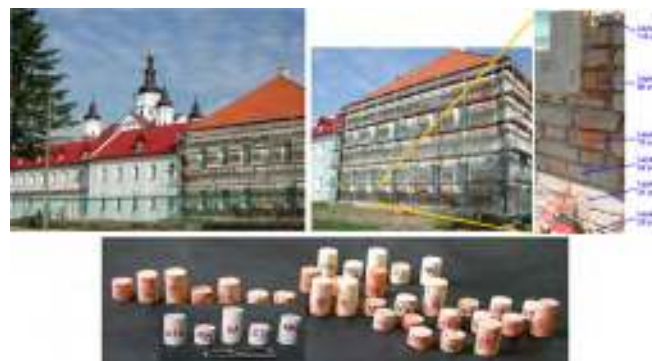
Figure 29 Micro-cores from bricks from South-East part of the Supraśl Monastery (Poland).

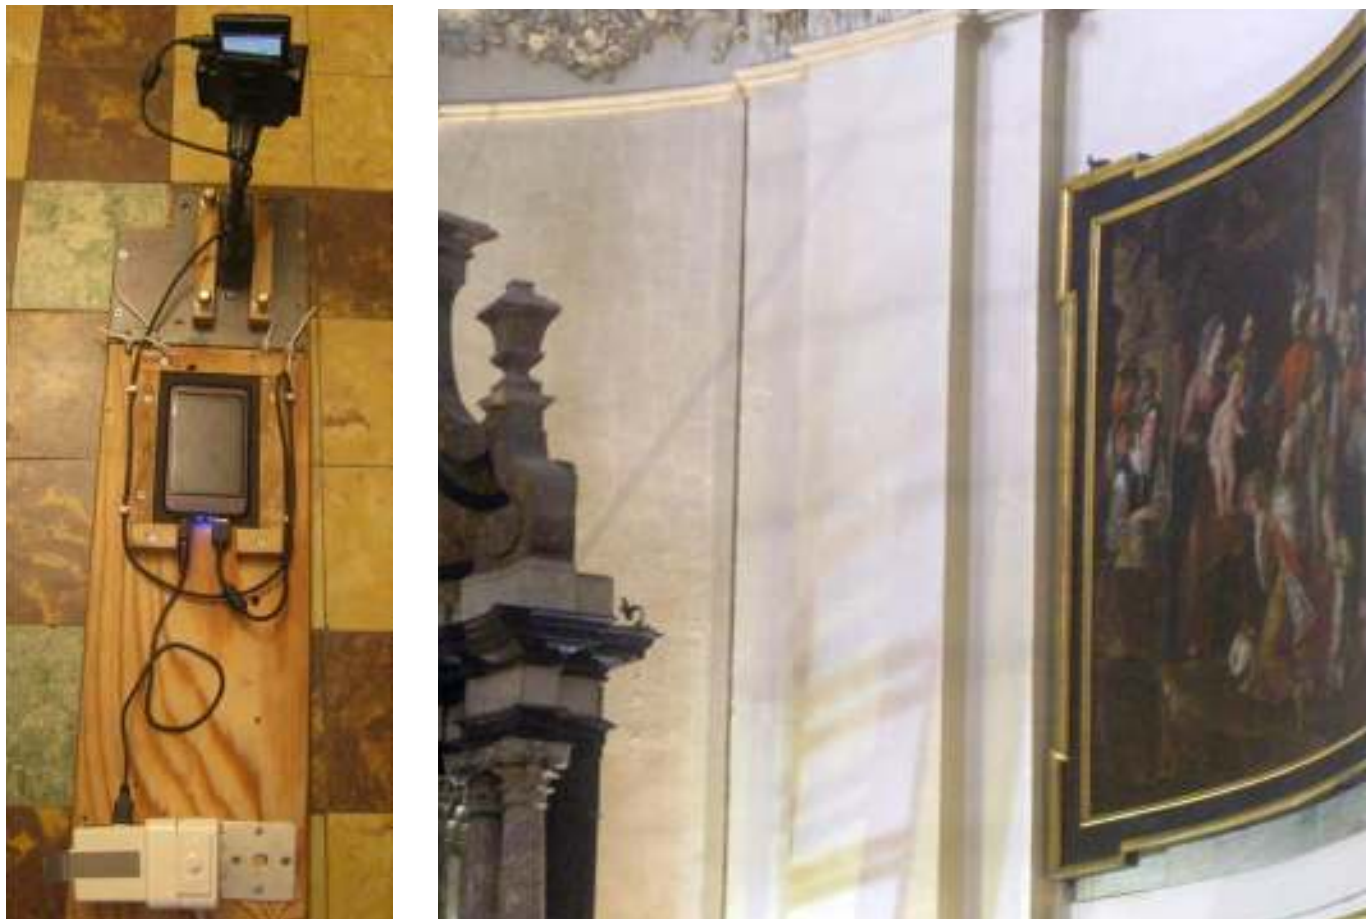
Figure 30. Displacement monitoring using a smartphone: left, equipment; right, smartphone position on the altar's cornice in front of the canvas.

After conservation and restoration works the canvas was repositioned on the church apse wall and monitoring equipment consisting of the smartphone, an external additional battery with a small solar panel and a standard socket charger was used (Figure 30, left). The monitoring equipment was positioned on the altar's cornice with the smartphone camera facing the canvas (Figure 30, right). Several images were taken immediately after the smartphone positioning to test various illumination conditions and their usefulness for monitoring purpose. Taking the monitoring images during the evening church service when most of the light would be switched on independent of the year period was decided.

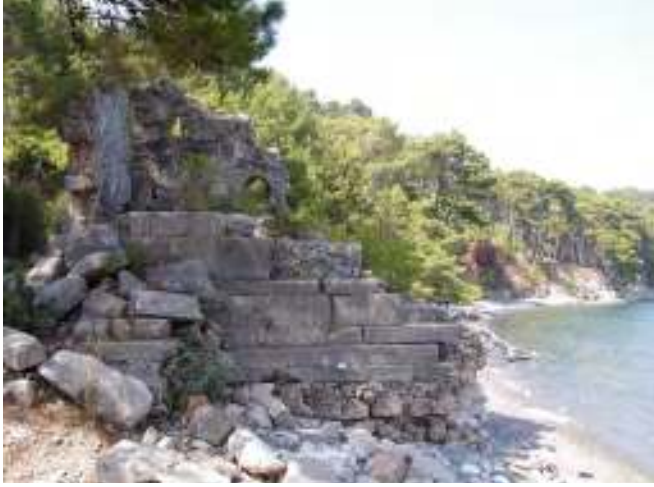
Figure 1. Flexible foundation base.

In earthquake areas; adequate construction would be stiff structure on soft soils, flexible structure on hard soils and rock to prevent resonance. At high seismic zones, the lateral stability of structures was provided by changing the natural frequency of soil or providing flexible base (Figure 1). If the rock bed or hard soil was deep, the foundation walls rested on a pillow layer of sand or gravel; If the rock bed was close to the surface, a flexible base was provided by placing single or more layers of wood at the foundation base [3]. If the rock bed was on the surface, the rock was carved in the form of trough so that each stone of the foundation wall could be placed in the rock as if resting in a cradle [4]. In between the rock and the foundation stone, briar, pieces of coal or animal skin was placed [5].

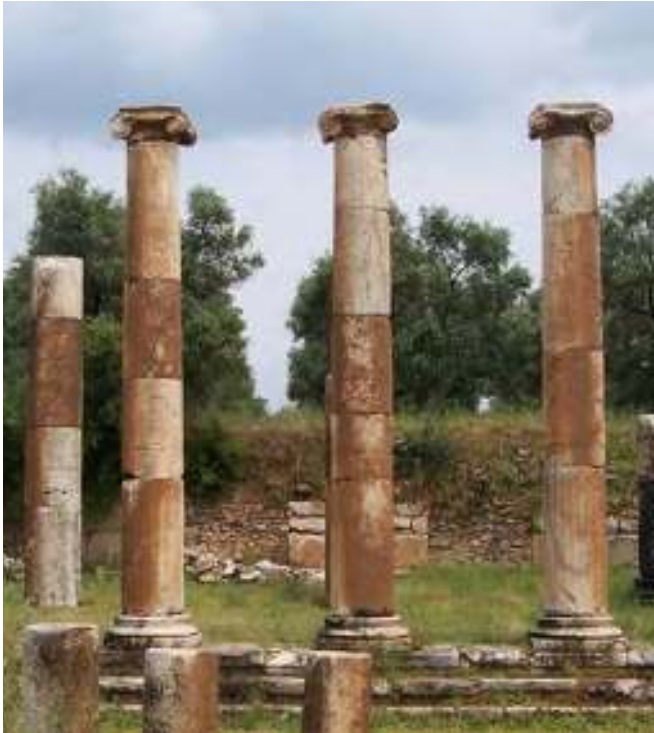
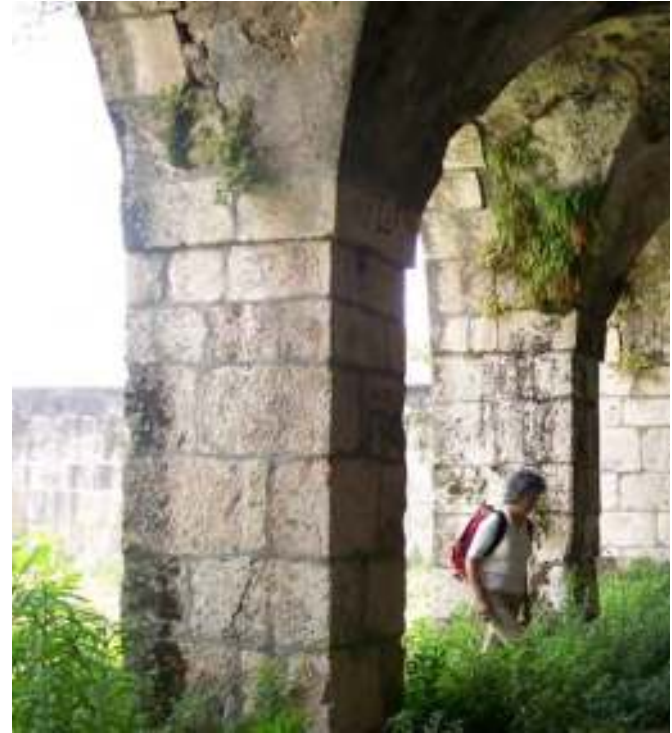
Figures 2a, 2b. Columns and Pier.

cross-section (Figure 2a). A column can be of one piece or several pieces placed one over another. In connection of columns to each other and to other elements are made either thick units rest dry laid one over another or thin units with metal connectors laid in lead. Piers are masonry wall segments constructed of small masonry units (Figure 2b).

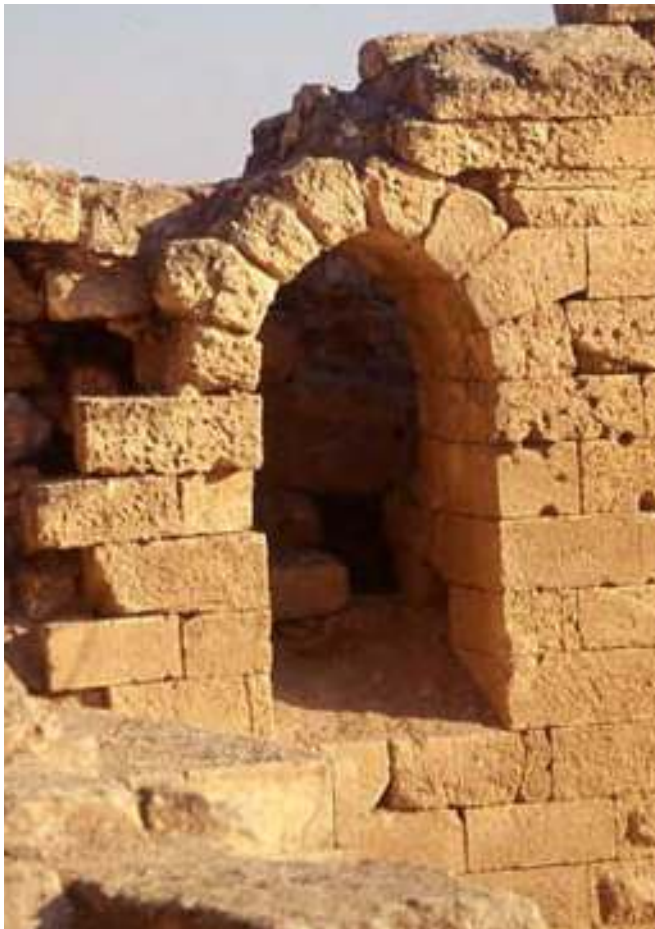
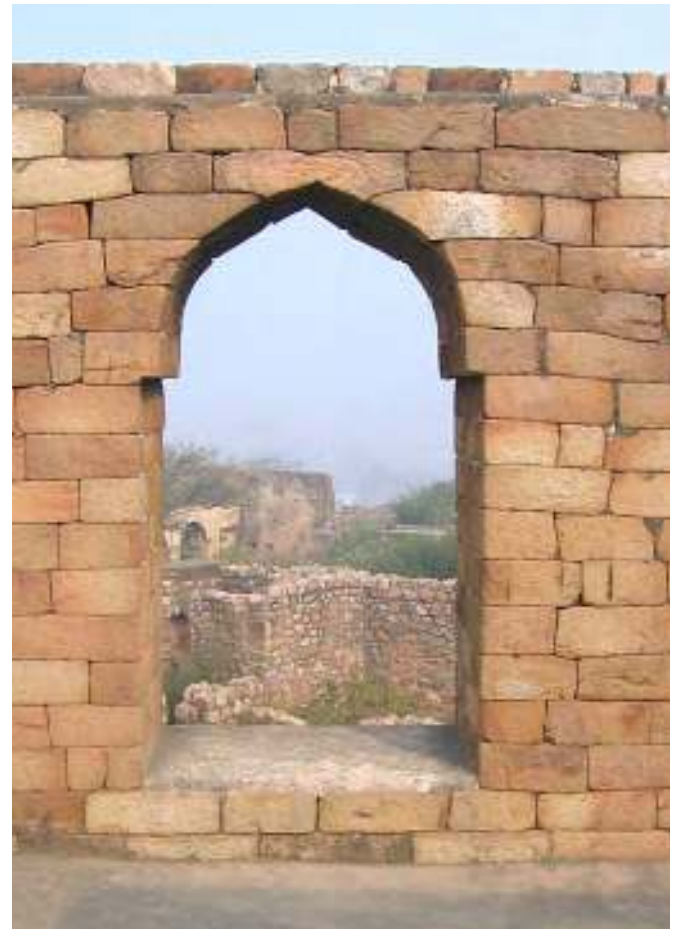
Figure 4a. Openings on the walls: arch, corbelled arch.

In historic masonry construction, the openings for windows and doors were spanned by lintels, by flat arch, by corbelling or by arches (Figures 4a, 4b, 4c). *Lintels* are horizontal elements of stone blocks, iron profiles or timber that span the door or window openings. Length of the span depends upon the material's modulus of elasticity. The *flat* or *lintel* arch, is made of small masonry units with a horizontal soffit

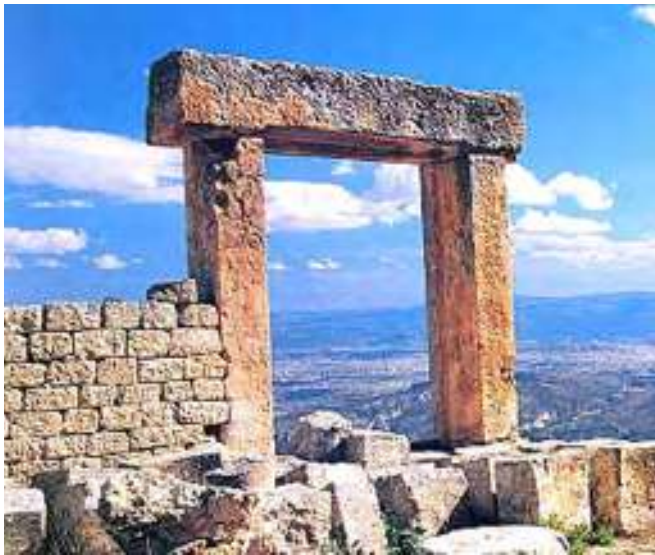
Figure 4c. Openings on the walls: lintel.

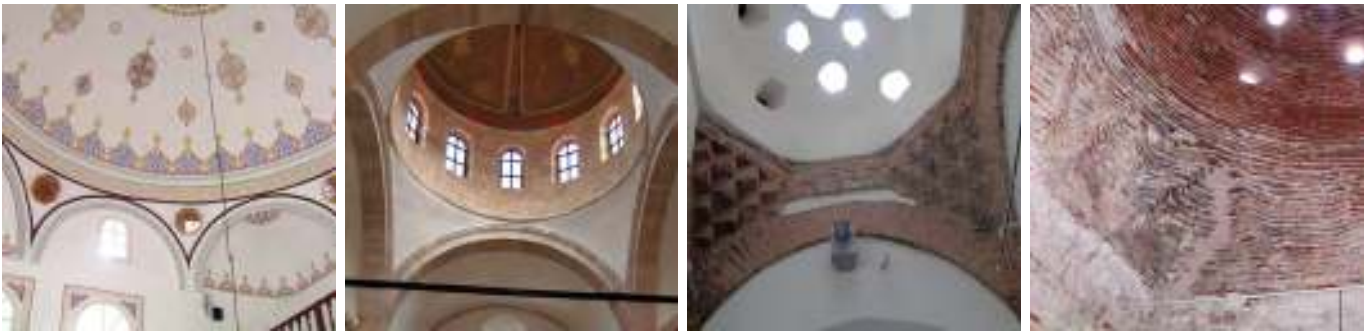
Figure 9. Transition elements.

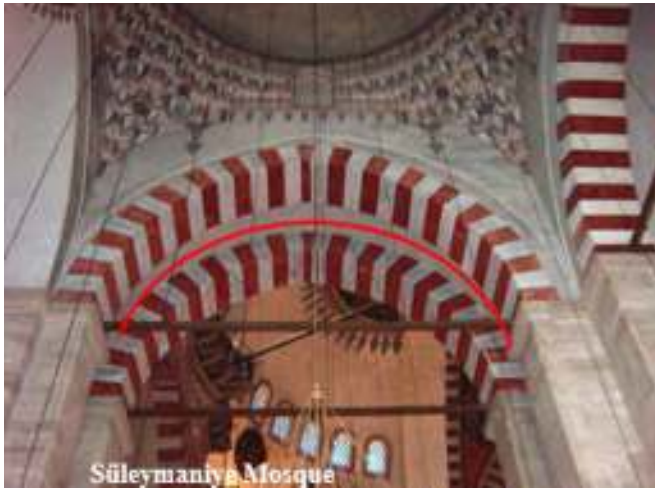
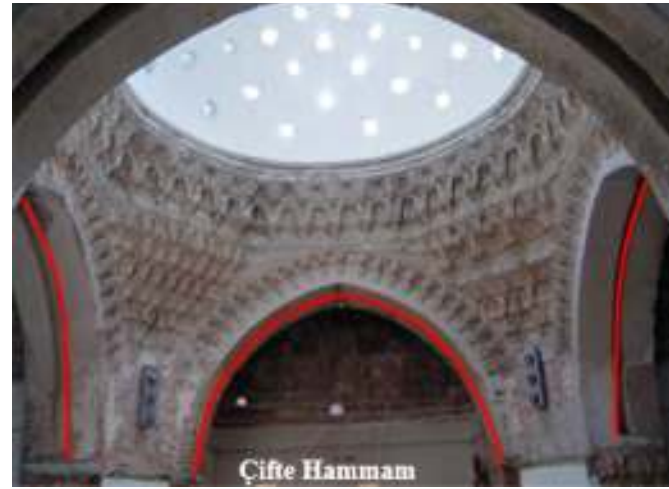
Figure 10. Seismic joints in Süleymaniye Mosque and Çifte Hamman.

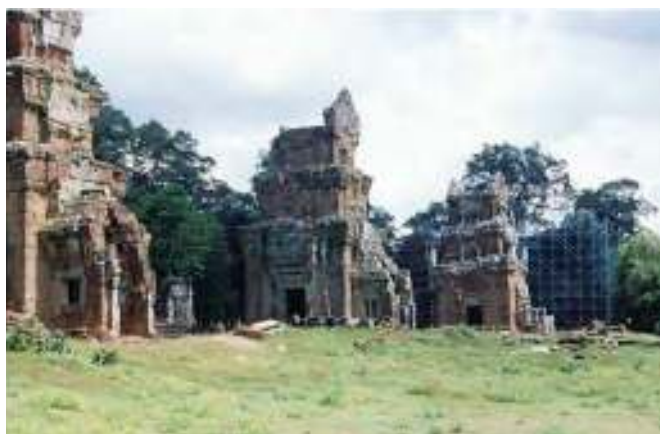
Figure 6. Prasat Sour Prat (Tower of Rope Dancer).

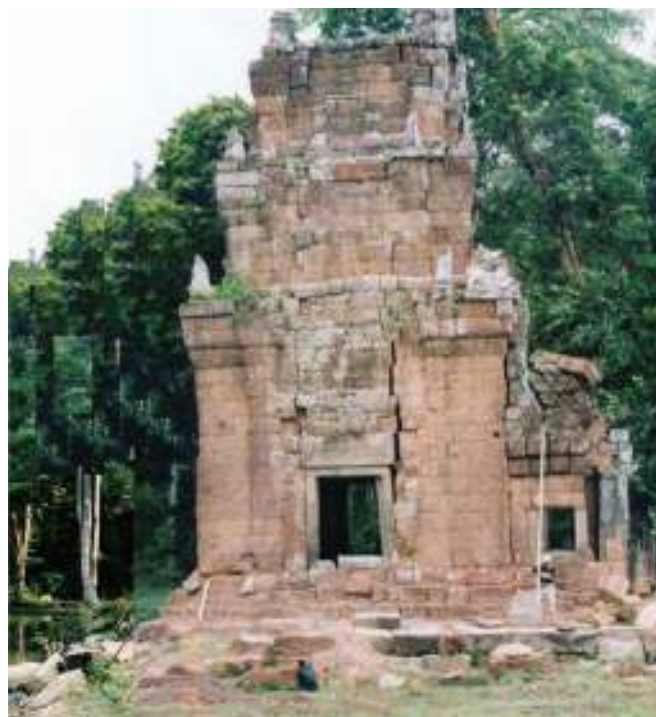
One of the 12 towers named as N1 that is inclined about 5 degrees northwards was selected by JSA for safeguarding work. The tower consists from a main tower with a front room called antechamber. The main tower is three story masonry structures with laterite bricks with 10 m in width at foundation and about 20 m in height. The inside of the tower is hollow structure with four open windows at every wall.

Figure 7. Prasat Sour Prat Tower N1.

Figure 8 shows vertical section and plan view of the N1 tower (Figure 7) near the north pond. The differential

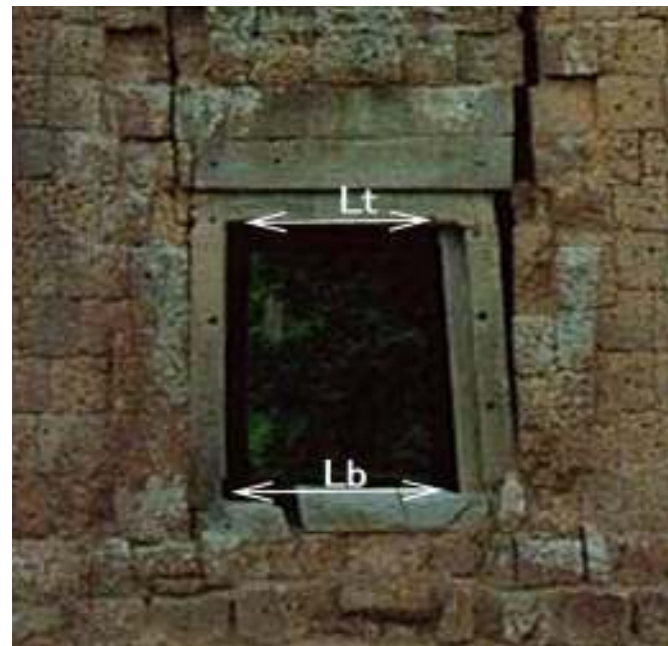
The open window of the west wall is deformed as shown in Figure 9. The widths of the bottom of the window are wider than those of the top for all four walls and the measured results are shown in Table I. The laterite blocks of the side face of the foundation are found widened. The characteristics of the deformation of the foundation are settlement and horizontal spreading. What kinds of deformation could result in the measured characteristics of settlement and horizontal spreading?

Figure 9. Open window of the west side of NI Tower.

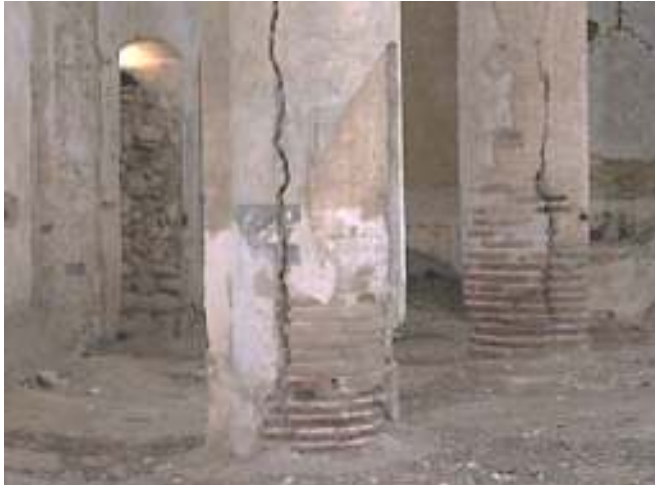
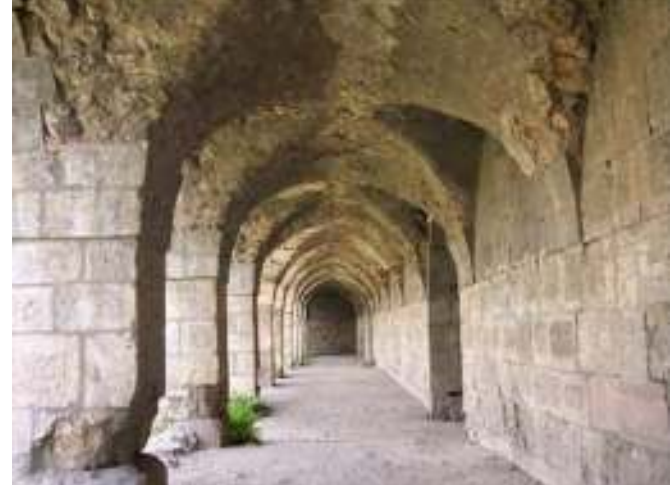
Figures 1a. Vertical cracks; 1b. Loss of the material.

below 60% of compression strength [1]. High compressive stresses may cause splitting, and consequent loss of the material (Figure 1b). In rubble filled walls, the inner core might exert thrust to the outer leaves under gravity loads. Under compression close to the ultimate compressive strength of the material, first vertical cracks, then out-of-plane displacement may be observed. Out-of-plane displacement of a wall may cause overall collapse of the building. Failure in compression may occur in the long term, even at moderate average compression stresses, due to the decay of the material or due to long-term damage (creep).

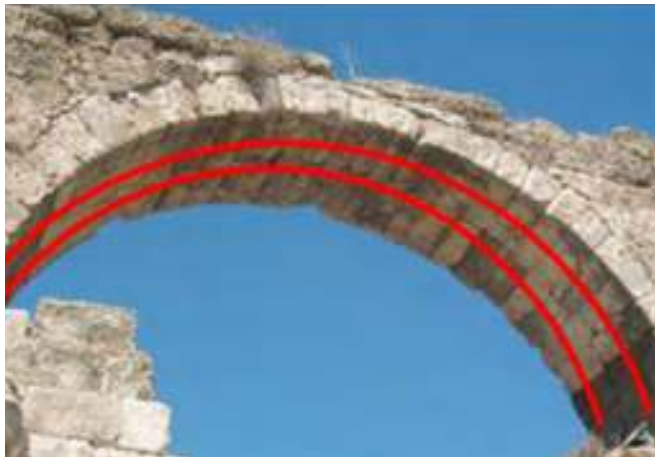
Figure 2. Longitudinal cracks along the arch.

In arches, continued gravity loads may give rise to longitudinal cracks running in the direction of the span near the edge of the arch, to bulging of the spandrels and to cracking of the wing walls [2]. These cracks may indicate that the arch has broken up into narrower rings, each spanning independently (Figure 2). If the cracks are compatible with equilibrium and if the separated parts can resist the load independently these cracks may not

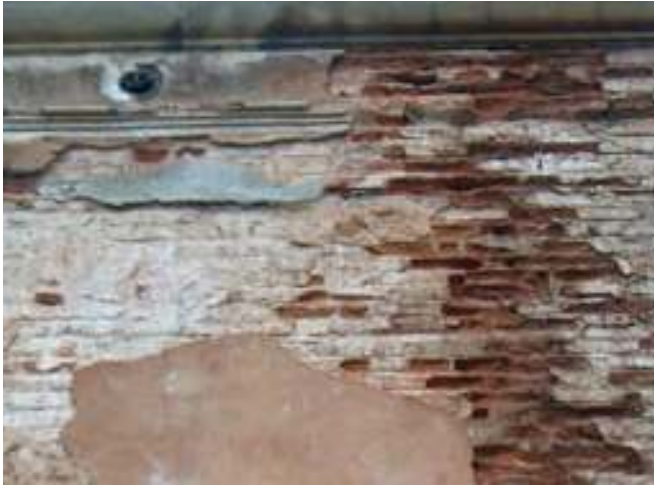
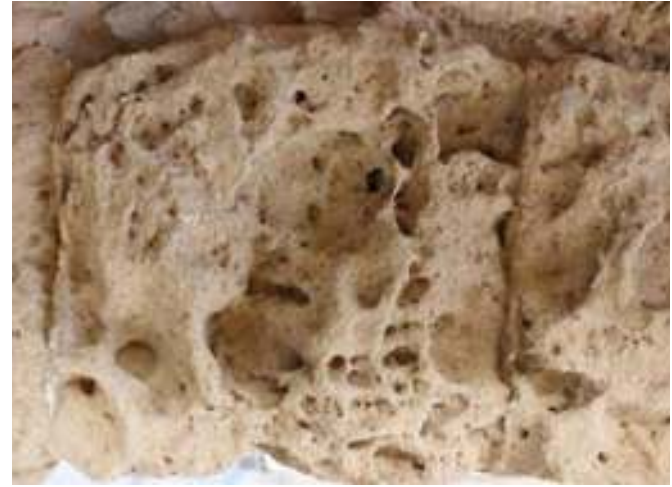
Figures 3. Effect of moisture + wind.
