**The First International  
Workshop on  
Restoration and  
Strengthening of  
Historical Structures**  
*Volume I: Papers*

Iranian Ministry of Cultural Heritage, Tourism and  
Handicrafts (MCTH)  
and  
International Scientific Committee on the Analysis  
and Restoration of Structures of Architectural  
Heritage (ISCARSAH)

# **The First International Workshop on Restoration and Strengthening of Historical Structures**

Ed. María Margarita Segarra Lagunes, Mehrdad Hejazi

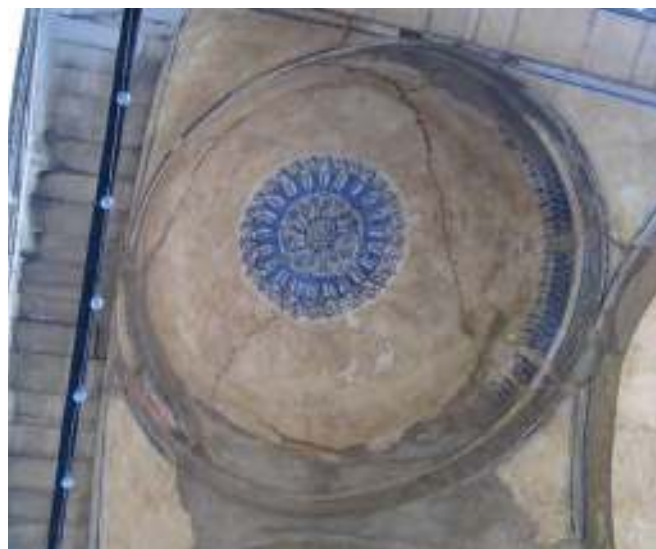
Figures 4. Crack on domes left: radially laid units, right: horizontally laid units (corbelled).

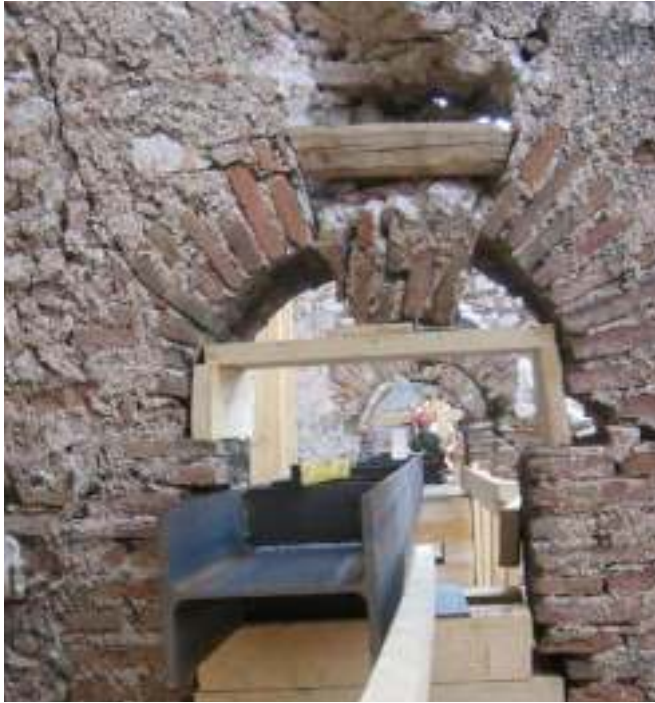
Figures 5. Hinges on the arch.

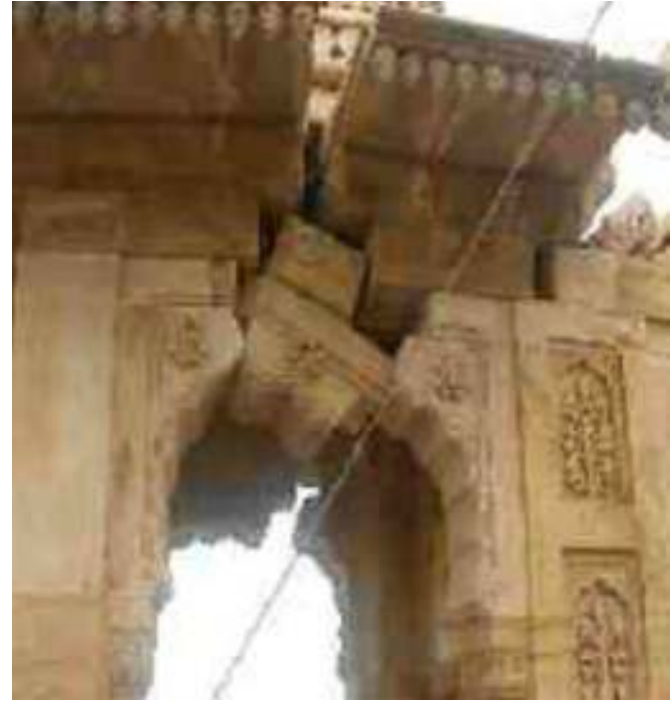
Applying shotcrete on walls, anchoring the steel ties with cementitious material or changing the flooring to reinforced concrete flooring give additional loads to the structure. Hammering of the reinforced concrete floor during earthquake may cause the collapse of wall under that floor (Figure 6).

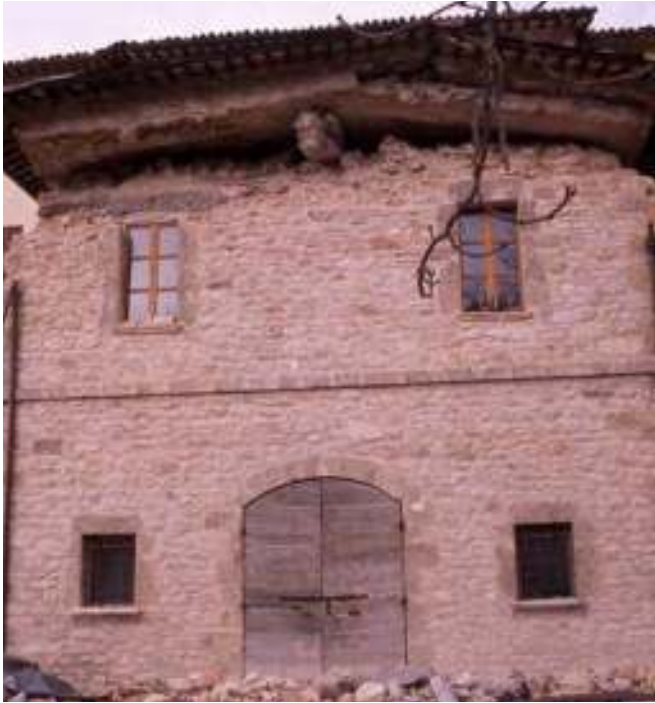
Figure 6. Hammering of RC roof.

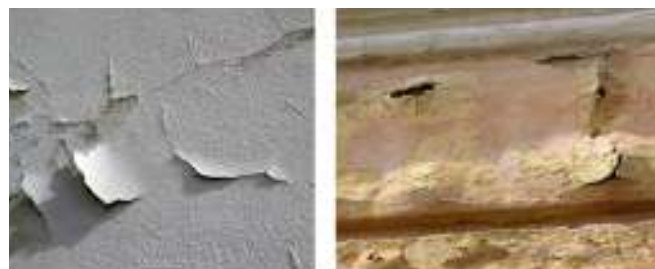
Figure 8. Examples of surface layer blossoming damage.

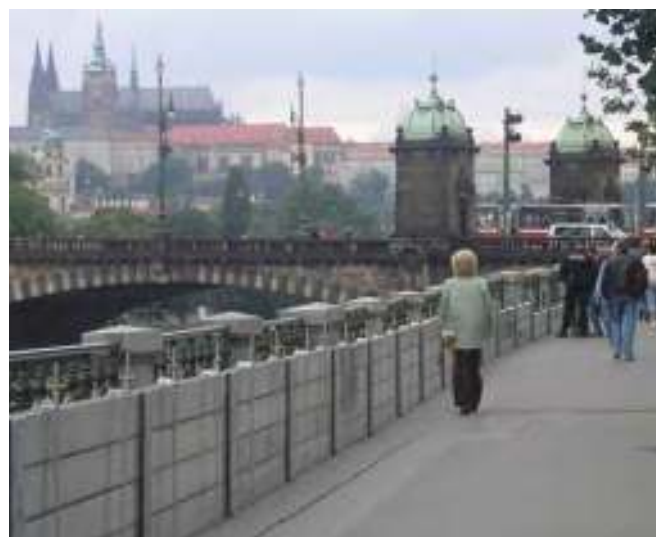
Territorial protection is the most effective using prepared technical means against floods – permanent or temporary ready to be easy installed. Temporary strengthening or additional supports help to free standing walls, sculptures as well as doors and windows (Figure 12). Measures reducing loads is another effective approach, namely temporary removal of objects

Figure 12. Example of temporary protecting wall.

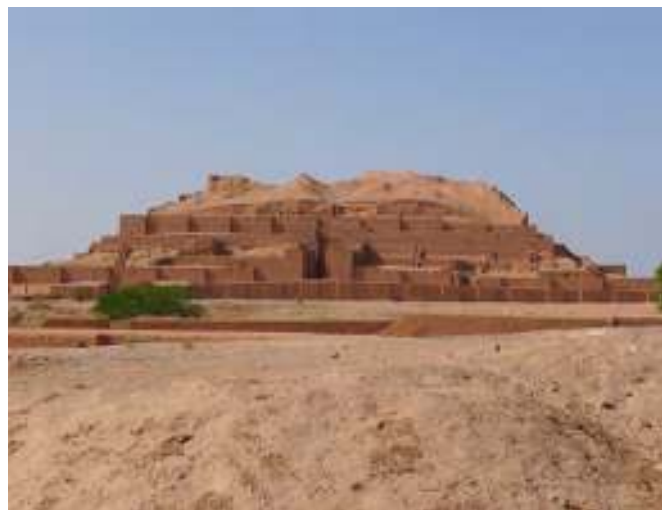
Ziggurats are monumental buildings erected in the Plain of Shinar, between the Rivers Tiger and Euphrates, several centuries after the Egyptian Pyramids. Their functions are scientific and religious, therefore their configurations are no longer pyramidal, but more geometrically elaborated (Figure 1).

Figure 1. Susa Ziggurat (Choqa Zanbil), Iran.

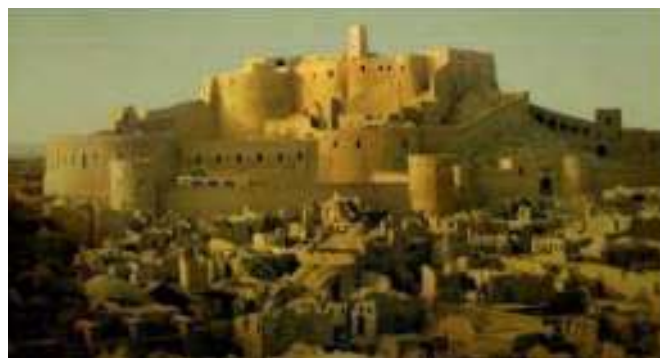
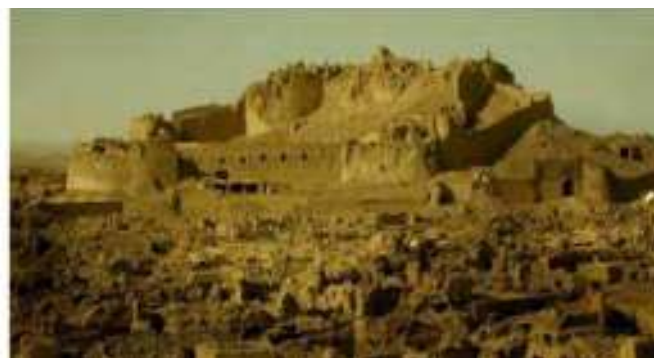
Figures 1. Bam Citadel: 1a. before and 1b. after the earthquake [1].

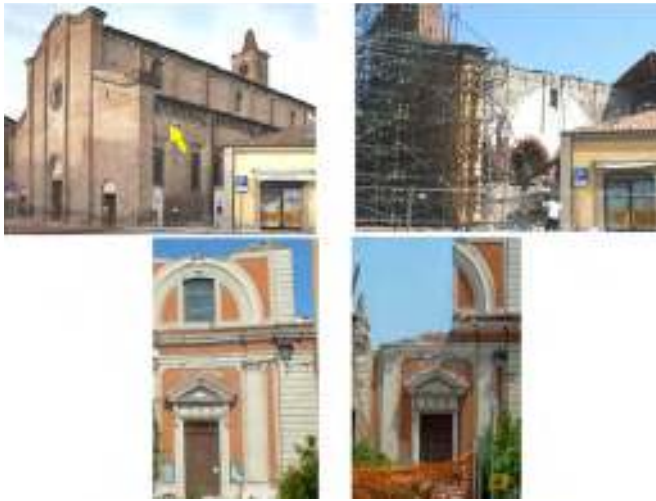
Figures 2. Damages of the church of San Francesco in Mirandola (top) and of the church of D.O.M. in San Felice sul Panaro (bottom), caused by the first shock and the aftershocks [8].

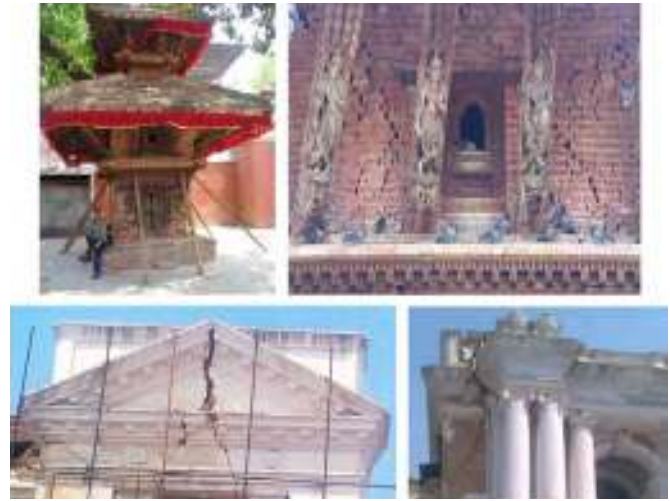
Figures 3. Damaged heritage structures in Kathmandu (Nepal), vulnerable to strong aftershocks.

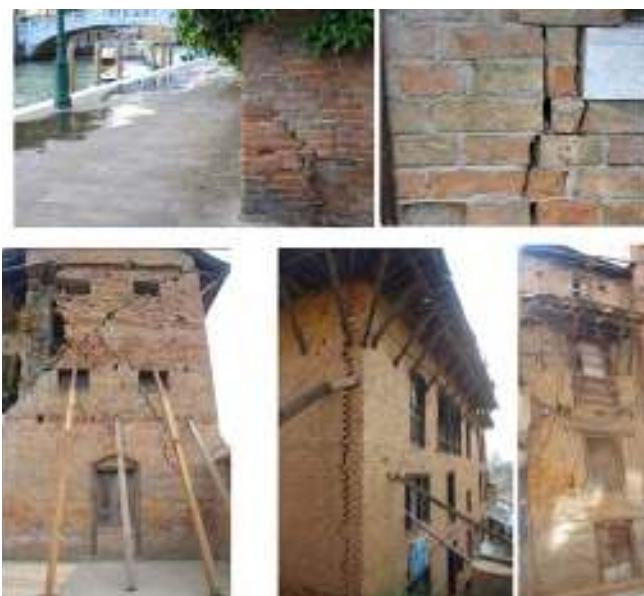
Figures 7. Cracked historical masonry structures with not stable foundation (Venice) and located in seismic areas (Nepal).

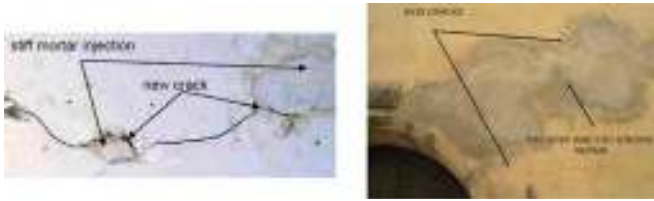
Figures 8. Cracked historical masonry after improper repair using stiff cement mortar.

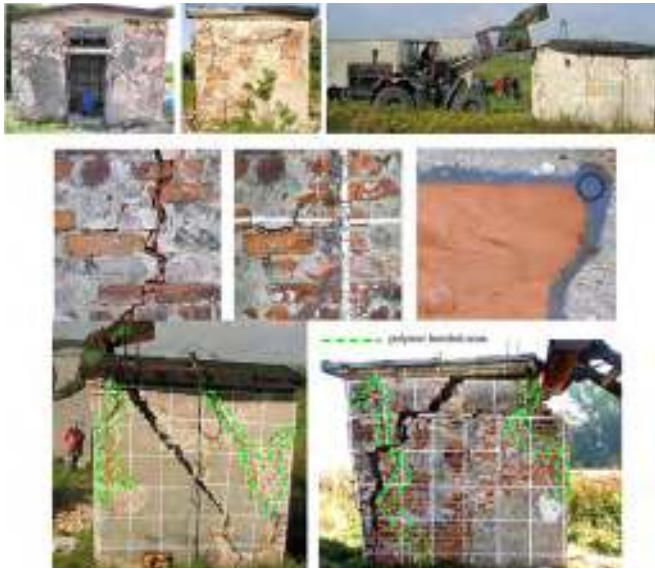
Figures 13. Dynamic in situ tests up to failure on small cracked masonry building, repaired by flexible joints made of polyurethane PM.

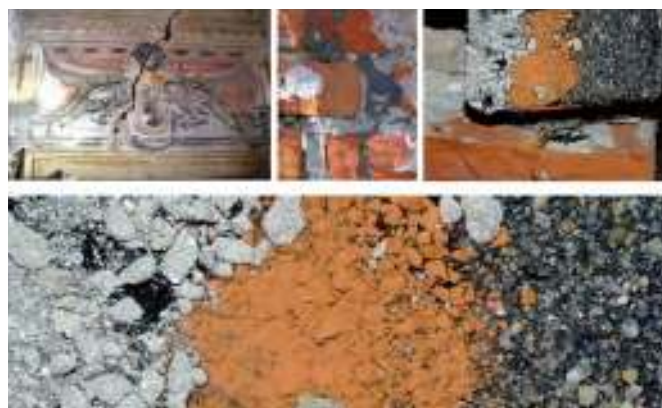
Figures 14. Polyurethane PM easily hidden under conservation materials fitted to the surroundings view, making durable joint of aesthetic external appearance (can be used in protection of frescos).

damaged structures are not allowed to be reconstructed (Figure 3 – cracked heritage structures in Kathmandu after the Nepal Earthquake 2015), thus the best way of assuring construction safety and recovering aesthetic view seems to be the use of PUFJ with the proper external cover (Figure 14).

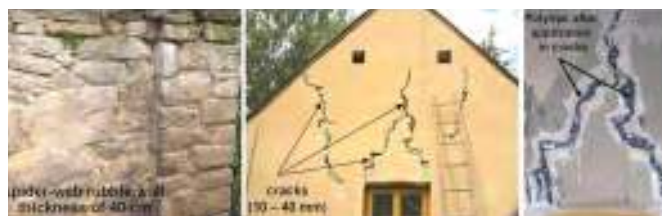
The PUFJ was tested on a masonry family building, constructed from spider-web rubble walls of poor quality. The walls consisted from sand-stones joined with weak lime mortar. Damages in the building appeared in form of cracked wall and were caused by settlement after a flood. The cracks were filled in with the flexible polyurethane PM (Figure 15). Effectiveness of the flexible joint was examined during the window exchange. The triangle wall fragment was suspending only on the newly constructed flexible joint for the period of several hours. There were no fissures on a wall plaster and on gypsum markers placed on the joint (as a simple

Figures 15. Cracks of masonry family building, constructed from spider-web rubble walls of poor quality, repaired by polyurethane PM flexible joint.

monitoring system) as well as no cracks have been observed or fissures on structure till now (for 12 years). This case confirms that flexible joints equalize stresses in brittle materials and protects cracked masonries of the weakened structure against appearing of new damages, during micro-movements occurrence of the separated building parts.

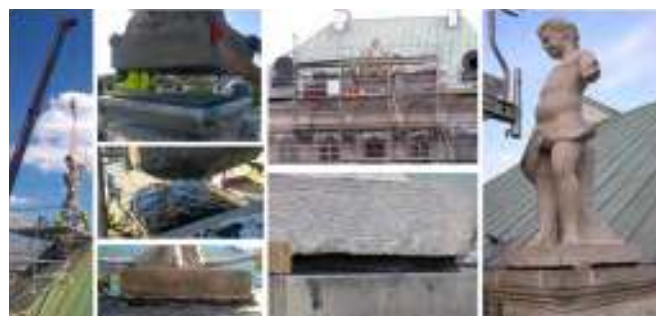
Figures 16. Protection (by prefabricated and constructed on side PUFJ) of heritage sculptures on palaces roofs in Warsaw against traffic vibrations destructing them.

High effectiveness of PUFJ was examined also on real structures during fastening of heritage sculptures on palaces roofs in Warsaw. The aim of flexible bonding was protection of stone figures against traffic vibrations destructing them. The prefabricated PUFJ and constructed on side have been working properly for 8 years (Figure 16).

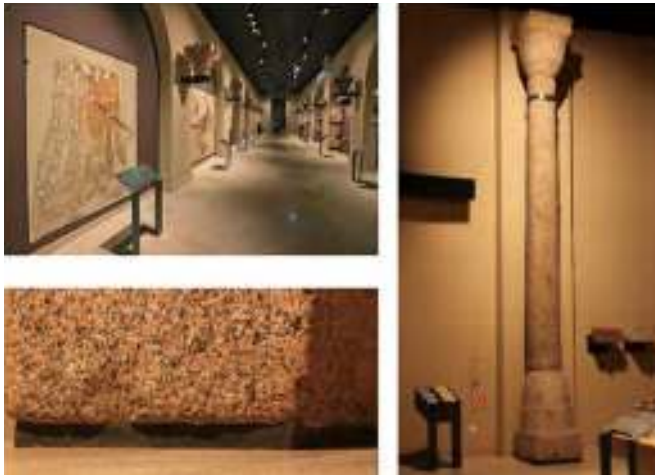
Figures 17. PUFJ damping traffic vibrations at the bottom of a column (Paulos Cathedral from 8<sup>th</sup> century rescued in ancient Pachoras) in National Museum in Warsaw (Poland).

Valuable cultural heritage museum exhibits have to be protected against damage during earthquakes, when are located in buildings in seismic areas or are endangered by dynamic actions (e.g. traffic vibrations). Even small shocks (not harmful to buildings) can demolish historical goods thus proper anti-vibration protections should be used. An example of such protection is presented in Figure 17, where the prefabricated PUFJ damps vibrations at the bottom of museum exhibits in National Museum in Warsaw (Poland).

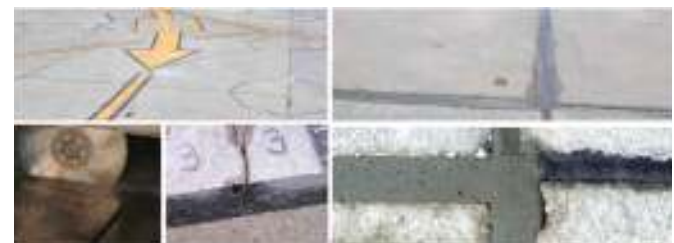
Figures 19. The repair flexible joint made of polyurethane PM, resistant to environmental and chemical factors acting on the joints at the cracked concrete airfield slab in the Cracow-Balice Airport.

Durability and high efficiency of PUFJ were confirmed during 8 years exploitation of a cracked concrete airfield slab in the Cracow-Balice Airport (Figure 19). The repair flexible joint made of polyurethane PM

was able to withstand all environmental and chemical factors acting on the joints during summers (up to  $+40^{\circ}\text{C}$ ) and winters (below  $-20^{\circ}\text{C}$ ) in Poland. The extreme cyclic loads and high deformations (coming from main gears of airplanes) were also carried by the flexible joints without any damage. The ability of transferring high loads and high deformations by PUFJ (made of polyurethane PM) was confirmed during cyclic laboratory tests in real scale. The hysteresis loop manifests good damping properties of the flexible joint [14].

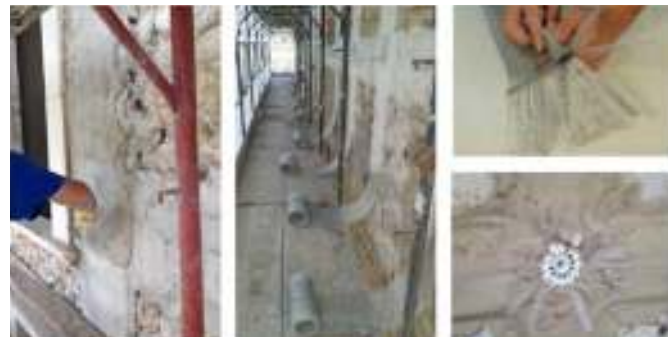
Figures 24. Composite strengthening of an historical building in L'Aquila (Italy), courtesy of Kerakoll.

The composite strengthening started to be use in retrofitting of real historical structures (Figures 24 and 25).

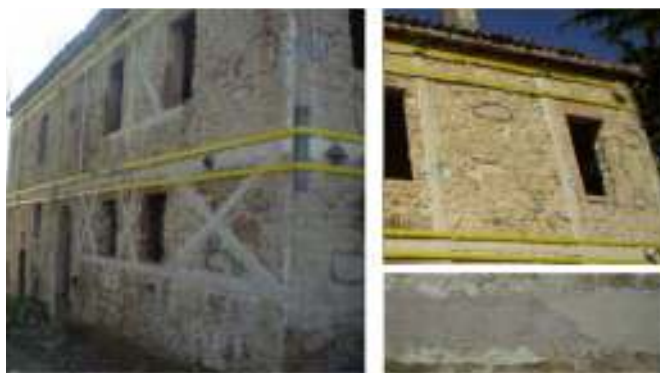
Figures 25. Seismic retrofitting of a damaged masonry building in San Marino, courtesy of Kimia.

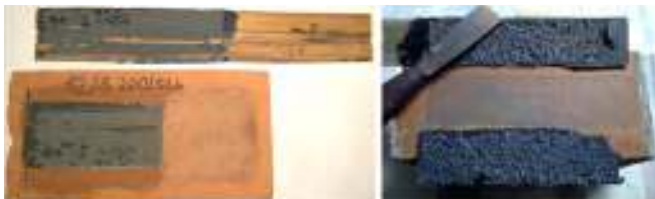
Figures 30. Reversibility of polyurethane PS flexible adhesive – easy removable with a spatula [19].

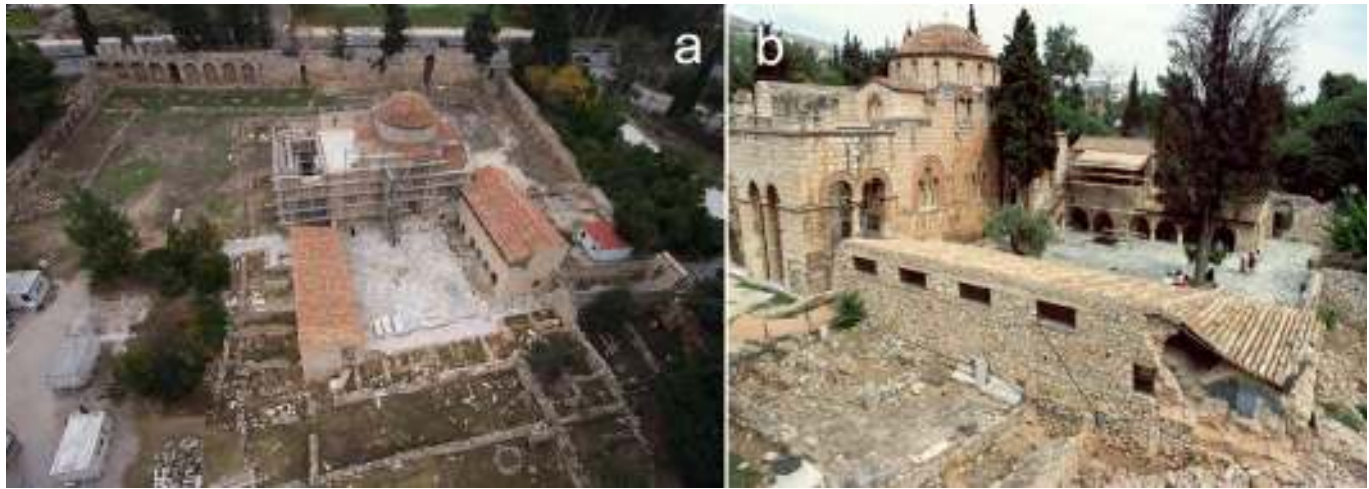
Figures 1a. The Monastery from S-W during restoration and 1b. after the earthquake [8] © Hellenic Ministry of Culture.

Daphni Monastery is one of the major middle-Byzantine monuments [1-4], situated in a forestry area at 11 km from Athens on the Sacred Way of the Classic Antiquity, from Athens to Eleusis. (Figure 1). It comprises various buildings laid out in an almost square plan, constructed over a period starting from the 11<sup>th</sup> century and onwards [3]. Currently, most of the buildings are in ruins, apart from the Katholikon, the two internal ranges of cells, the cistern and the northern fortification walls (Figure 1).

extended collapses in the constructions of the south courtyard and the surrounding ruins. The buildings at the eastern and western side of the yard are the only ones, among the series of cells, that have survived. However, even those buildings preserve at a very limited extent their original byzantine or post-byzantine form, as they underwent large scale reconstruction in the 19<sup>th</sup> and 20<sup>th</sup> centuries (Figure 1b).

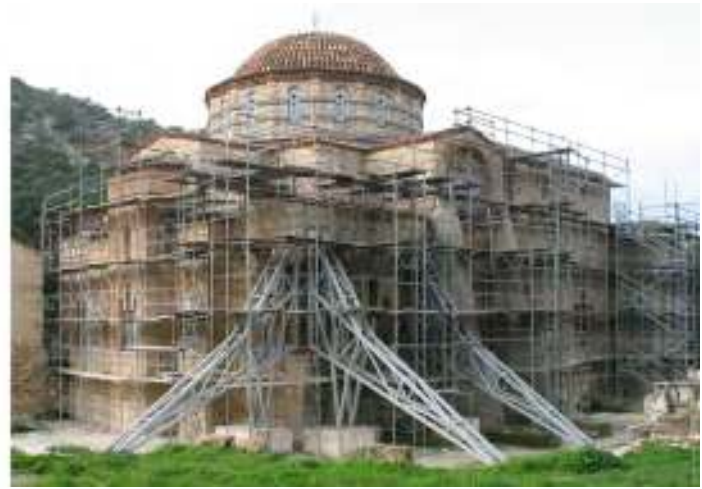
Figure 4. Raking shores installed in the NE corner [5] © Hellenic Ministry of Culture.

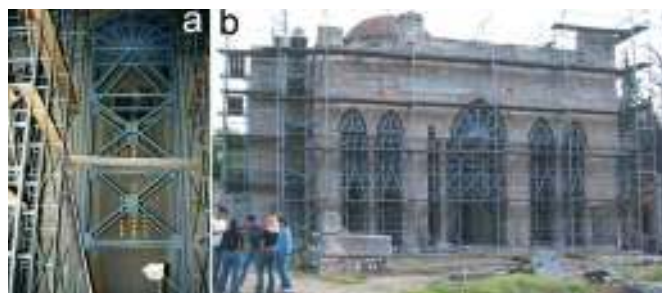
Figures 5a. Vertical steel props in the interior and 5b. in the exonarthex [5] © Hellenic Ministry of Culture.

To this end various alternative solutions were examined [5]. Figure 3 shows schematically the retained one. In the NE corner of the building, three double-framed steel raking shores was constructed, as in this area a pronounced tilting of the external walls has been noticed and the telltales installed just after the earthquake, indicated further opening of cracks and a tendency of the corner to detach (Figure 4). In the interior (Figure 5a), and in the exonarthex (Figure 5b), vertical steel props

were built beneath the main arches, in order to provide vertical support to their cracked structure.

Both the raking shores and the vertical props were self-supported elements, which would be activated only in case of further increase of the deformations of the structure. Thus, between the metal framework and masonry walls, a 12 cm full layer of wooden beams and wedges (together with a 3 mm soft packing) were inserted, to provide good contact with the masonry without harming the surfaces, while allowing relative movement, unless the structure did start to move towards them. Moreover, the upper part of the exonarthex walls and the NW and SW piers were confined using steel plates and bars.

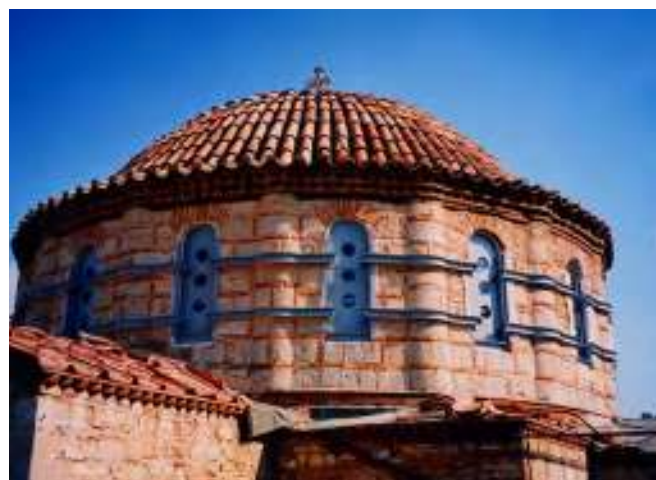
Figure 6. Dome's windows bracing [5] © Hellenic Ministry of Culture.

Regarding the drum of the dome, specially designed steel elements were constructed to brace the windows and confine in two levels the masonry piers (Figure 6), taking special care to assure the in-situ assemblage of all these structures without harming the mural mosaics. Furthermore, the following measures have been undertaken: (a) the installation of adequate types of scaffoldings in the interior and exterior of the church, in order to offer safe working conditions for the Personnel, and (b) the removal of the tiles of the roof and the applica-

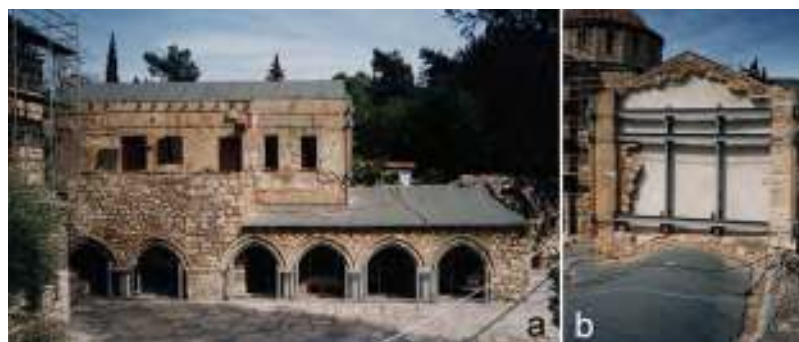
Figure 7a. West façade of the Eastern range of cells and 7b. emergency measures to the collapsed south wall of first floor [8]  
© Hellenic Ministry of Culture.

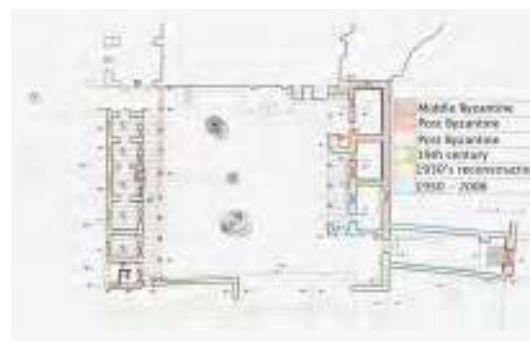
Figure 8. Main construction phases and interventions of the buildings of the south churchyard [8].

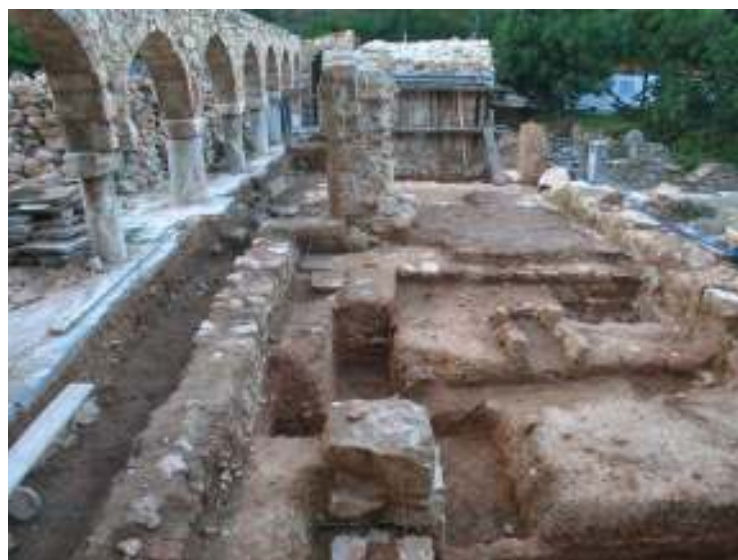
Figures 11. View of the Western range of cells, during the consolidation works of old masonries and of archaeological remains found underneath the 1930's construction (left) and restored (right) [8] © Hellenic Ministry of Culture.

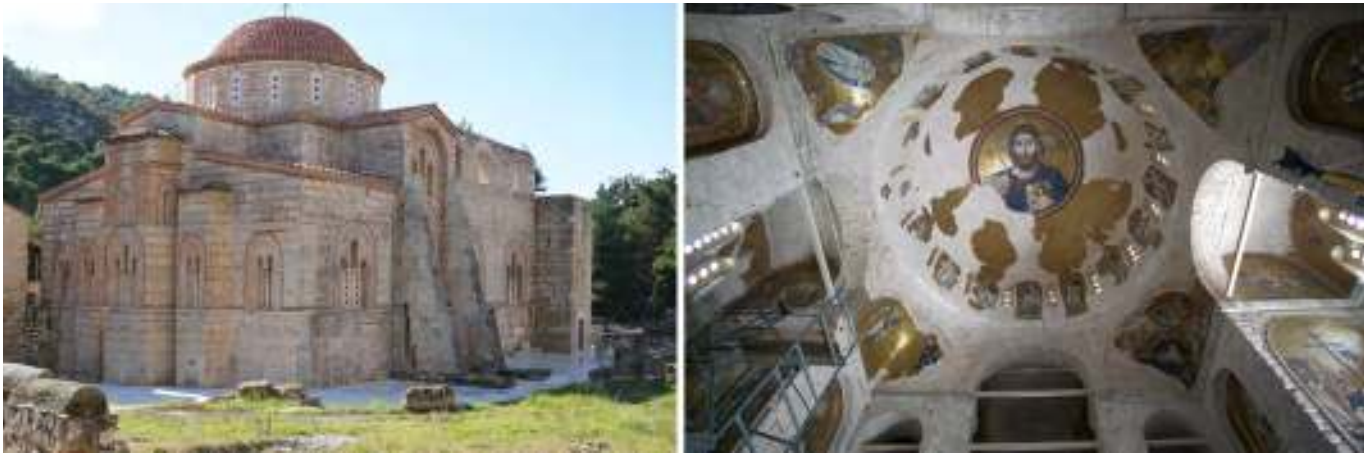
Figure 14. Left, N-E view of the church and right, view of the dome, after the recent restoration works © Hellenic Ministry of Culture.

The Katholikon belongs to the octagonal type and preserves large part of the original mural mosaics of excellent art. It comprises the main church, the sanctuary, the narthex and four chapels, which complete its orthogonal plan. In the western part, only the perimeter walls of an exonarthex or portico and those of a spiral stairway tower leading to the upper floor have survived (Figure

14). The central part of the main church is cross-shaped in plan, the hemispherical dome rising over its square core. The dome has 7.9 m internal diameter and is 16.3 m high, and rests on an almost cylindrical drum with 16 piers and 16 vaulted windows (Figure 14). The dome and its drum are carried by eight pendentives and eight arches (four semicircular and four embodied in the squinches of the corners), forming an octagon and achieving in this way the transition from circle to square. Thus, twelve piers (laying out in a square plan), provide support to the dome together with the groin vaulted arms of the cross, situated in a higher level (Figure 14 left). All the other parts of the monument are covered with byzantine groin vaults.

leaf masonry type, with varying widths of their leaves [25]. Plain brick masonry was used for the construction of all the windows and doors (Figure 14 left), as well as of the entire vaulted roof and all arches, apart from those of the west façade of the portico, where curved stones were used by the Cistercians Monks. In order to proceed to the architectural and structural investigation and analysis and the design of interventions, a thorough geometrical and architectural survey of the monument at a general scale of 1:25 was decided. Furthermore, the recording of its mural mosaics at a very large scale (1:5) was considered necessary, in order to serve the need for a very detailed documentation and design of conservation interventions of the mosaics by the Conservators [9].

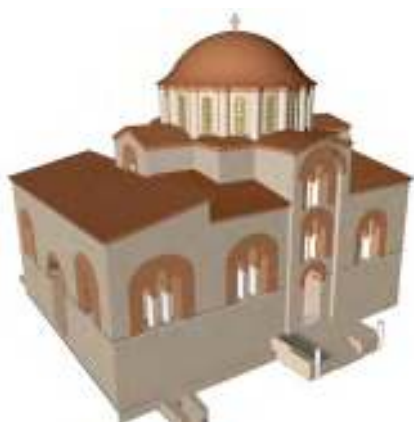
Figure 15. W and S façade: 1<sup>st</sup> construction phase. 3D representation [4].

tion type of masonry is similar in the two phases, the composition and final texture of pointing mortar used is different, thus allowing for the two phases to be identified in situ. The first phase comprises the main church and the narthex (Figure 15). A reddish mortar containing crashed bricks was used for the pointing of the joints of the monument's external façades. At a second phase, a portico or exonarthex was added to the church (in its west part); masonry piers in the corners and marble ionic columns in the middle were used to support the arches of the added perimeter walls. Over the portico and the west part of the church a first floor was also added (Figure 16). Finally, a spiral staircase tower was constructed in the NW corner of the narthex. A whitish mortar with a yellowish patina was used for the pointing of the joints of the external façades.

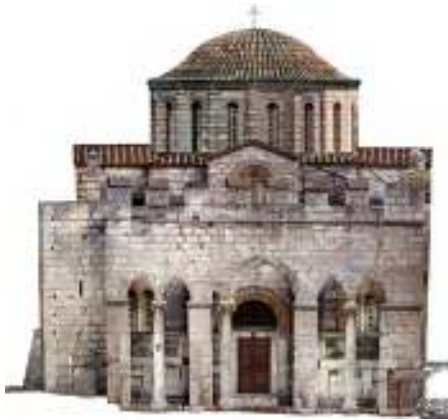
Figure 17. Graphical representation of the W façade of the portico as restored by the Cistercians [4].

the Cistercian monks mainly in the west part of the monument (13<sup>th</sup>-15<sup>th</sup> c.). The upper part of the west wall and the majority of arches, were reconstructed with curved stones following the gothic style (Figure 17). Furthermore, the exonarthex was covered with a timber roof and bastions were built on the top of the walls. The remains of the constructions of the first floor, the narthex and the rest of the church were also locally repaired. These extensive interventions in the west part of the Katholikon can be considered as the third construction phase of the building.

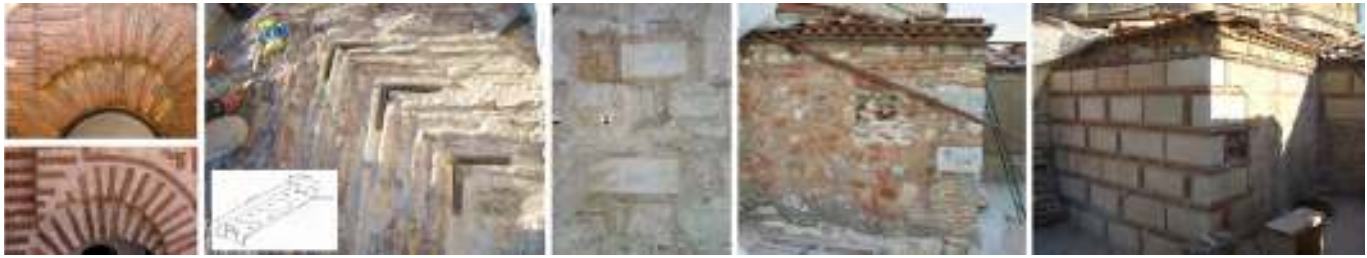
Figure 25. First phase structural restoration interventions (removal of 1960's cement re-pointing mortars, stitching of cracks with titanium plates or stones and local reconstruction to correct past alterations) adapted from [9] © Hellenic Ministry of Culture.

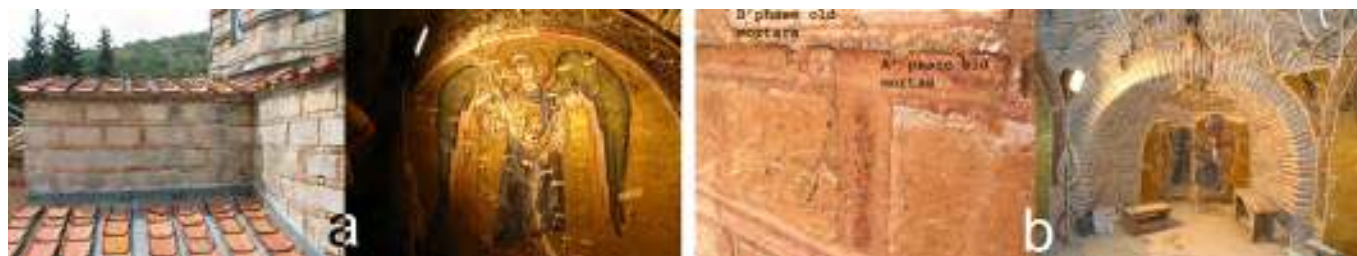
Figure 26a. North external façade of the East arm of the cross bearing old byzantine mortars (left) and the heavily damaged mosaic in its internal façade (right). 26b. External old mortars of 1st and 2nd construction phase (left) and internal precious mosaics, which had to be preserved in situ (right) adapted from [9] © Hellenic Ministry of Culture.

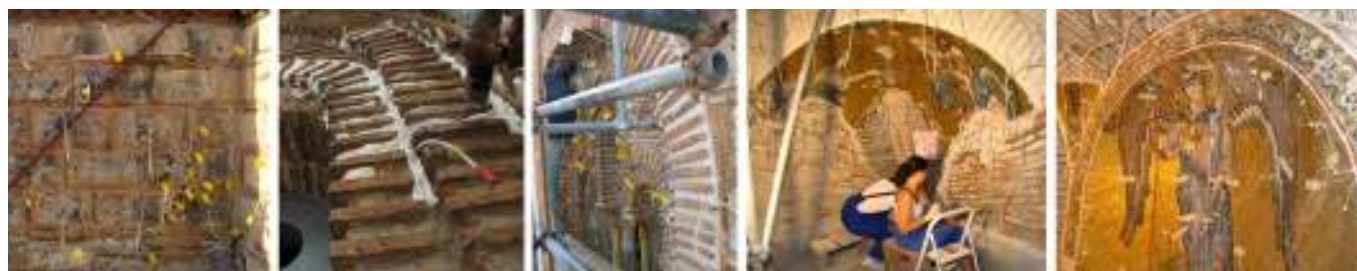
Figure 27. Preparation for grouting of masonry, bearing old mortars and of mural mosaics adapted from [9] © Hellenic Ministry of Culture.

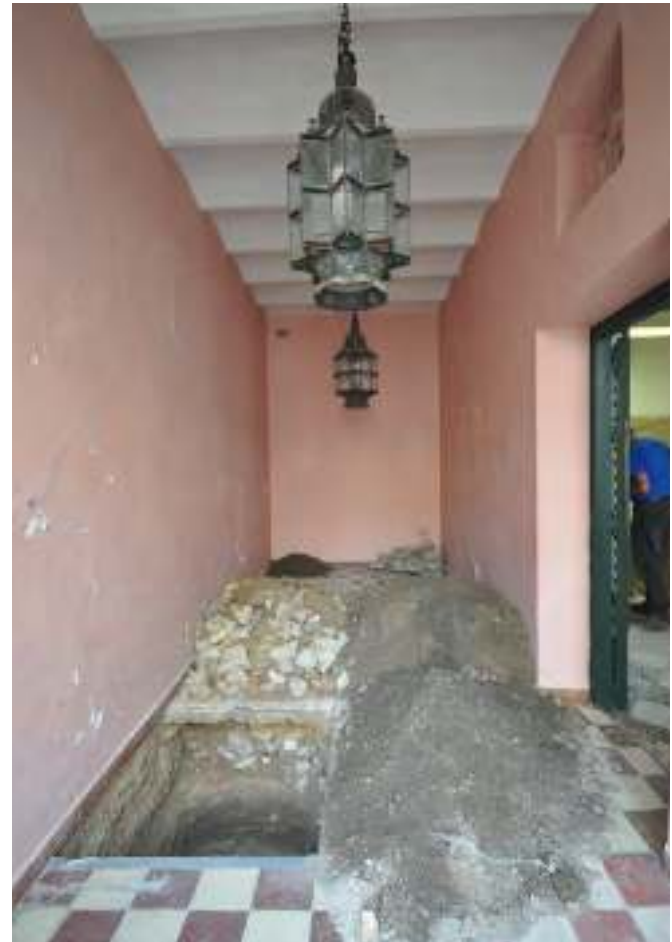
Figure 2. At the Tangier American Legation Museum in Morocco a sondage was required to expose the foundation systems as part of diagnosing issues with building settlement.

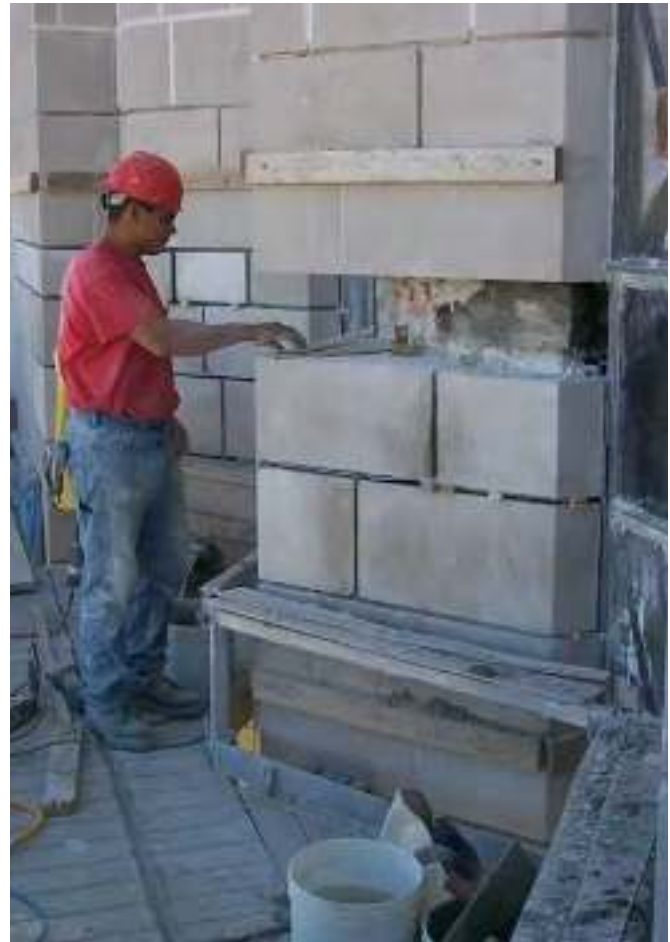
Figure 3. As part of the therapy on the 121 meter tall Nebraska State Capitol, USA the limestone units were selectively removed to expose the steel support structure beneath so that the corrosion could be removed, the steel painted, and flashed prior to reinstallation of the limestone.

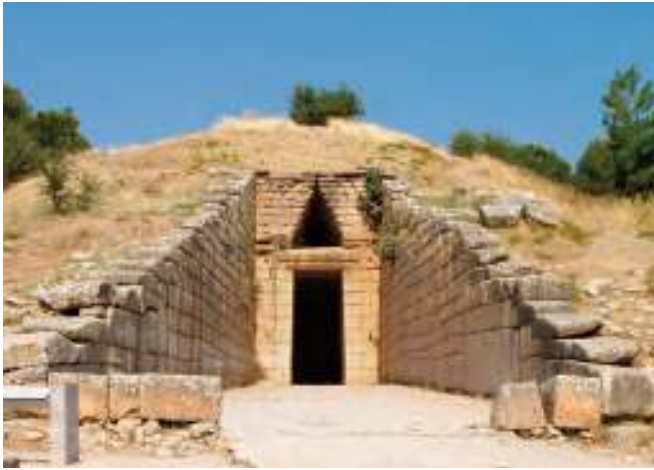
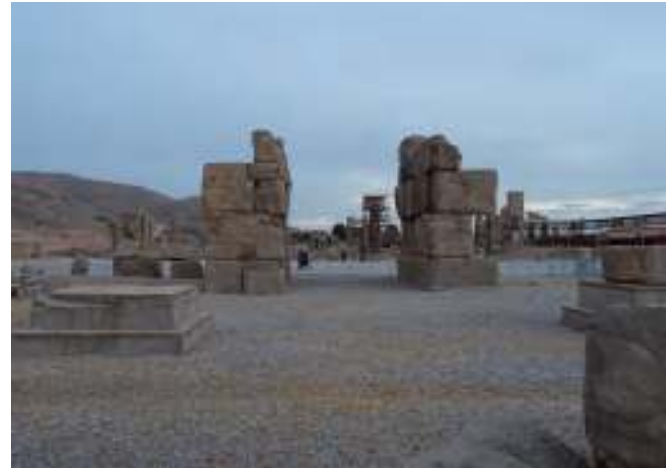
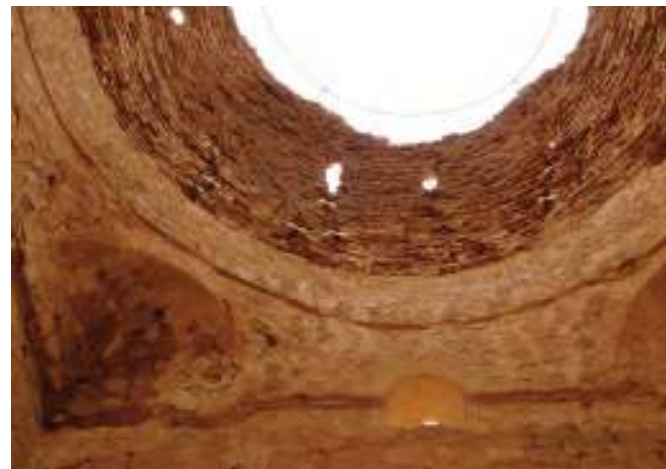
Figures 1. Various types of construction of masonry faces: dry-, brick, stone- and earthwork.

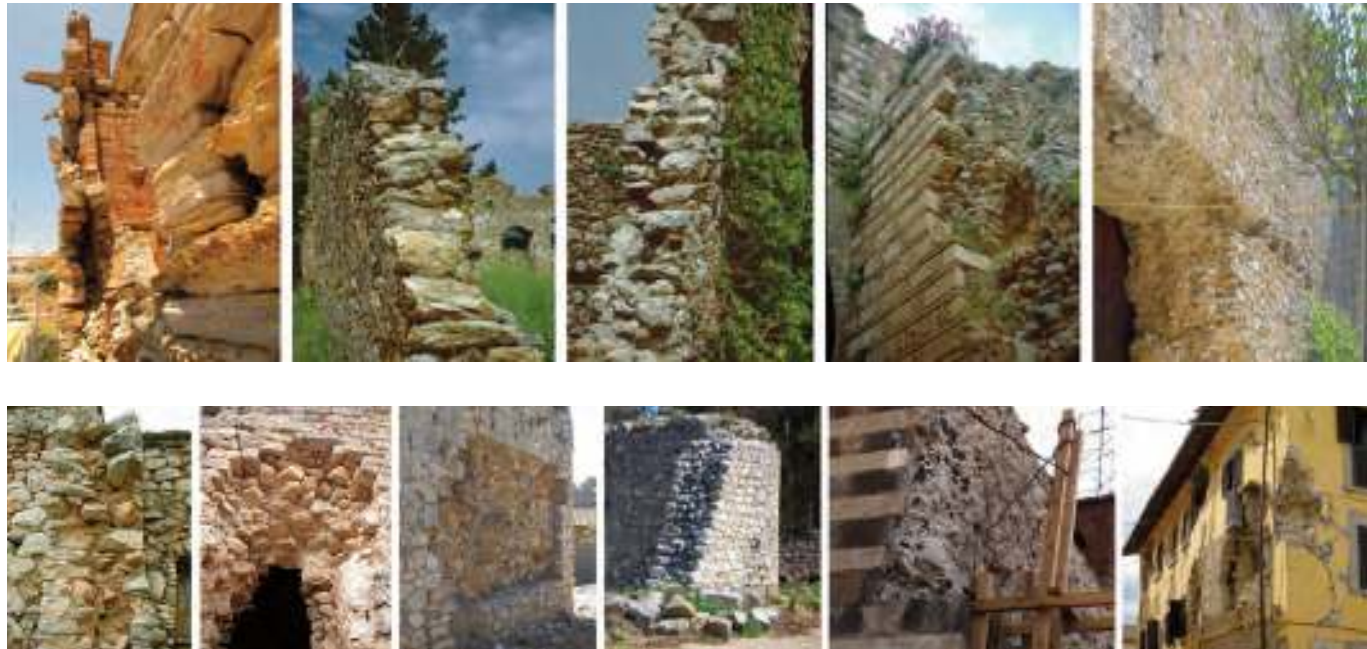
Figures 2. Various types of construction within the thickness of masonry.

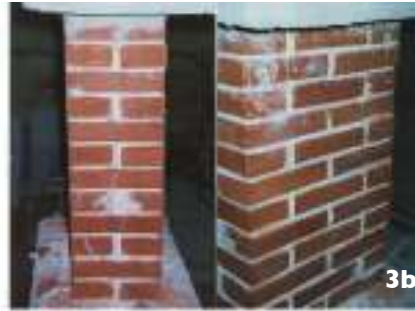
Testing of masonry in compression shows that failure is due to the occurrence of vertical cracks, both on the faces of the wall and within its thickness (Figure 3b). The cracks cross mortar joints, as well as the much stronger masonry units. It should be noted that, in the tests shown in Figure 3b, the compressive strength of the bricks was equal to 50MPa, whereas the compressive strength of the mortar was equal to 1MPa only. The working hypothesis adopted with the purpose of interpreting such a behaviour is the following: As the modulus of elasticity of mortar is

Figures 3a, 3b, 3c. The Mechanics of single leaf masonry to compression.

significantly smaller than that of the masonry units and-on the contrary-the Poisson's ratio of the mortar is higher than that of the masonry units, the vertical stress,  $\sigma_z$ , imposed to the masonry prism (Figure 3c), leads to higher lateral dilatancy of the mortar than the brick. As the lateral deformation of the prism at the level of mortar joints has to be equal for the two bonded materials, the mortar exerts horizontal tensile stresses to the brick, whereas the brick exerts horizontal compressive stresses to the mortar. Thus, the mortar is subjected to (favourable) triaxial compression, whereas the brick is subjected to (unfavourable) heterosemous state of stresses. As a result, the tensile strength of the brick (under simultaneous vertical compression) is significantly reduced and this phenomenon may interpret the occurrence of vertical cracks crossing the strong material. On the contrary, the strength of the mortar in the joints under vertical compression is enhanced, thanks to the presence of

This oversimplified model, based on the (obviously, unrealistic) assumption of elastic behaviour of the constituent materials of masonry, leads to a formula (Figure 3c), in which the ratio between the compressive strength of masonry and that of masonry units ( $f_c$  and  $f_{bc}$  respectively) is expressed as a function of the Poisson's ratio of the two materials ( $v_b$  and  $v_m$ ), the ratio between the moduli of elasticity of mortar and brick ( $\beta$ ), the ratio between tensile and compressive strength of the unit ( $\lambda$ ) and, finally, on the ratio between the thickness of the mortar joints and the height of the masonry units ( $t_m/t_b = \alpha$ ). Although oversimplified, this formula is able to predict with sufficient accuracy experimental results obtained from

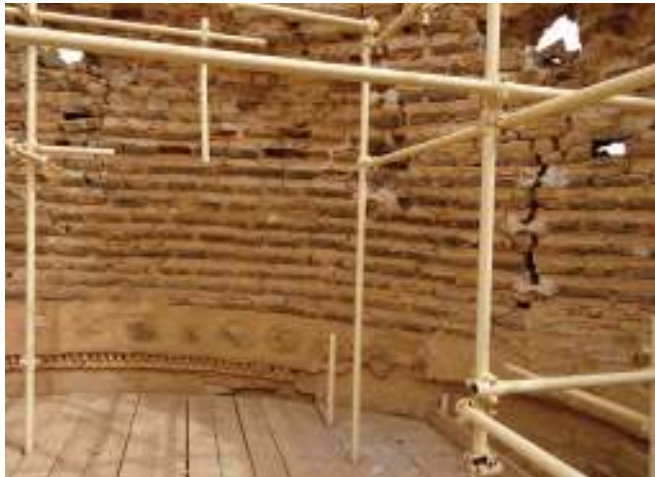
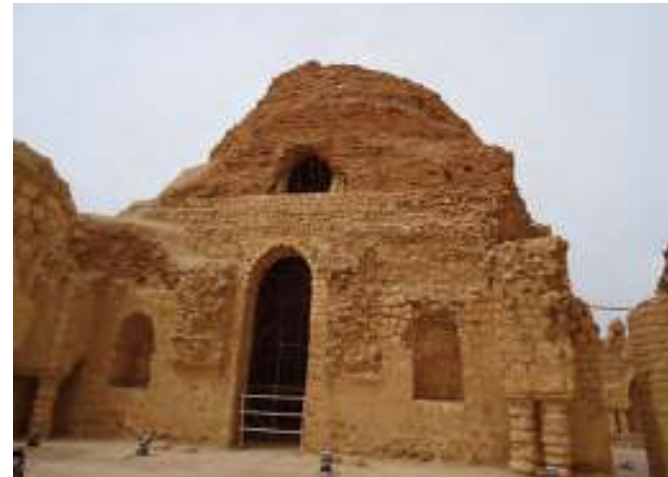
Figures 4. Typical historical masonries in Iran.

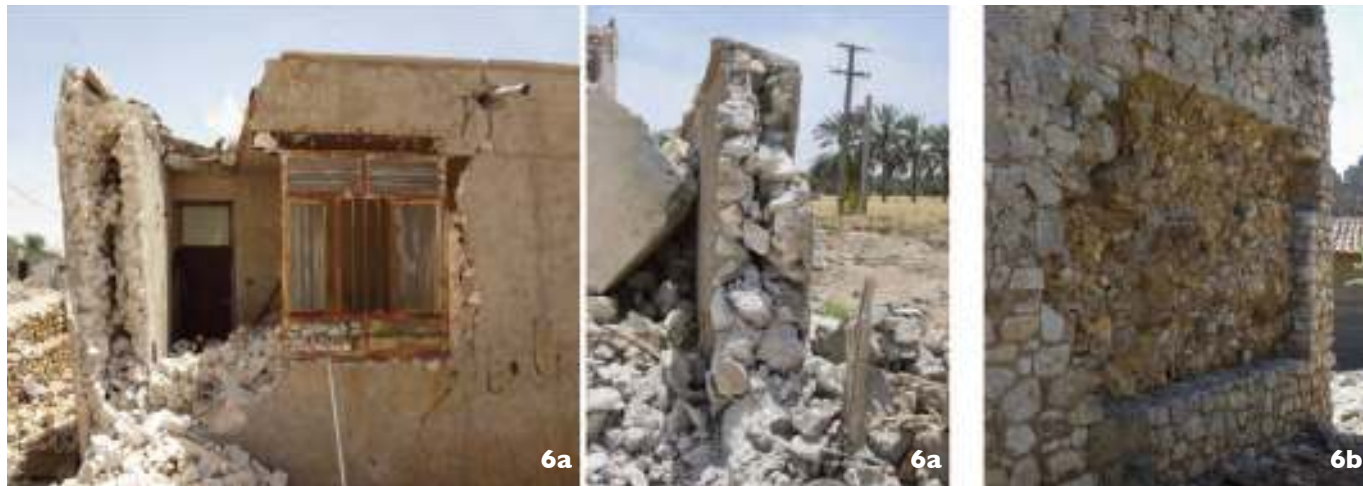
Figures 6. Three-leaf masonries in: 6a. Iran [6] and 6b. Greece.

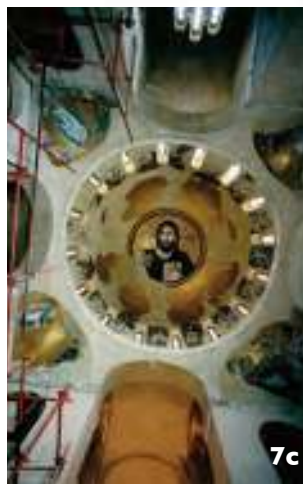
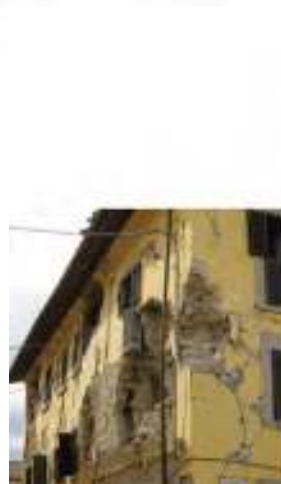
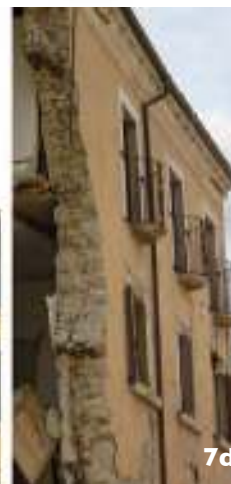
Actually, in the two graphs of Figure 7b, one can see the horizontal deformation of the wallette shown in Figure 7a (the horizontal deformation stands for the sum of openings of all vertical cracks on the faces of the wallette), as well as the transverse deformation (which stands for the sum of the openings of all vertical cracks within the thickness of the wallette) vs. the imposed vertical load. One may observe that, although both families of cracks-those on the faces and those within the thickness-occur more or less at the same

Figures 7a. Crack pattern of a wallette tested in-lab [7], 7b. deformation vs. vertical load for wallettes tested in [7], 7c. the cupola of the Katholikon of Dafni monastery supported by arches and squinches, 7d. cracks within the thickness of masonry walls after the 2016 Rieti earthquake, Italy.

level of loading (approximately equal to 1/3 of the maximum load), from then on, the cracks within the thickness open much faster than the cracks on the faces of masonry. Indeed, at the point of attainment of the maximum load, the total opening of cracks on the faces is of the order of 1,0mm, whereas that of cracks within the thickness is 5 to 6 times larger. Thus, this tendency of the individual exterior leaves to bend outwards is confirmed, although the tested wallettes were of very limited slenderness. The question arises whether those in-laboratory observations are confirmed also in-situ.

As shown in Figure 7d, such a separation occurs in some cases as a crack between the leaves of masonry, in others in a rather catastrophic form. What is also of significance for the Structural Engineer who is responsible for the assessment of a historical structure at its current state is that the (critical for the bearing capacity of the element)

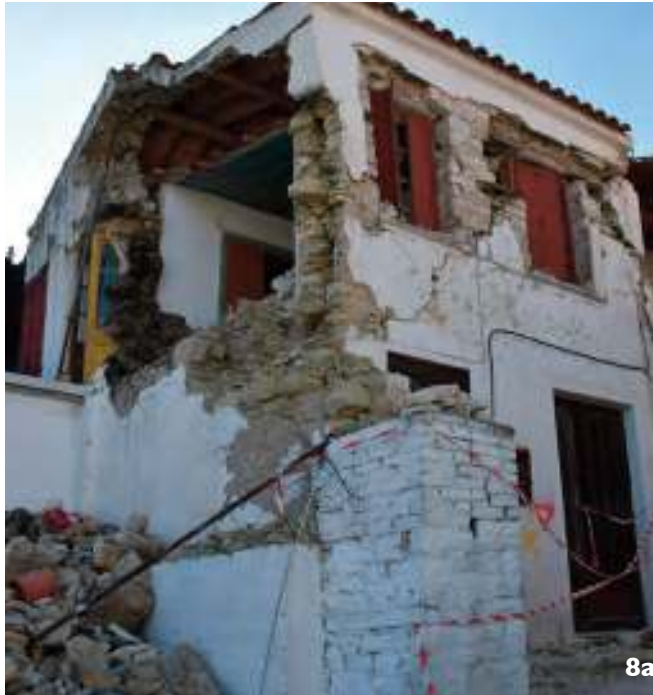
Figures 8. The effect of separation of the leaves of masonry: 8a. In-plane shear and partial out-of-plane collapse of a three-leaf wall and 8b. Out-of-plane collapse of the central region of a wall.

However, due to the separation of the leaves, the shear resistance of the weakest leaf is governing. The combination of in- and out-of-plane seismic action led to the partial collapse of the exterior leaf. In fact, the exterior leaf is subjected to smaller vertical load (as the roof is supported mainly by the interior leaf) and, hence, it is more vulnerable both to in-plane shear and to out-of-plane bending.

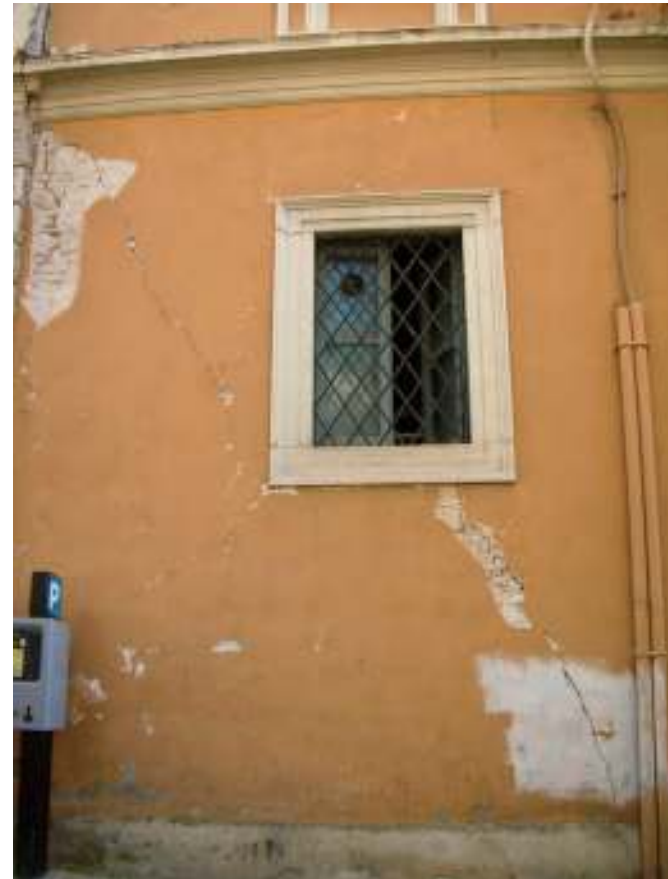
Do shear cracks pass through mortar joints exclusively or do they cross masonry units as well? As shown in Figure 14, the morphology of shear cracks depends on several parameters, namely: (i) The relative mortar to masonry unit mechanical properties. Actually, in the usual for stone masonries case, where the strength of stones is by orders of magnitude higher than that of the mortar, shear cracks pass through mortar joints exclusively. On the contrary, in earth construction, where earth masonry units are of

similar strength with earth mortar, cracks are expected to cross both units and mortar. (ii) The size of masonry units and the thickness of mortar joints. As shown in Figure 14c, although before removing the plaster the crack seems to be rather like a straight line (insinuating that it crosses both mortar and masonry units), the removal of plaster reveals a masonry constituted by small size stones and thick mortar joints. Thus, the crack finds an easy way to travel through the mortar joints, without any need to deviate, in order to avoid the (stronger) stones.
