**The First International  
Workshop on  
Restoration and  
Strengthening of  
Historical Structures**  
*Volume I: Papers*

Iranian Ministry of Cultural Heritage, Tourism and  
Handicrafts (MCTH)  
and  
International Scientific Committee on the Analysis  
and Restoration of Structures of Architectural  
Heritage (ISCARSAH)

# **The First International Workshop on Restoration and Strengthening of Historical Structures**

Ed. María Margarita Segarra Lagunes, Mehrdad Hejazi

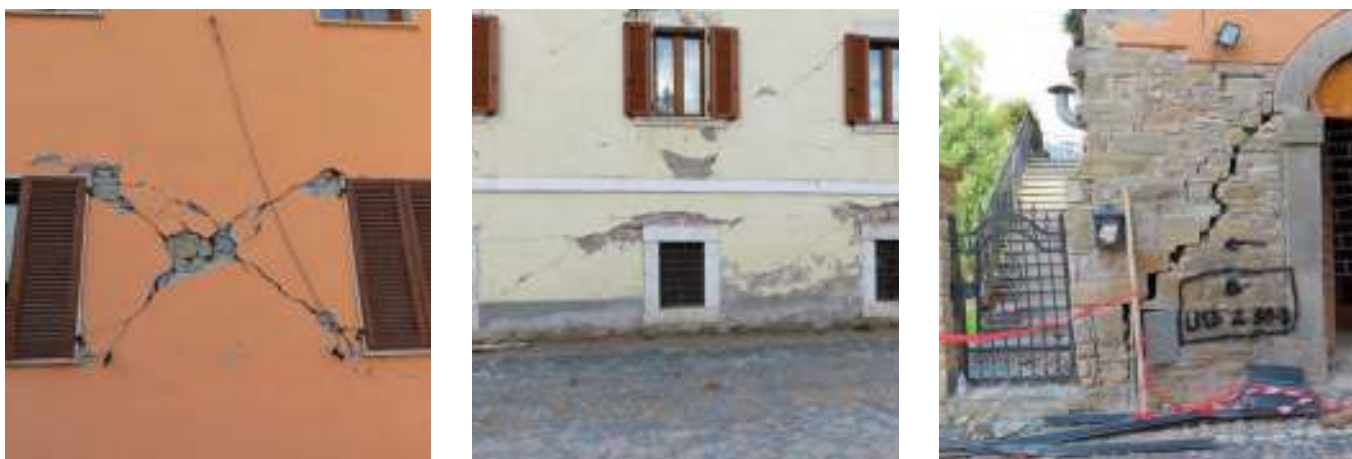
Figures 13. Typical damage due to in-plane shear.

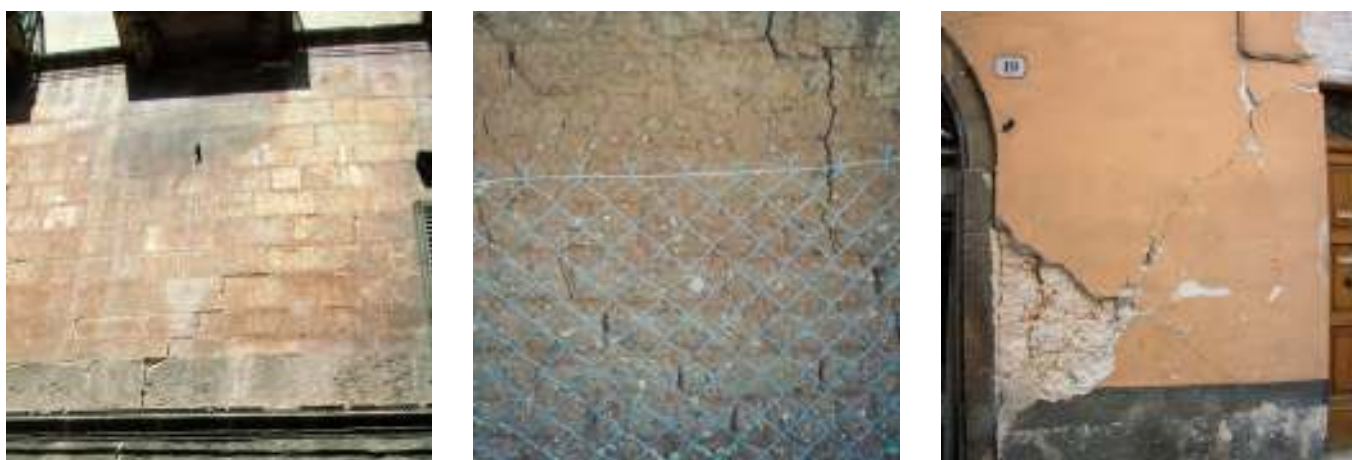
Figure 14. Morphology of shear cracks in 14a. Stone masonry, 14b. Earth masonry, and 14c. Masonry made with small size stones and thick mortar joints.

similar strength with earth mortar, cracks are expected to cross both units and mortar. (ii) The size of masonry units and the thickness of mortar joints. As shown in Figure 14c, although before removing the plaster the crack seems to be rather like a straight line (insinuating that it crosses both mortar and masonry units), the removal of plaster reveals a masonry constituted by small size stones and thick mortar joints. Thus, the crack finds an easy way to travel through the mortar joints, without any need to deviate, in order to avoid the (stronger) stones.

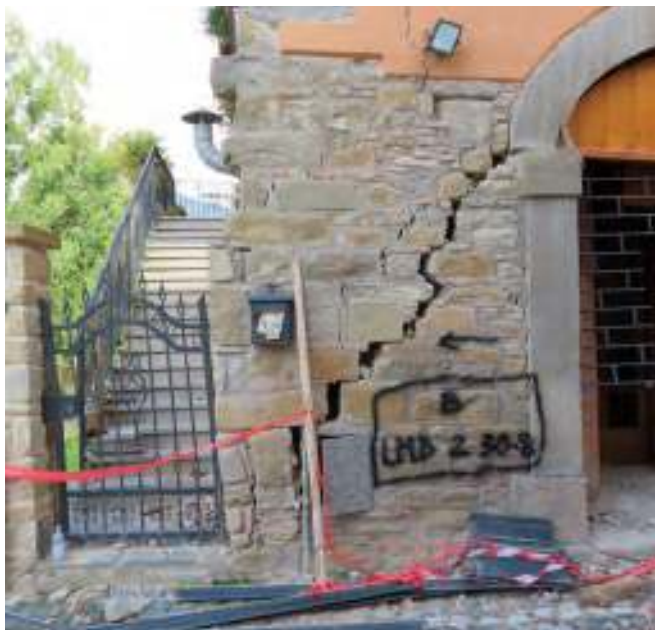
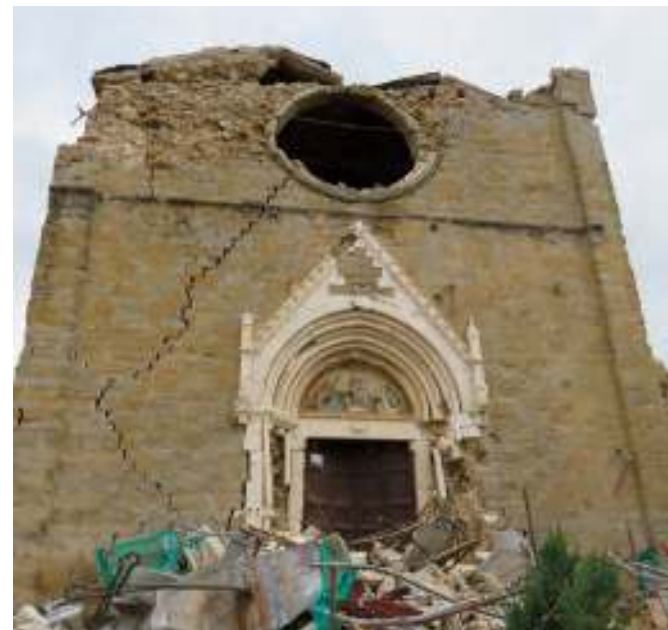
Figures 16. Walls subjected to large lateral displacements.

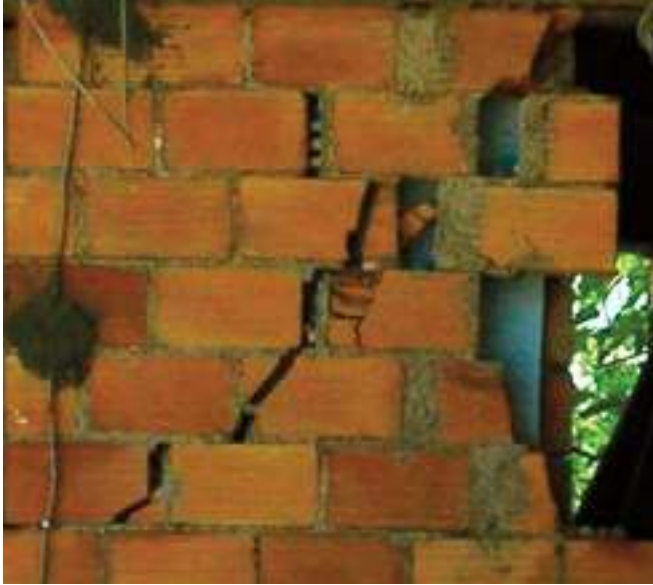
Figure 17. Failure of blocks in various locations along shear cracks.

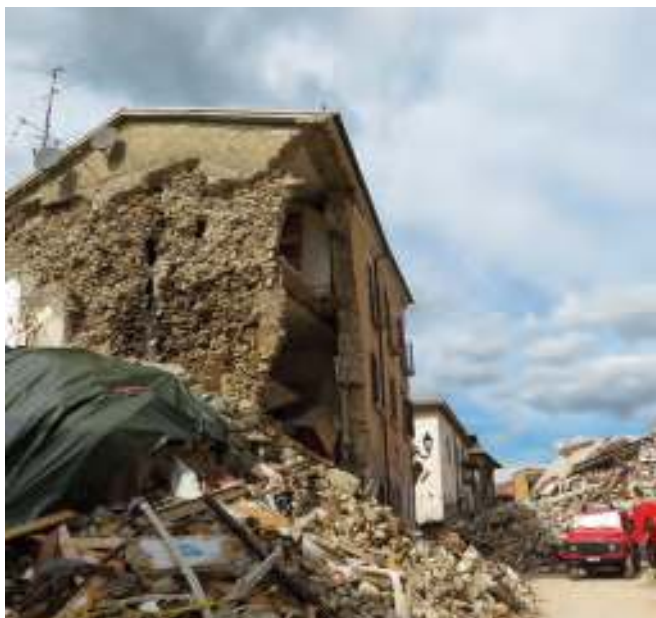
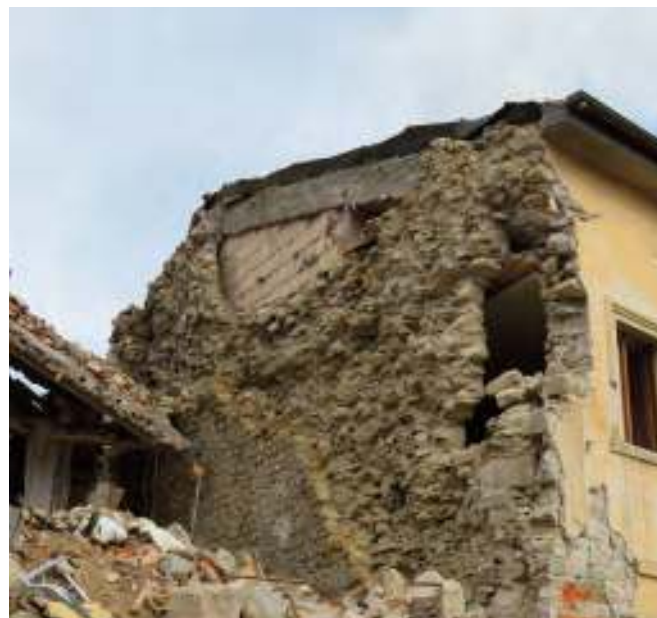
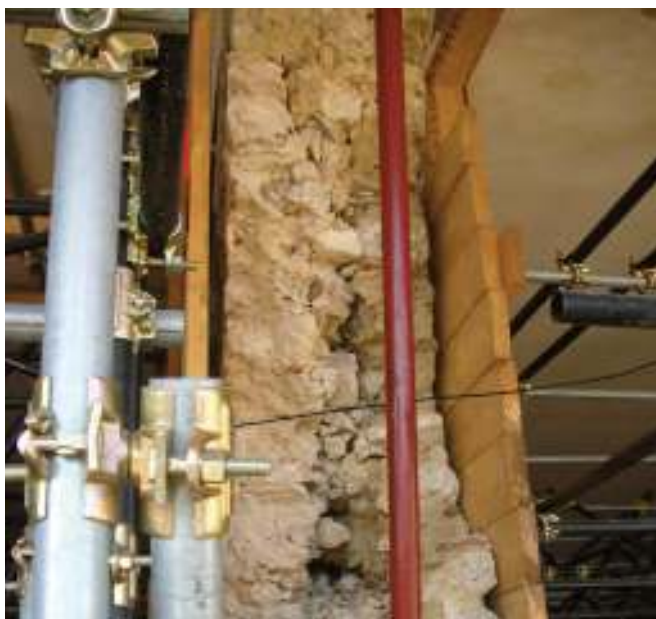
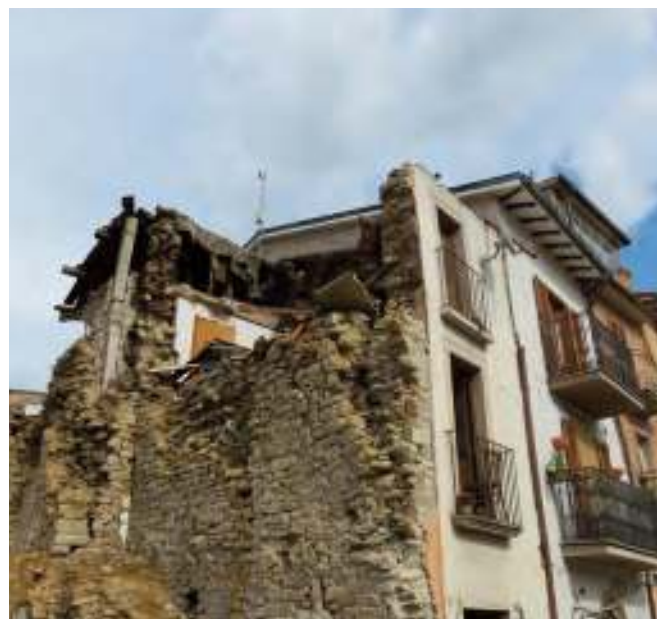
Figure 20. The out-of-plane bending of multi-leaf masonry elements may lead to separation among the leaves and to out-of-plane collapse of the outer leaf.

The most vulnerable leaf is, obviously the exterior one, since it is not provided with intermediate supports (on the contrary, the interior leaf may be laterally supported by transverse bearing walls or even by transverse partitions), whereas it may be not connected to the roof or to intermediate floors. In those cases, partial or full collapse of the exterior leaf may occur (Figure 20).

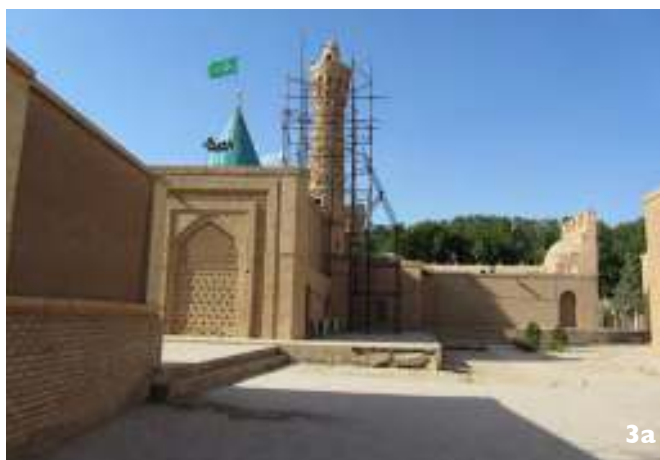
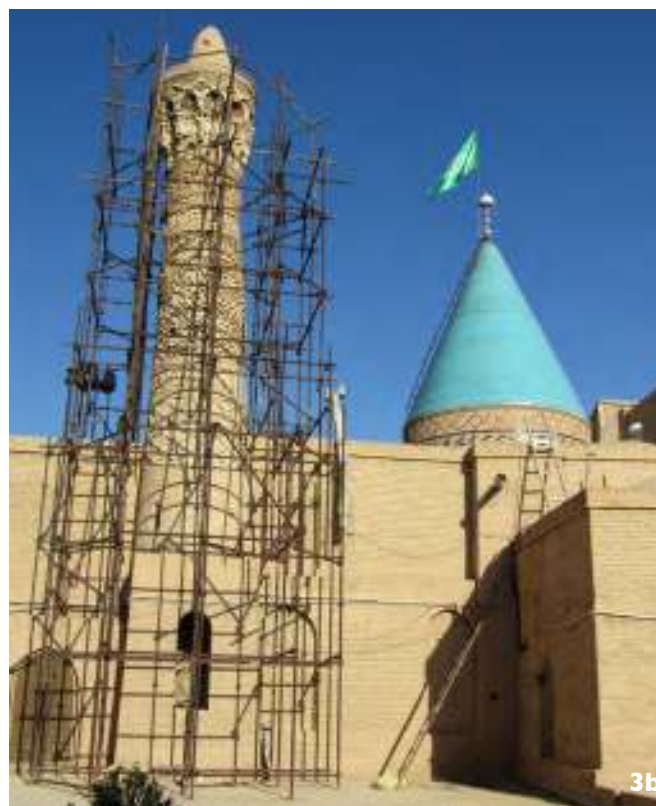
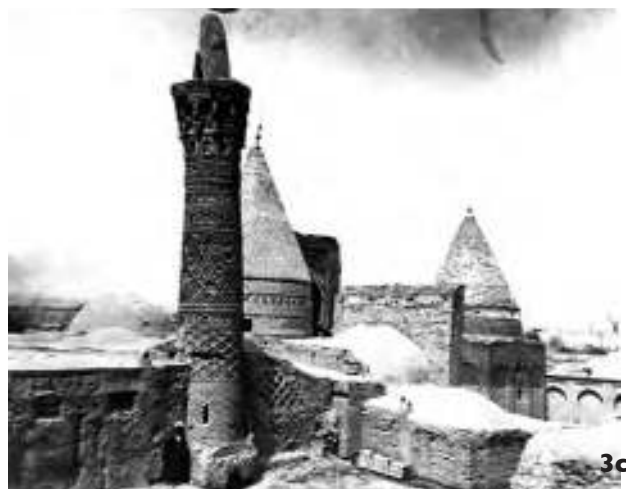
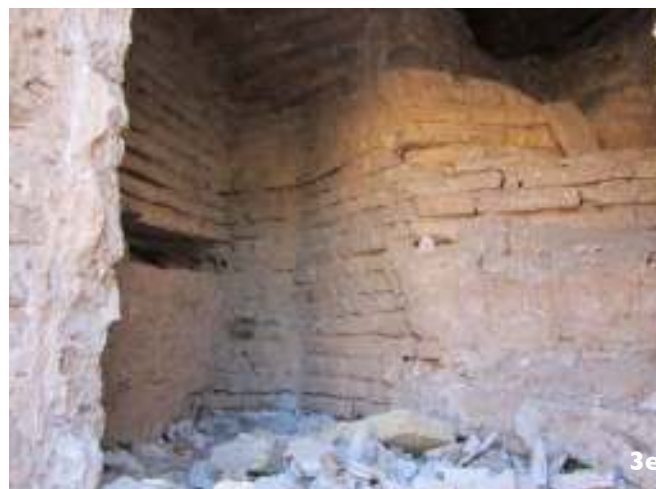
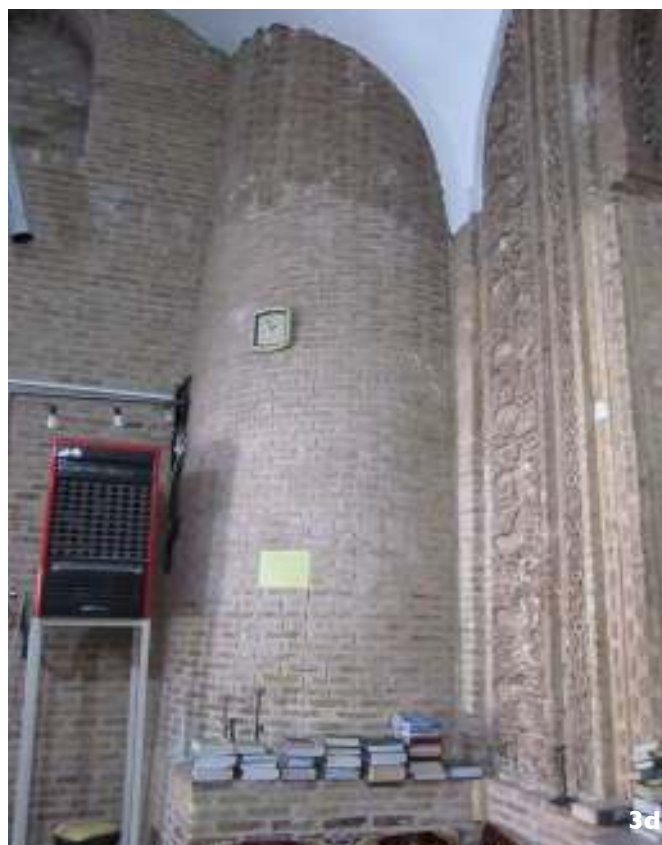
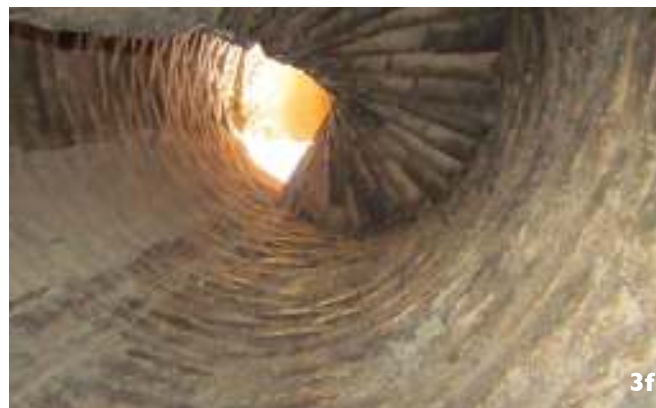
Figures 3. General photos and images showing different parts of the minaret: 3a. location within the complex, 3b. eastern side, 3c. eastern side, as photographed few decades ago, 3d. lower portion of western side, photographed few decades ago, 3e. entrance to the minaret (at its eastern side, 3f. lower side of the spiral staircase connected to the minaret shell, 3g. upper side of the spiral staircase.

Figures 2 and 3 show the location of the minaret in the Bastam historical complex and the various parts of the minaret. Figure 4 shows the position of the minaret in the plan, as well as an elevation and an approximate section of the minaret. The general condition of the building in which the studied minaret is located seems to be in good condition (Figure 3a).

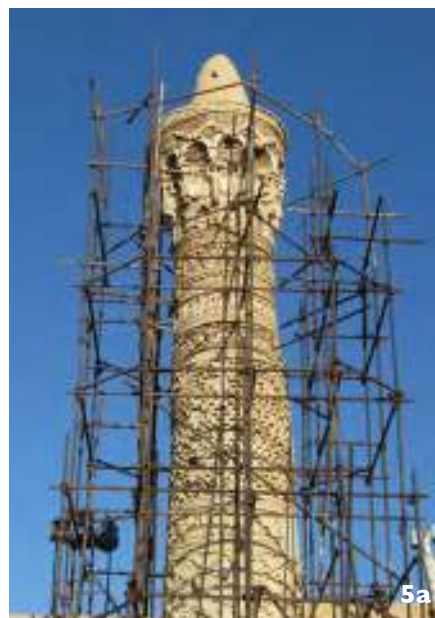
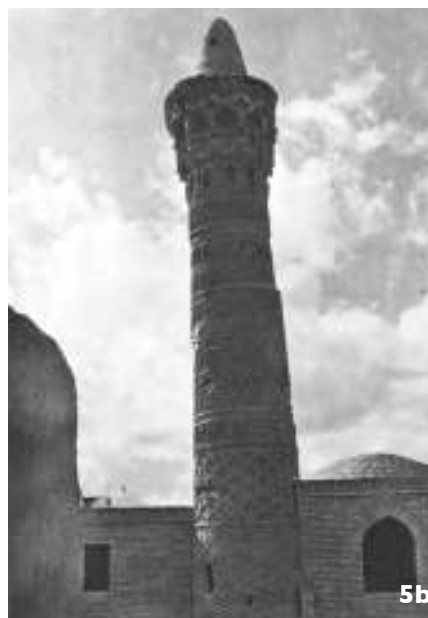
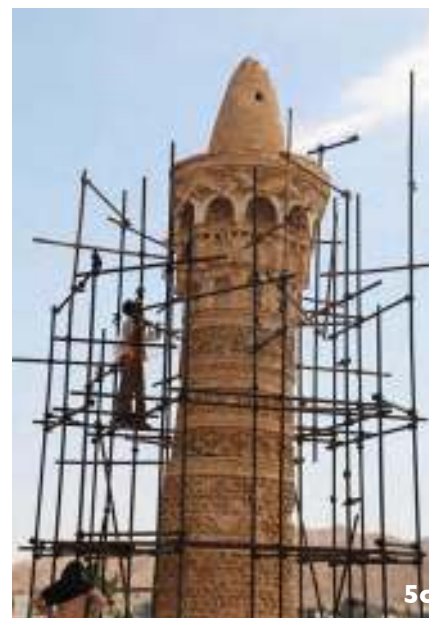
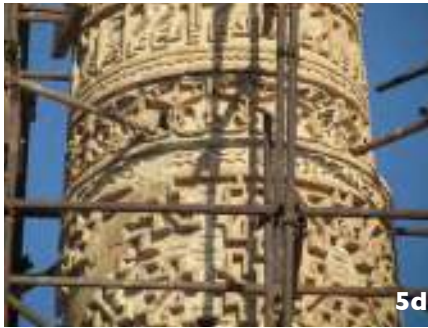
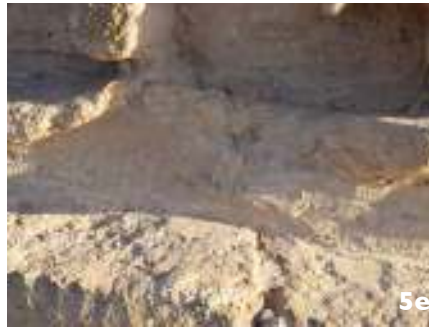
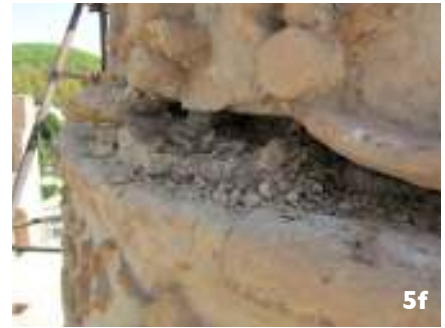
Figures 5. Recess at the external side of the minaret at two-thirds of its height: 5a. eastern side at present, 5b. eastern side, photographed few decades ago, 5c. western side at present, 5d. close-up view of the eastern side, 5e. recess at the eastern side (downwards view), 5f., 5g., 5h. recess at the eastern side inside the minaret (upwards view).

the stability of the minaret and the measures to be taken for its preservation is as follows: a) the recess of the northern side of the minaret at two-thirds of its height (Figure 5), and b) the cracks (visible on both exterior and interior face of the minaret shell) at different parts of the upper half of the minaret and a number of holes at mid-height (Figure 6).

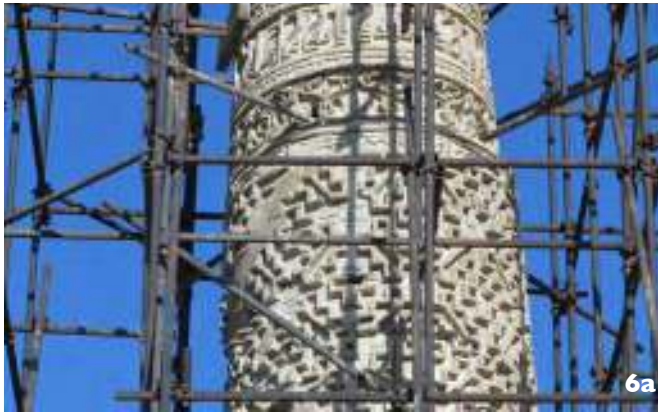
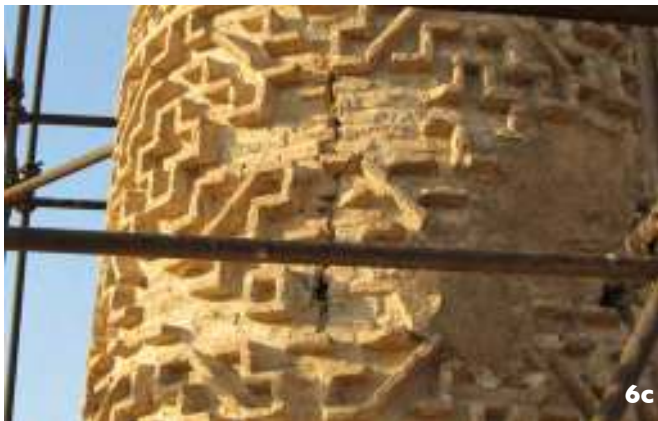
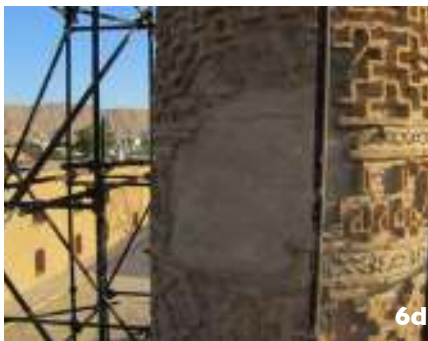
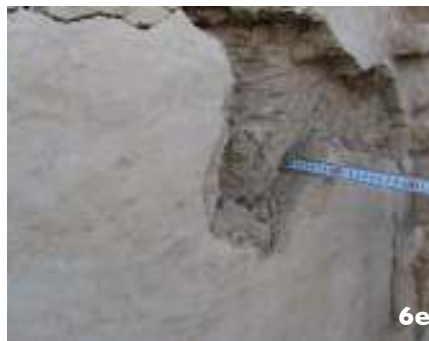
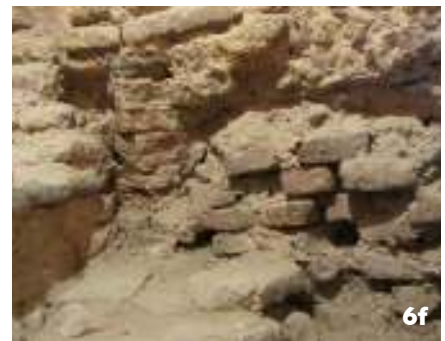
Figures 6a. Diagonal crack at the south-western side (filled with mortar), 6b. diagonal crack at the south-western side, photographed few decades ago, 6c. diagonal crack at the south-eastern side and vertical crack at the southern side, 6d. and 6e. external side of the hole at the northern side filled with mortar, 6f. internal side of the hole at the northern side filled with bricks, 6g. holes at the north-western side, 6h. and 6i. cracks inside the minaret, 6j. external layer on the main shell of the minaret near the apex.

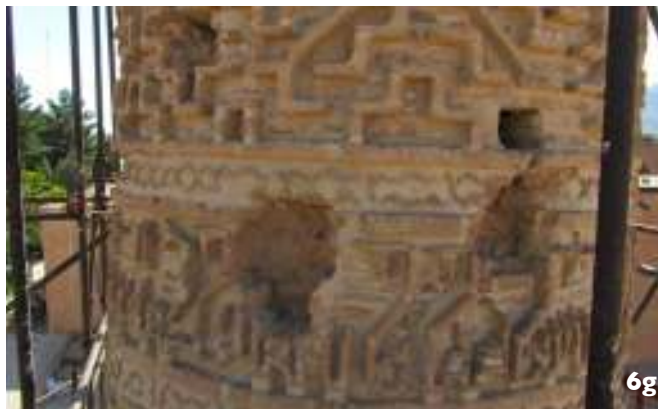
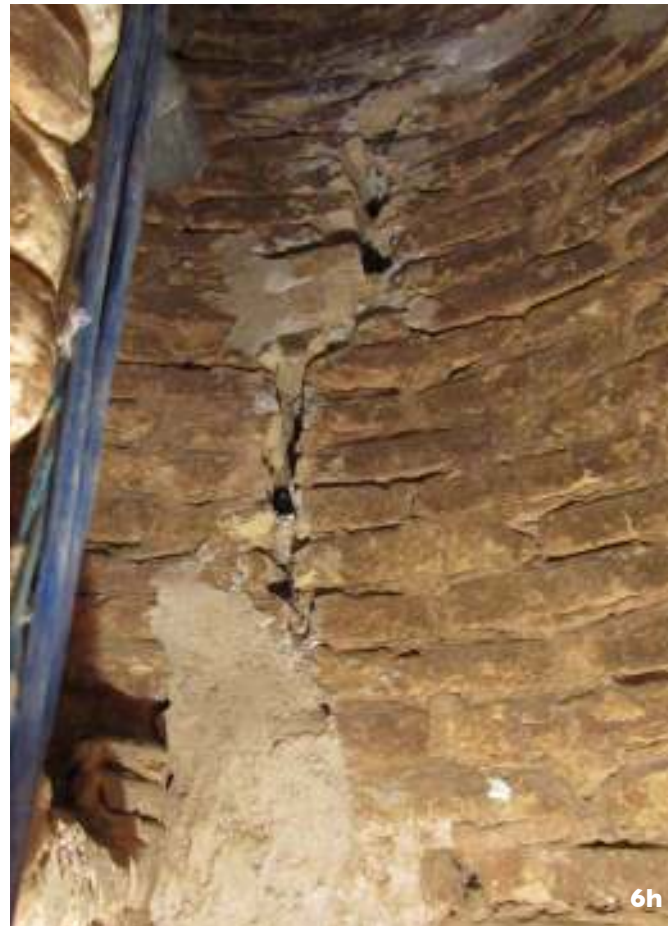
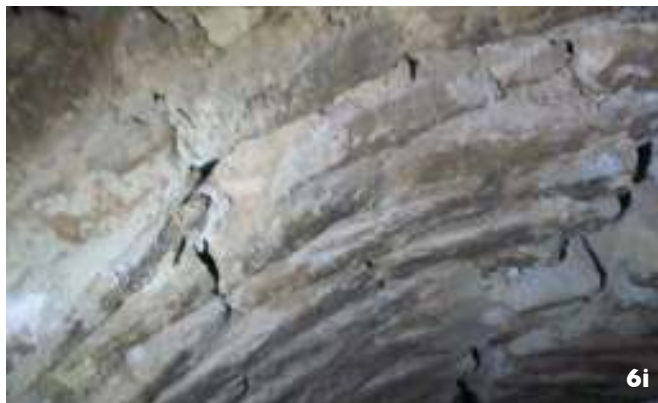
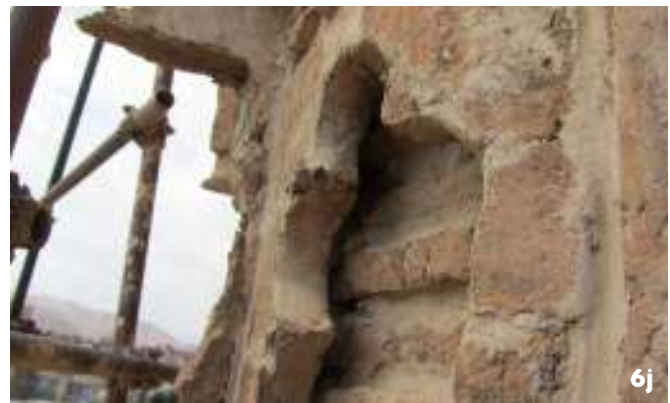
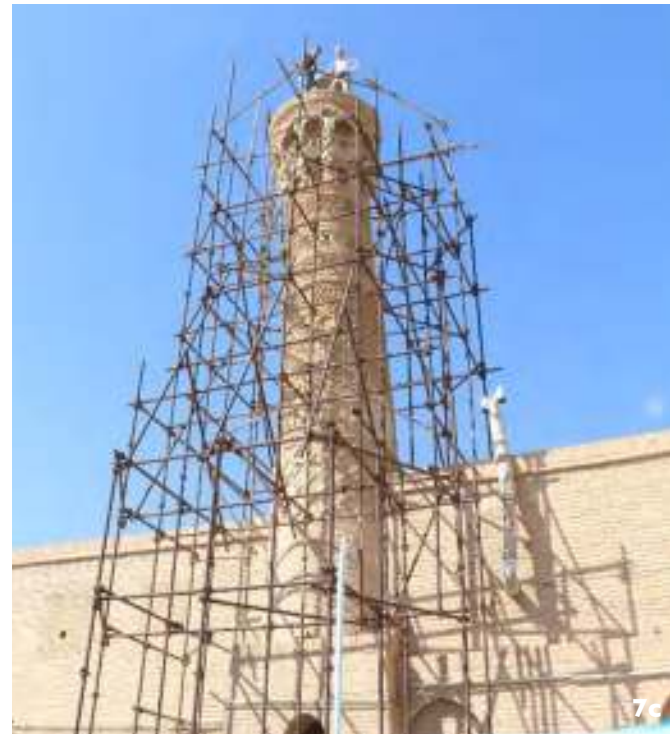
Figures 7. Vibration test: 7a. the locations of sensors (accelerometers), 7b. sensor at mid-height of the minaret, 7c. generating vibration in the minaret by hands, 7d. generating harmonic ground vibration using heavy rollers.

current state of the minaret, decisions were made about the location of the sensors (Figures 7a and 7b). For that purpose, a site inspection (foundation, interior of the minaret and roof of the main building) was also needed.

When the excitation was applied, the response of the structure was recorded through the sensors and stored. The graph of the power spectrum can be seen in Figure 8.

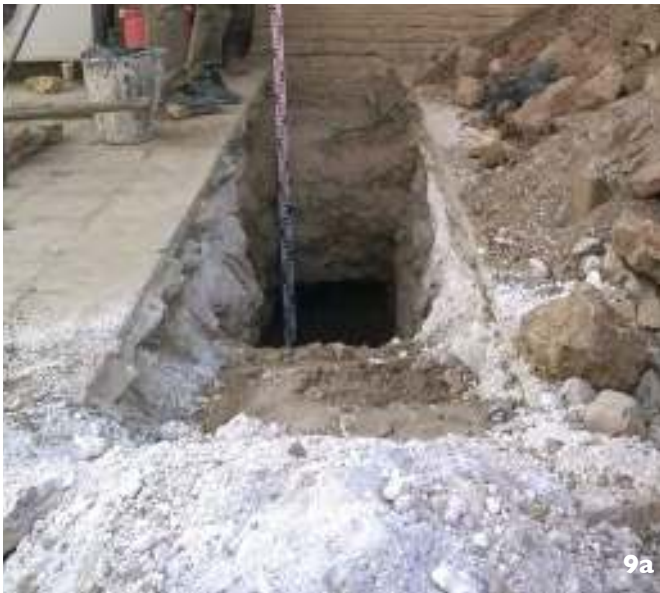
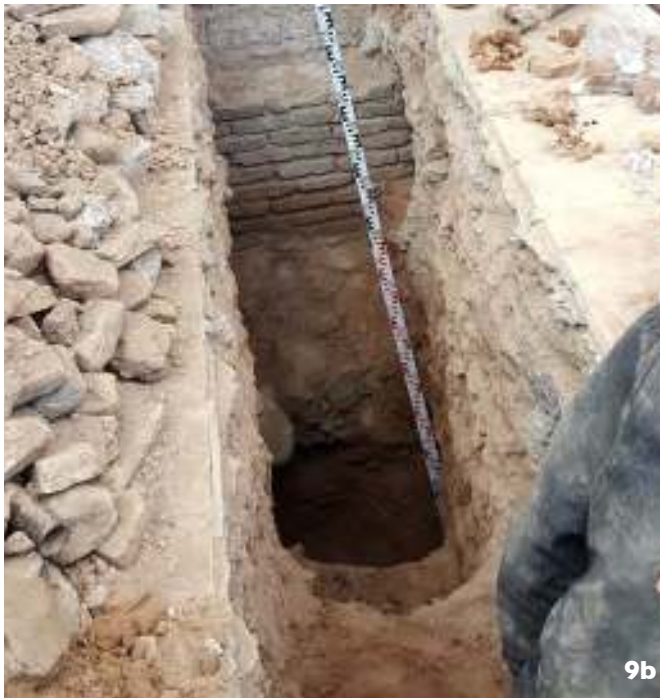
Figures 9a. At the eastern side of the southern wall adjacent to the minaret, 9b., 9c. and 9d. at the eastern side of the minaret.

These two trenches with two already existing trenches were used for geotechnical assessment (Figure 9). The foundation is made of coarse to medium sized rubble of up to 40 cm in diameter, brick and lime mortar (Figure 10a).

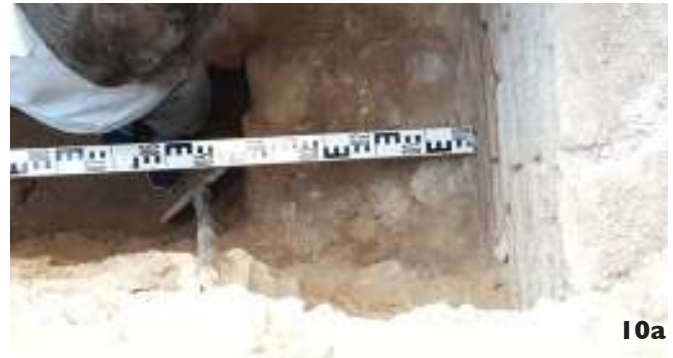
10a

Figures 10a. Foundation of the minaret protruded the upper wall (eastern side of the minaret), 10b. loose sand and silty soil with ash near the eastern side of the minaret.

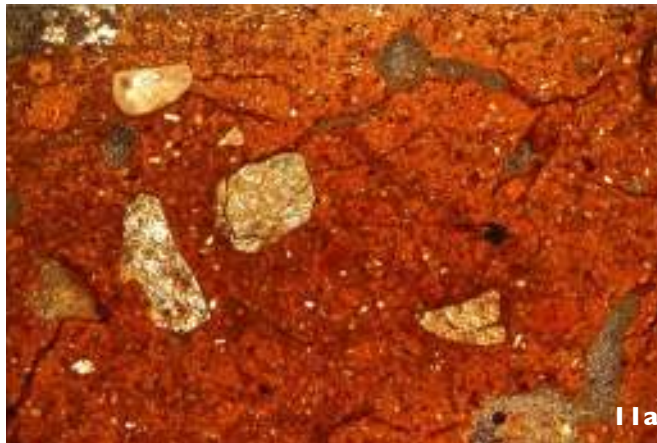
Figures 11a. Lime crumbs in old brick of the minaret, 11b. lime and quartz crumbs in old mortar of the minaret.

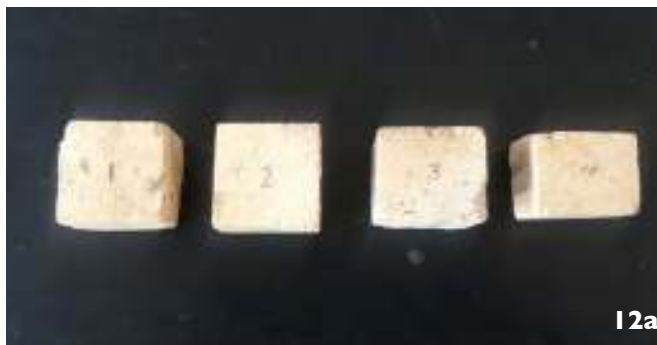
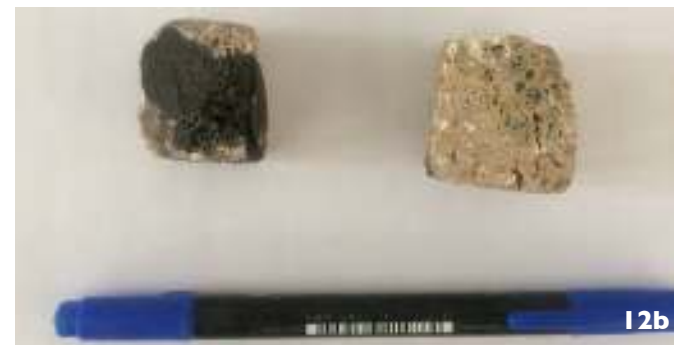
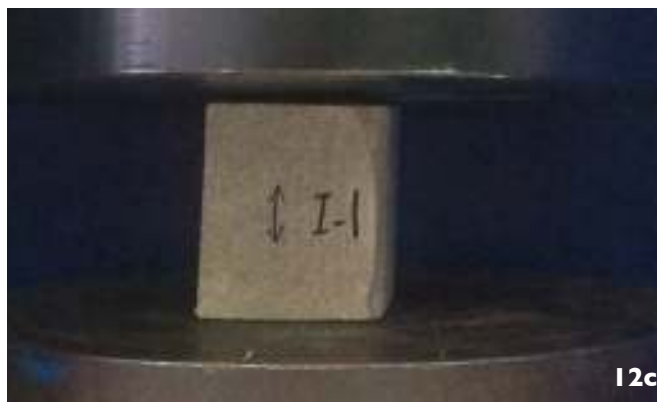
Figures 12. Materials samples in the foundation: 12a. adobe, 12b. mortar, 12c. stone, 12d. stress-strain diagram of dry adobe.

Stress-strain diagrams, modulus of elasticity and uniaxial compressive strength for dry and wet conditions have been determined (Figure 12).

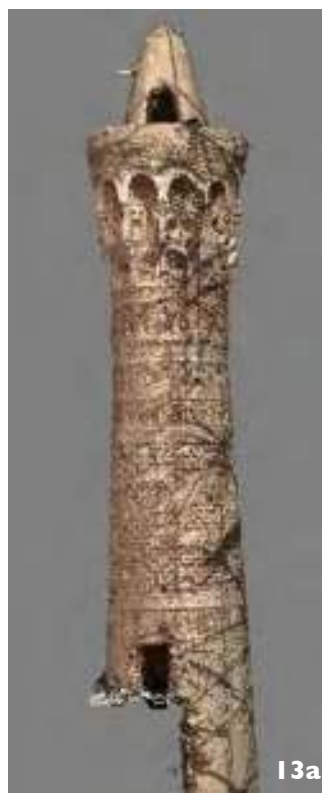
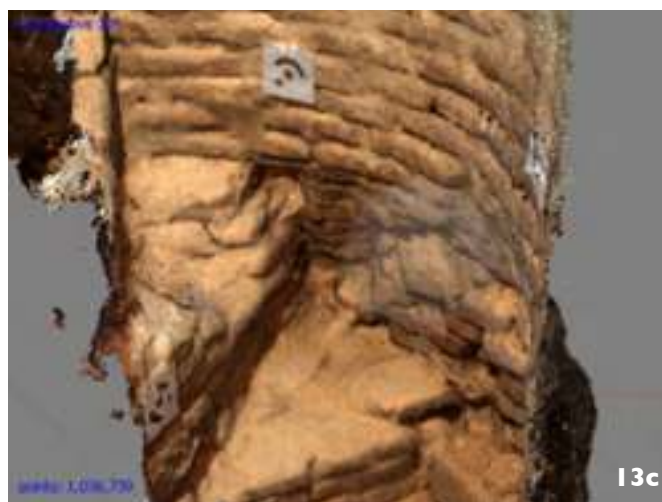
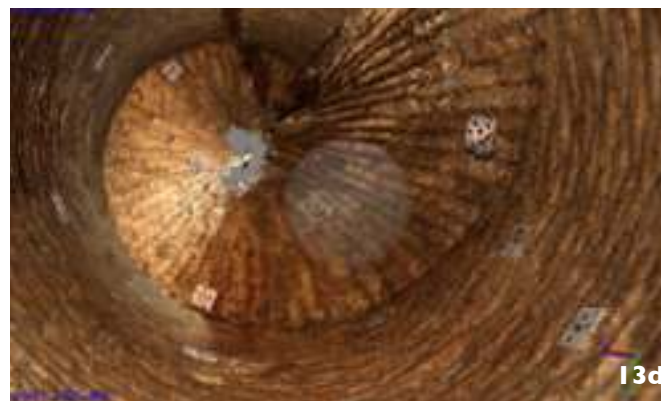
Figures 13. Close range photogrammetry of the minaret, cloud point samples: 13a. outer side, 13b. close-up outer side, 13c. and 13d. inner side.

In order to determine the conditions of the damages to the minaret and also its probable inclination a close range photogrammetry of the minaret was carried out. The preliminary result of the photogrammetry of the minaret is presented in Figure 13.
