## BULLETIN

September 2026

| ERIES-REVAULTS: Building a<br>full-scale vaulted masonry<br>specimen for seismic testing | |

## Conservation and seismic vulnerability assessment of the lanterns of the Águas Livres Aqueduct, Lisbon

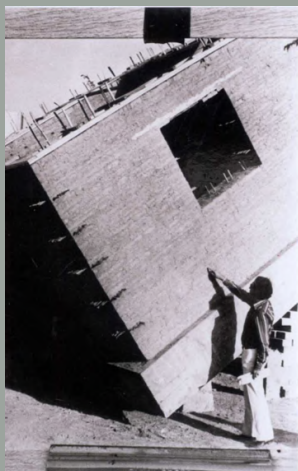
Julio Vargas in 1975 testing a reinforced adobe dwelling on the tilt-up table

Due to the difficulty of applying concentrated loads to a very weak material like the adobe masonry, his experimental work focused on a tilt up table where full scale adobe modules could be built and experiment the efficiency of several reinforcing techniques with natural materials. The recommendations from these tests were corroborated with seismic simulation tests after the implementation of the shaking table in the Structures Laboratory in 1984.

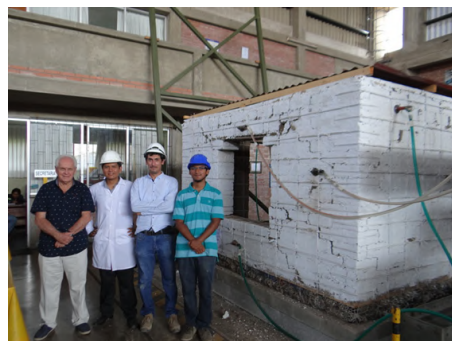
Julio Vargas and collaborators after a shaking table test of an isolated and reinforced adobe dwelling

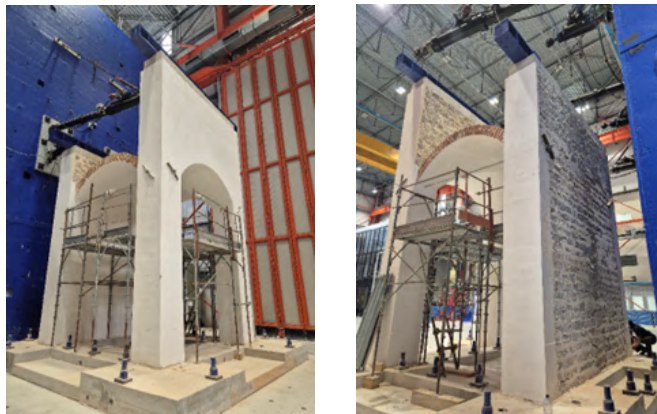
Figure 1: Views of the full-scale specimen

The specimen consisted of a cross vault confined by transverse and longitudinal arches and supported by pillars and an external wall. Its construction reproduced traditional building techniques of historic masonry structures. Hand-made solid clay brick masonry was used for the vault and arches, while roughly cut limestone masonry was adopted for the walls and pillars. Both masonry typologies were built using natural hydraulic lime mortar.

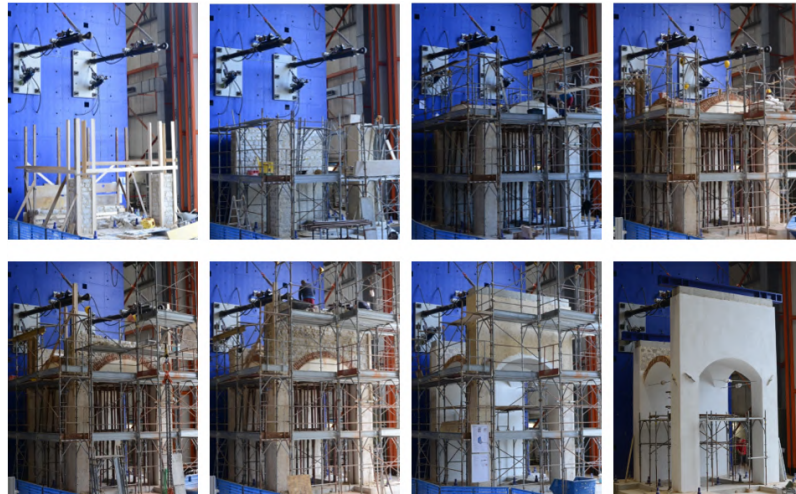
Figure 2: Construction sequence of the specimen

Figure 3: Construction sequence of the vault and arches

The construction sequence followed the progressive building process of a vaulted bay (Figure 2). The pillars and external wall were first raised to the springing level, and a timber centering was then positioned to support the construction of the vault and arches. The cross vault and arches were built simultaneously, starting from the four corners and progressing towards the crown (Figure 3). Once they were completed, the upper portions of the walls were built, the tie rods at the vault springing level were tensioned, and the timber centering was removed.

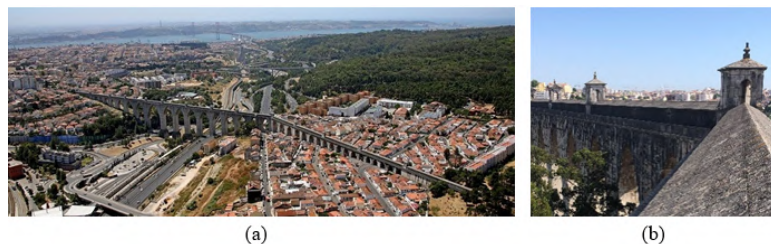
**Figure 1:** (a) Águas Livres Aqueduct. Neighbourhoods Serafina on the right; Campolide on the left. (b) Canal gallery, lanterns and lateral walkways

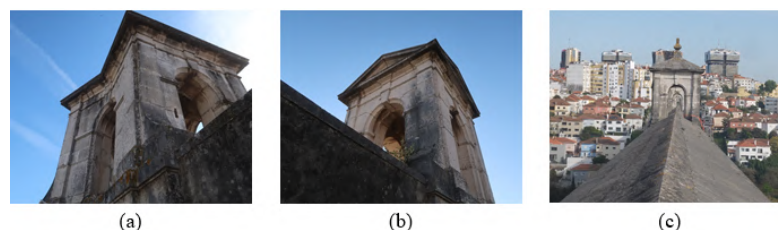
**Figure 2:** Lanterns typologies. (a) LT1; (b) LT2; (c) LT3

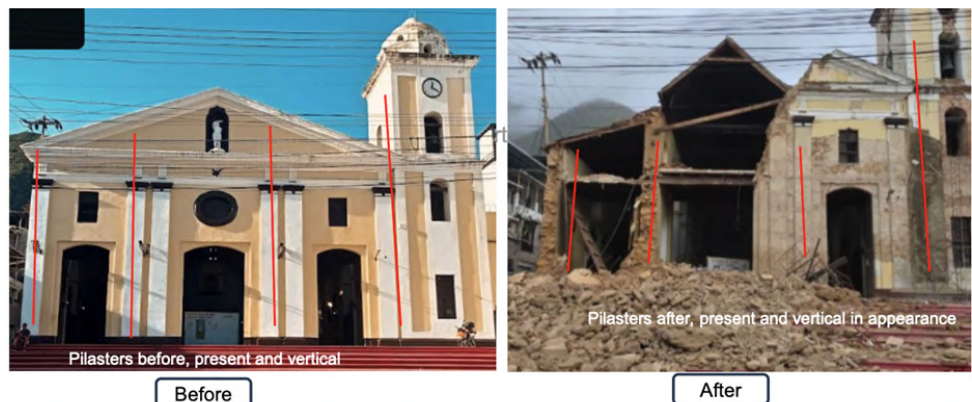
**Figure 2:** San Sebastián de Maiquetía (Image source: Google Maps (before), Venezuela via Facebook (after))

The clearest pattern to emerge involved La Guaira's colonial and republican-era masonry, largely rebuilt following the 1812 earthquake using empirical load-bearing wall systems and flexible timber roof framing. These assemblies had performed well through two centuries of regional seismicity, but showed consistent vulnerability under the multi-directional accelerations and cumulative fatigue of this doublet sequence: diagonal shear cracking through thick masonry walls, tension failures separating orthogonal wall junctions, and the loss of towers, spires, and parapets as falling hazards. Cases we documented in detail include the Iglesia Católica San José de Araulí, Iglesia Nuestra Señora de La Candelaria, Iglesia San Diego de los Altos, the Basílica Catedral de Valencia, and the asymmetric twin-tower damage at Iglesia de la Inmaculada Concepción de Montalbán.
