## Message of the President Görün Arun

# Frequent errors of ancient timber structures and consequent failures

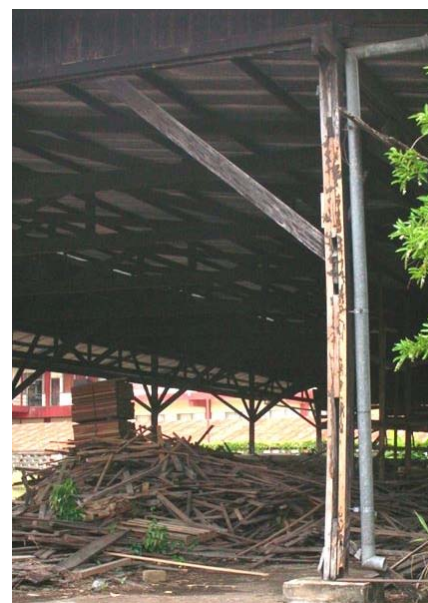
Figure 2. Timber frame in Paramaribo showing, through the deformations, the behaviour of a node of a frame stiffened by means of a strut.

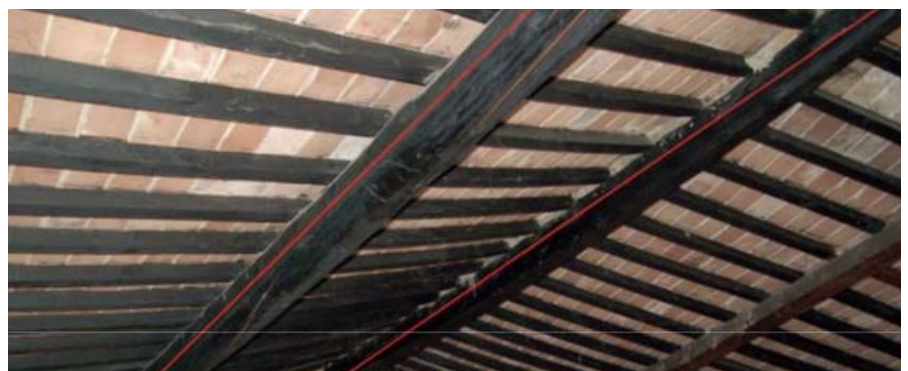
Figure 3. Deflection of a member of a simple roof carpentry, Certaldo.

Figure 4. The deflection of the three timber members and of the joists.

All the members underwent a severe inflexion due to the deficient size, and creep but no ruptures, that usually accompanies the deformation of a roof, or leakage, caused by rainwater ponding, had occurred yet. Though no real structural damage had occurred, the situation was not acceptable with respect to the requirements of the present-day practice codes and structural safety standards.

Since inflections of this size are rare and, on the other hand, they show the phenomena with strong evidence of causes and effects that is very useful for further research, the strengthening measure adopted by the author (2013) was a permanent timber propping consistent with the original structure i.e. the addition of three supporting timber arches whose thrust is absorbed by steel cables placed horizontally. The deformations were not wiped out.

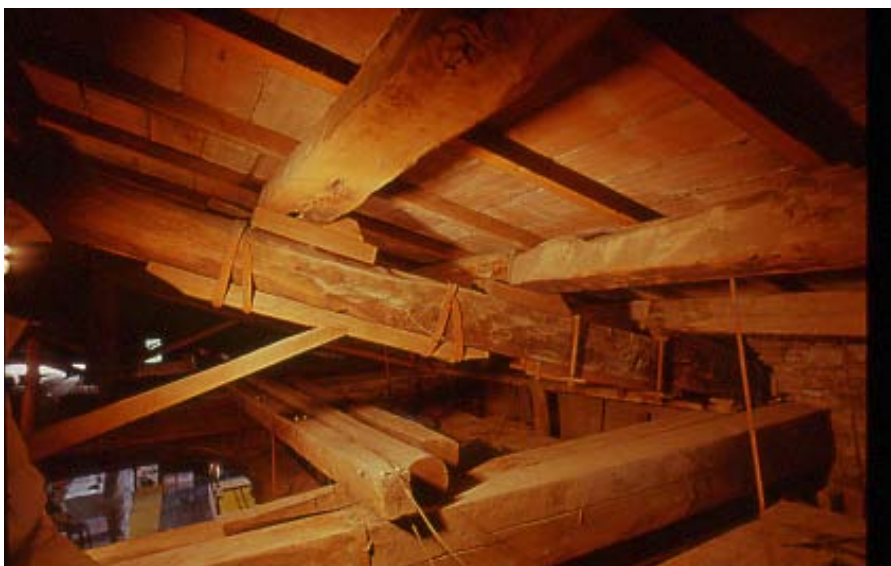
Figure 6. The last strengthening work, composed by an additional stiffening bracket, fixed with iron ties, and by a new strut, was not sufficient to prevent further deformation of the rafter and of the new strut of this truss (Tesi, Tampone, Martini, 1989, cit.). Note the cut made in the bracket to accommodate the end of the strut.

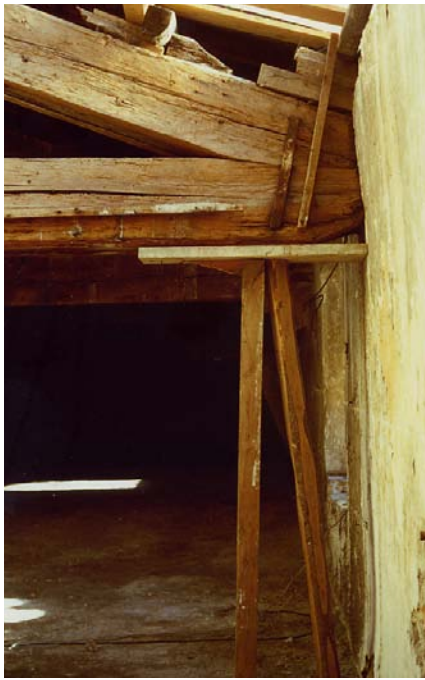
Figure 8. Effects of combined situation of short rafter of a truss and fungal attack of the node. Note the deformation of the tie (Tampone, Atlas, 2016, cit.).

Main effects are local inflexion of the tie in sections downstream the node and widening of the angle between the members; cracks are inevitable (Tampone, Atlas, 2016, cit.).

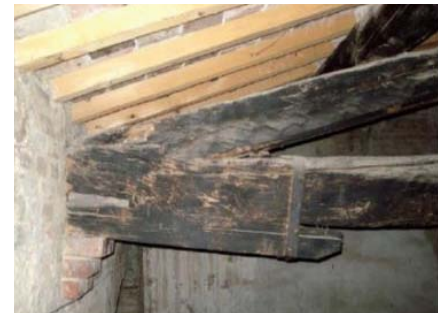
Figure 9. Node of the truss of the Ceraldo Palace of the Vicars roof showing severe failure.

high ratio humidity of the setting or of the walls, especially those brought by fungi that start a decay of the materials and reduce and almost nullify the strength of the wood, trigger a failure that is characterized by a solution of continuity of the heel along the fibres and by the sliding of the heel and of the rafter along the tie. The error of making hollows in the members in order to accommodate a concurring member was very diffused; typical in this sense those made at the lower edge of the rafters to house the end of the struts. The execution of the hollows cuts the compressed fibres and reduces the depth of the reacting section. Cracks in the section occur frequently (Fig. 9).

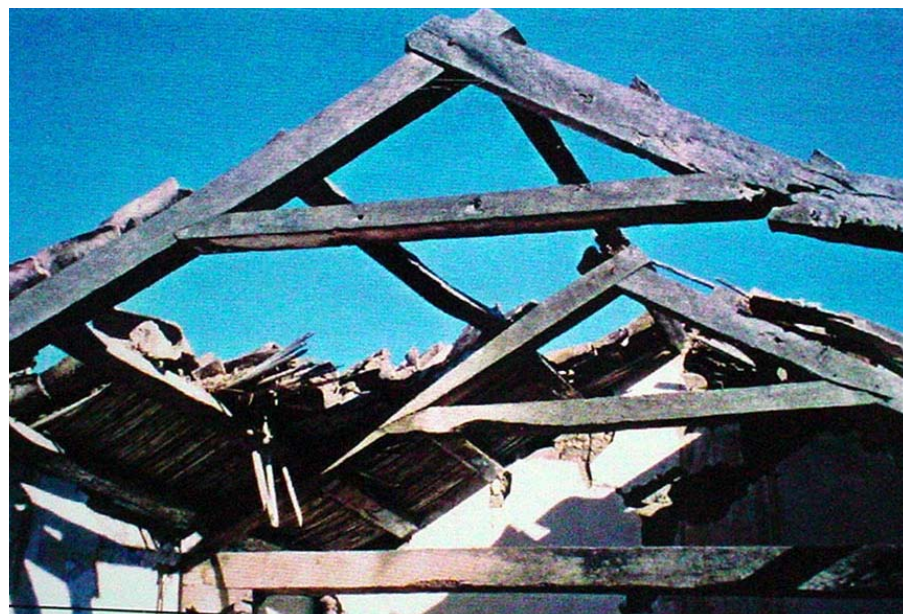
Figure 11. Rupture of a rafter in the joint with the strut due to the hollow made in the member (from Tampone, Atlas, 2016, cit.).

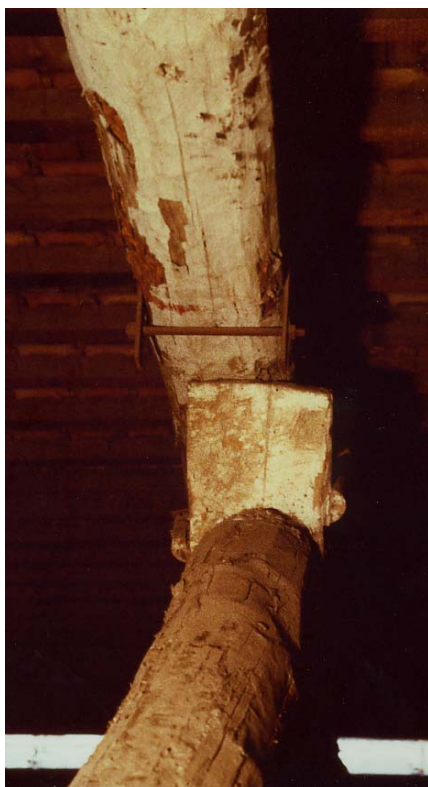
Figure 12. Makeshift assembly, with considerable eccentricity, of a post to the rafter of a truss. The post is deformed (from Tampone, Atlas, 2016, cit.).

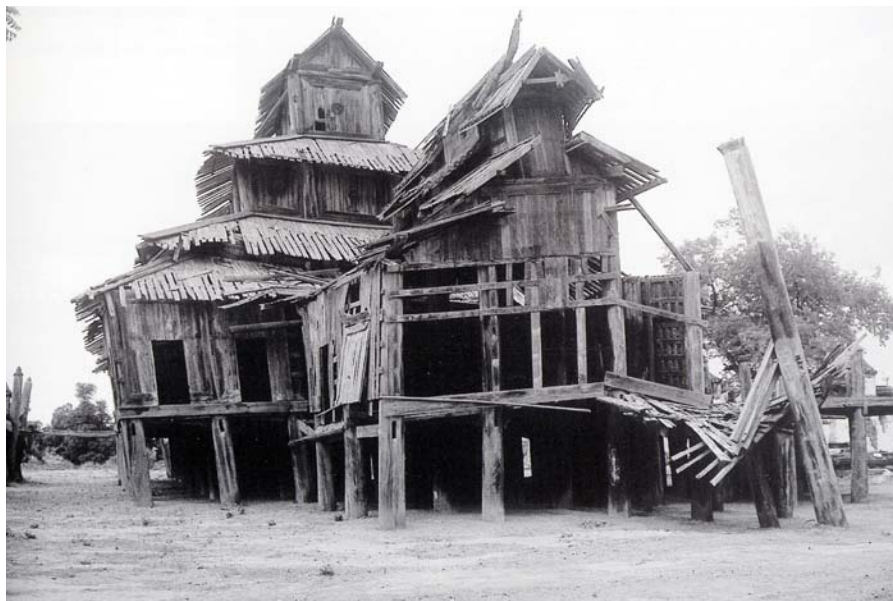
Figure 14. Rigid rotation of one of the bodies of a timber building in Myanmar (from Tampone, Atlas, 2016, cit.).

Second, since the vaults are also suspended to the tie beams of the trusses of the roof, the severe deflection of the long and thin ties caused the inflexion of the main pillars that are loaded by struts that stiffen the joint between the two members (Fig. 14).

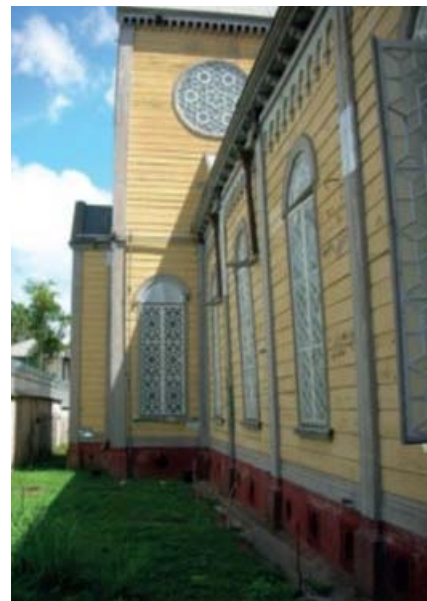
Figure 15. Rigid rotation of the wall of the side nave (Tampone, Atlas, 2016, cit.).

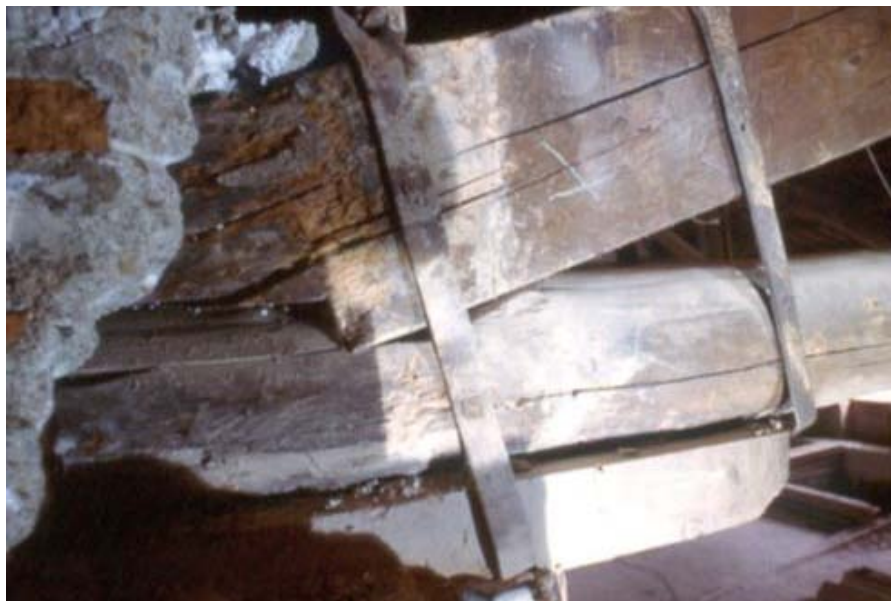
Figure 17. Sliding of the rafter due to rupture of the heel of the tie beam of a truss. The size of the sliding is evident in the picture (18 cm circa). The two collar ties are not correctly placed and do not work efficaciously (from Tampone, Atlas, 2016).

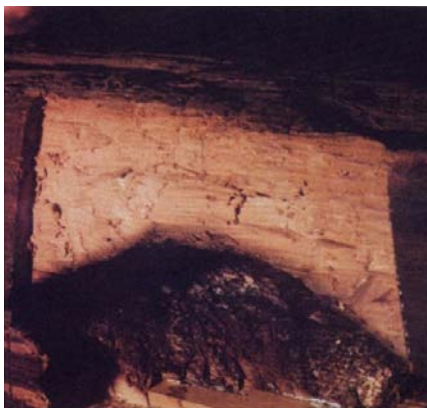
Figure 18. The burn at the tie beam of a truss in the Fencing hall of Fortezza da basso, Florence (Tampone, 1989, cit.).

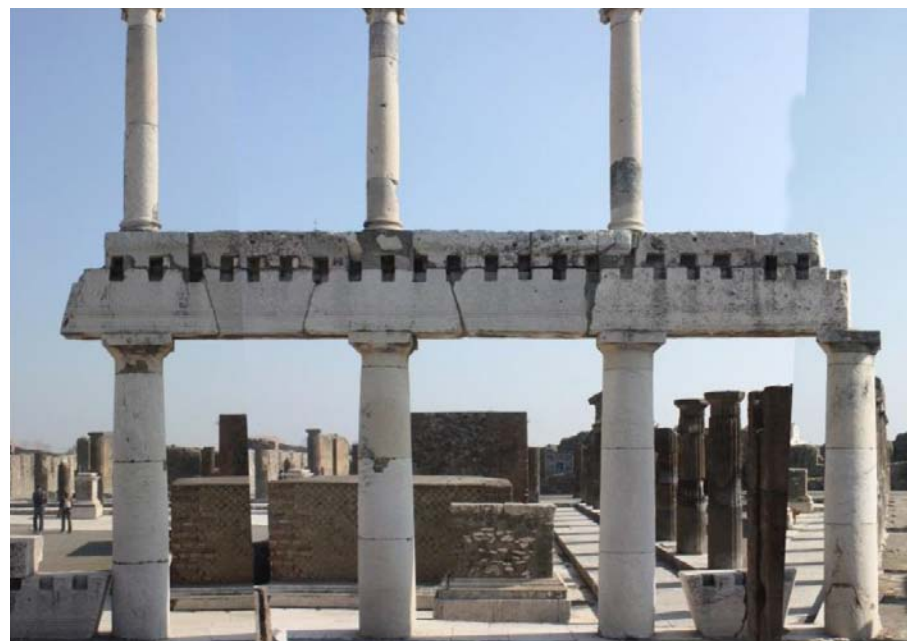
Figure 1. The forum of Pompeii: (a) Aerial view of the southern part of the Forum showing the colonnade under investigation inside the circle; (b) Two storeys colonnade with multi-drum columns and multi-blocks segmented trabeations.

The structure under investigation (Figure 1b) is a two-storey colonnade of the Forum in Pompeii (Figure 1a) made of white limestone. The colonnade was erected in the

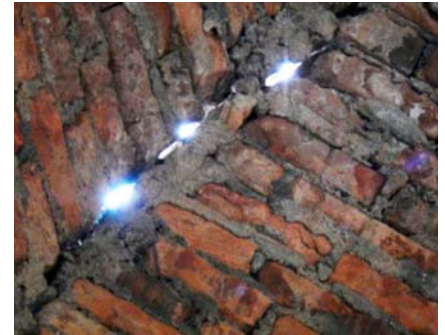
Figure 11. Fissures on caskets of the dome of the temple of Santa Lucía (Source: by the authors).
