International Scientific Committee on the  
Analysis and Restoration of Structures of  
Architectural Heritage

Newsletter n. 18-19-20  
April - December, 2018  
ISSN 2306-0182

# Authenticity and Integrity of Architectural Heritage

**CHO, In-Souk**, DaaRee Architect & Associates, Seoul (Korea)

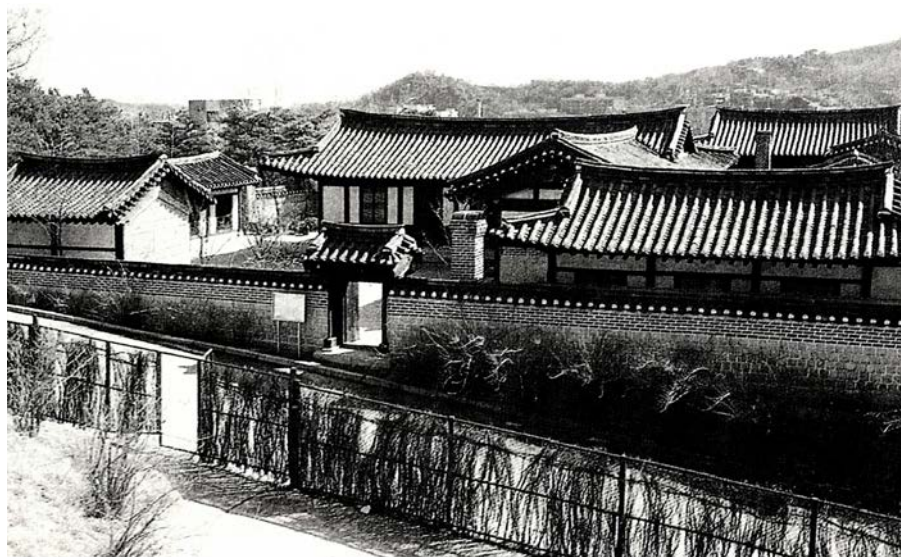
The Residence of *HAN Gyu-Seol*.

The inherited traditional dismantling technologies were carefully applied to the residence. Skilled roof tile technician, major carpenters and minor carpenters, and stone mason worked on it. Careful dismantling work carried on from the clay roof tile through the wooden structure to the mud walls and stone platforms.

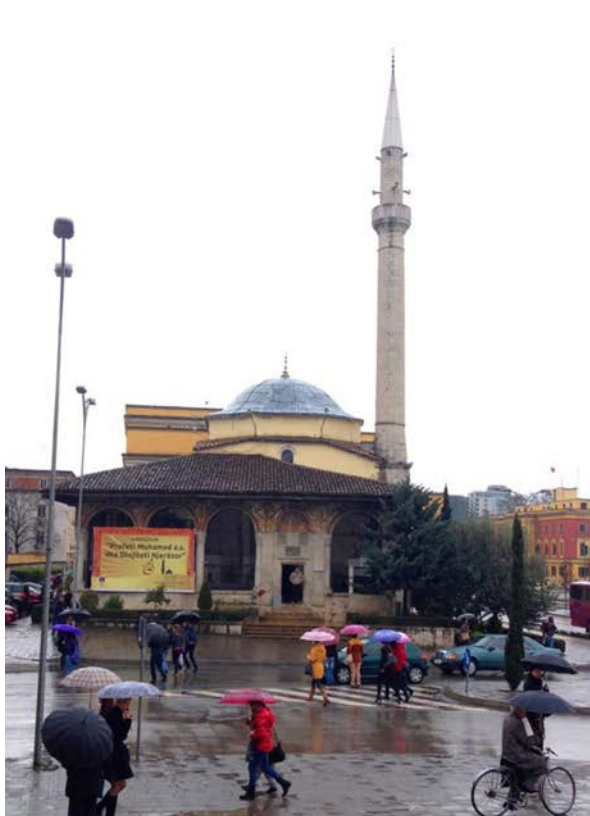
Figure 1: Ethem Bey Mosque.

Ethem Bey Mosque is located in Tirana – Albania and it was built in 1793 and restored in 1822 [7]. It was converted into a museum in 1967 and re-used as a mosque in the 1990s [8]. Ethem Bey Mosque has a single-domed square plan (Figure 1). The women's part (separated from the vision and common use with the men) is organized as a mezzanine floor sitting on two circular columns and reached by the staircase which leads to the minaret as well. The outer praying area (son cemaat yeri) has an

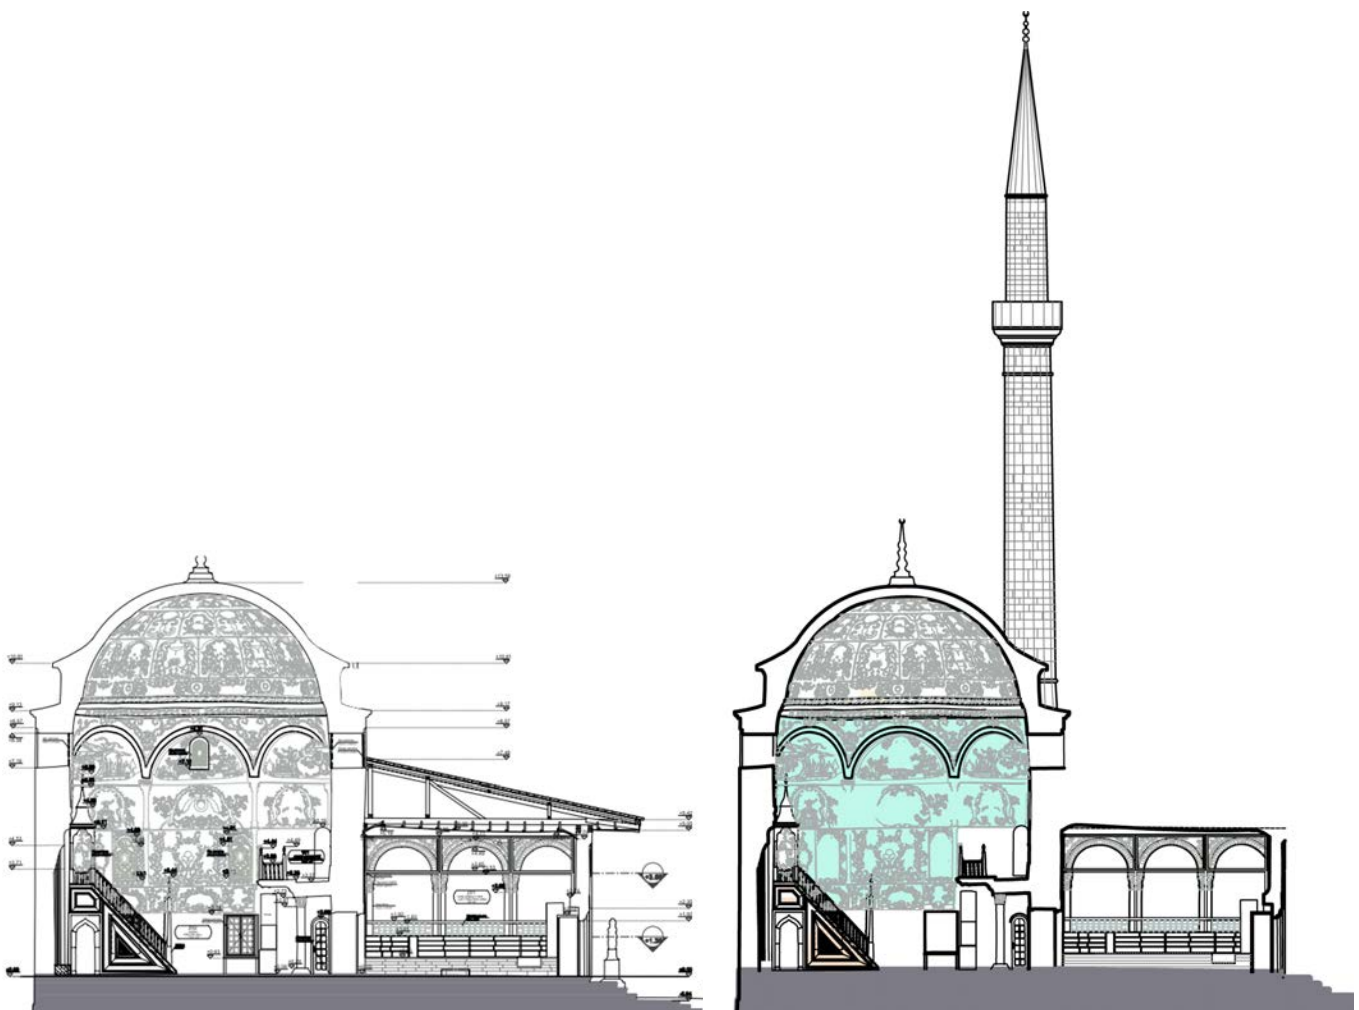
Figure 2: Cross section of Ethem Bey Mosque [11].
