## Message of the President Görün Arun

### Disasters and Heritage

# Iscarsah

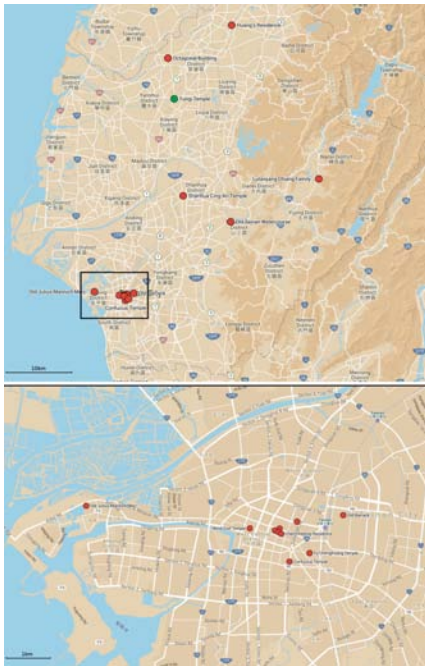
Figure 3: Listed buildings with structural concerns after 2016-02-05 earthquake in Tainan Municipality (Earthquake data: Tainan Municipal Administration of Cultural Heritage; Map data: 2016 ©Google).

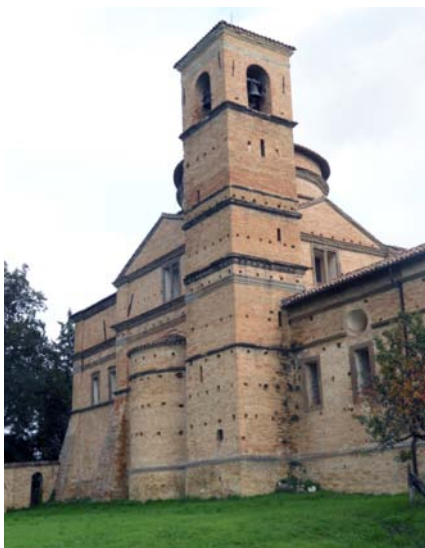
en el fondo la iglesia de San Bernardino con la cúspide de la torre del campanario y cuatro pequeñas torres en las esquinas<sup>49</sup>, se nota que el contrafuerte no está presente. Como el lienzo es de la primera mitad del siglo XVII, ello confirmaría la hipótesis que los mencionados refuerzos sean posteriores, probablemente del siglo XVIII y, según algunas conjeturas, incluso posteriores al terremoto de 1781.

Fachada sureste con contrafuertes (Foto S. Gizzi, 2012).

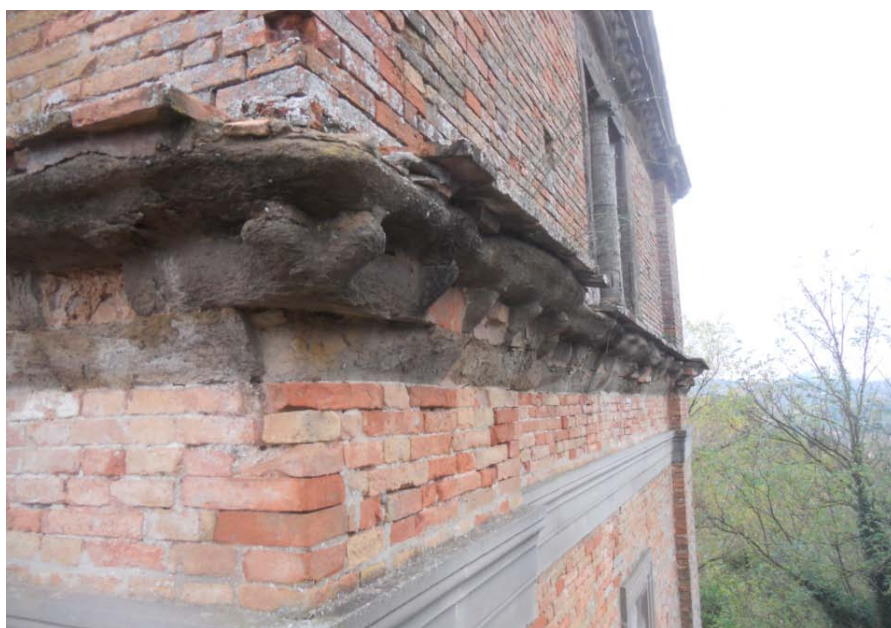
Detalle de las cornisas originales y de sustitución en el frente noroeste (Foto S. Gizzi, 2013).

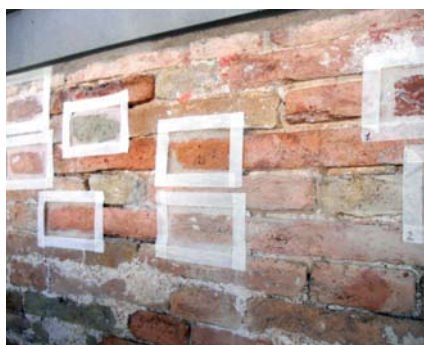
Pruebas de consolidación de los ladrillos y test de tratamiento del mortero (Foto S. Gizzi, 2015).

gregadas requieren una mano de obra altamente cualificada y productos de compleja aplicación (silicato de etilo, nanosílices; microemulsiones acrílicas; morteros hidráulicos con granulometrías muy finas para las inyecciones), con operaciones delicadas y laboriosas, que demandan un control muy preciso para minimizar la incertidumbre sobre el resultado final y en el corto o mediano plazo (eficacia; inercia química, ausencia de cambios de color).

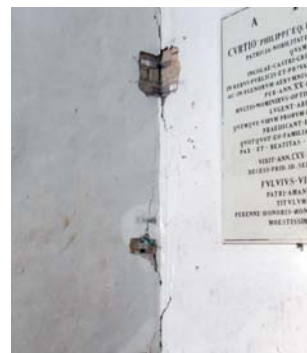
Espías para monitorear las fisuras en el interior de la iglesia (Foto Gamma s.r.l. Fano, 2015).
