Characterization and preservation of the “gaiola” construction. An overview.

Vítor Cóias

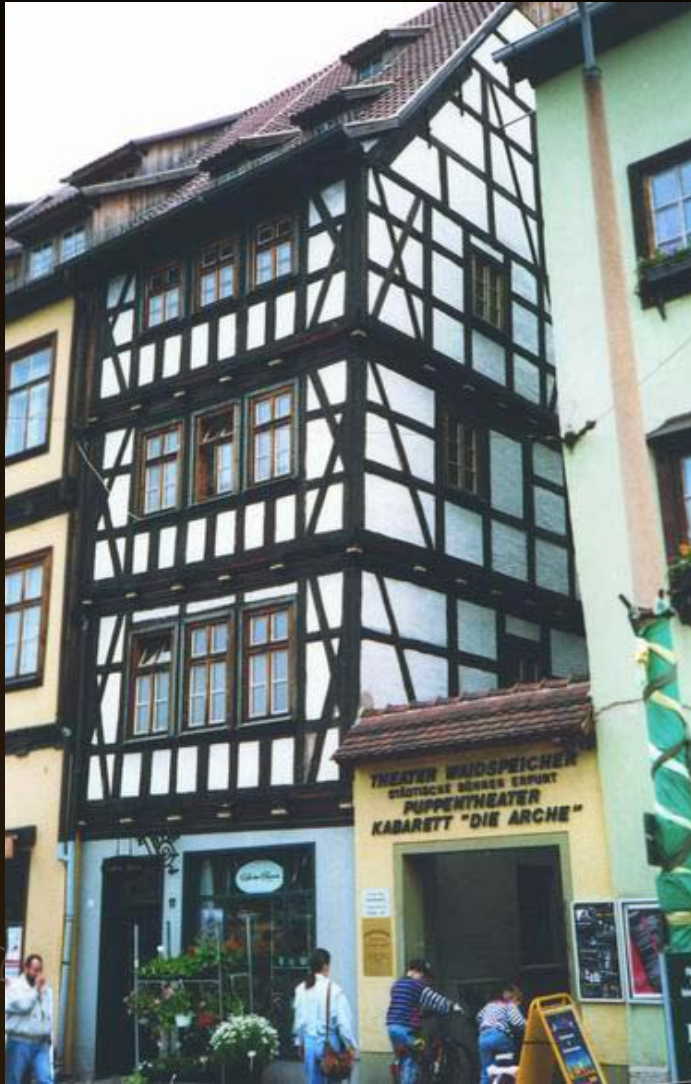
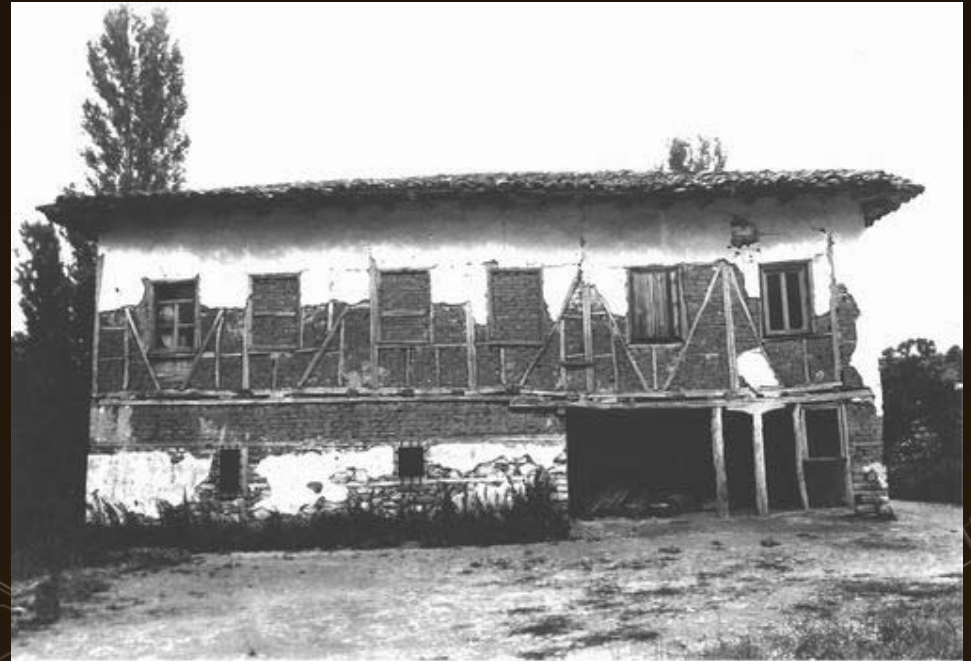
← fachwerk
bondruk ↓

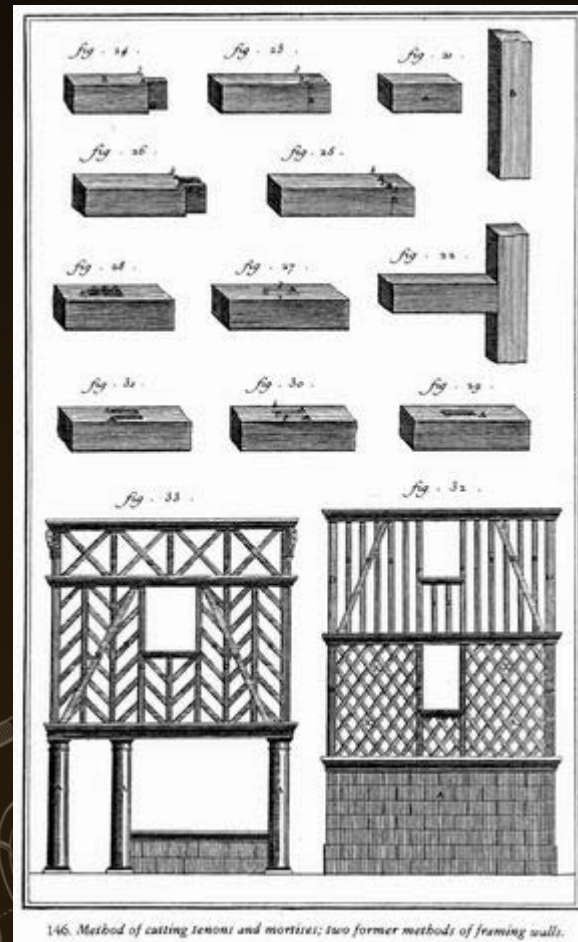
In his Encyclopaedia, Diderot included drawings of timber framed walls, although they were intended as façade walls, not as interior bracing walls.

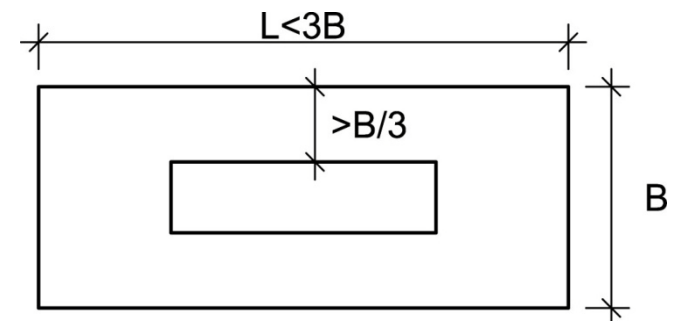
Buildings where grouped in very regular blocks, with proportions in accordance with present time seismic design guidelines.

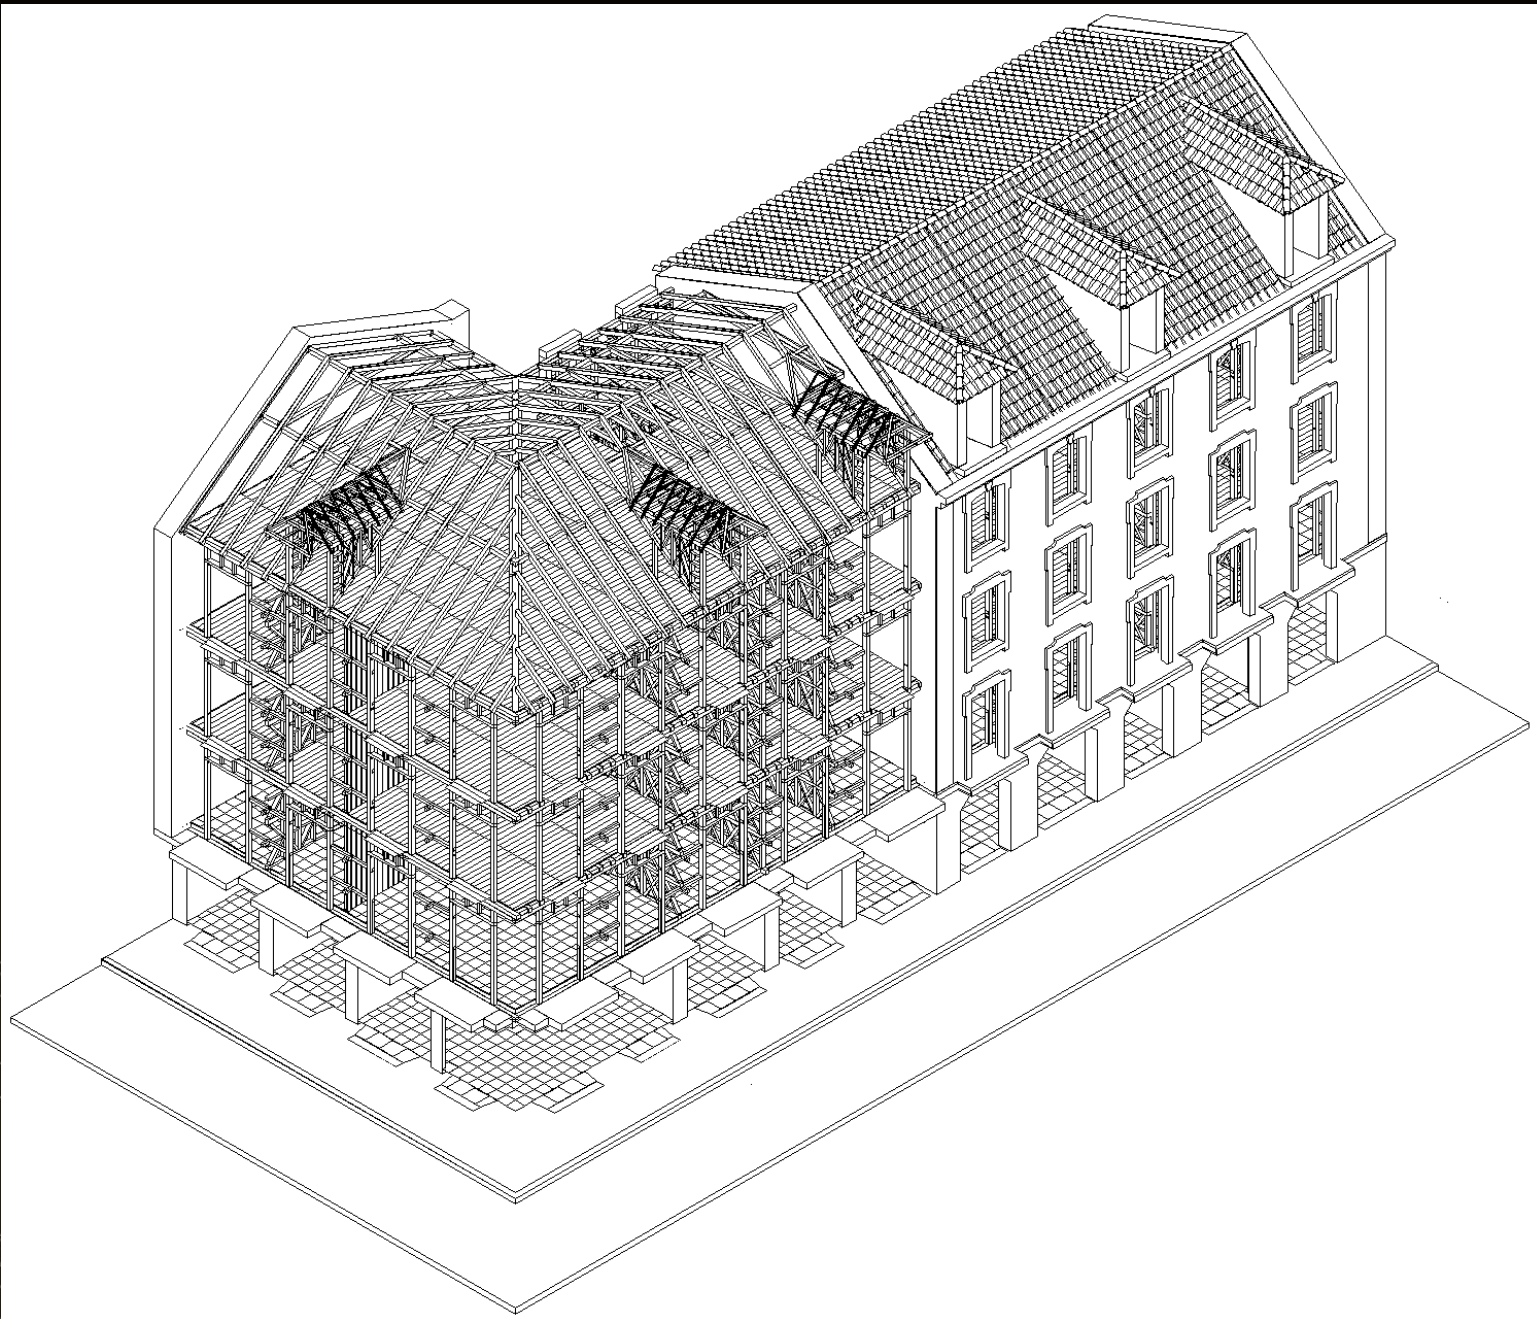
Rubble masonry
fills the spaces of
the trussed walls
for damping. ↓

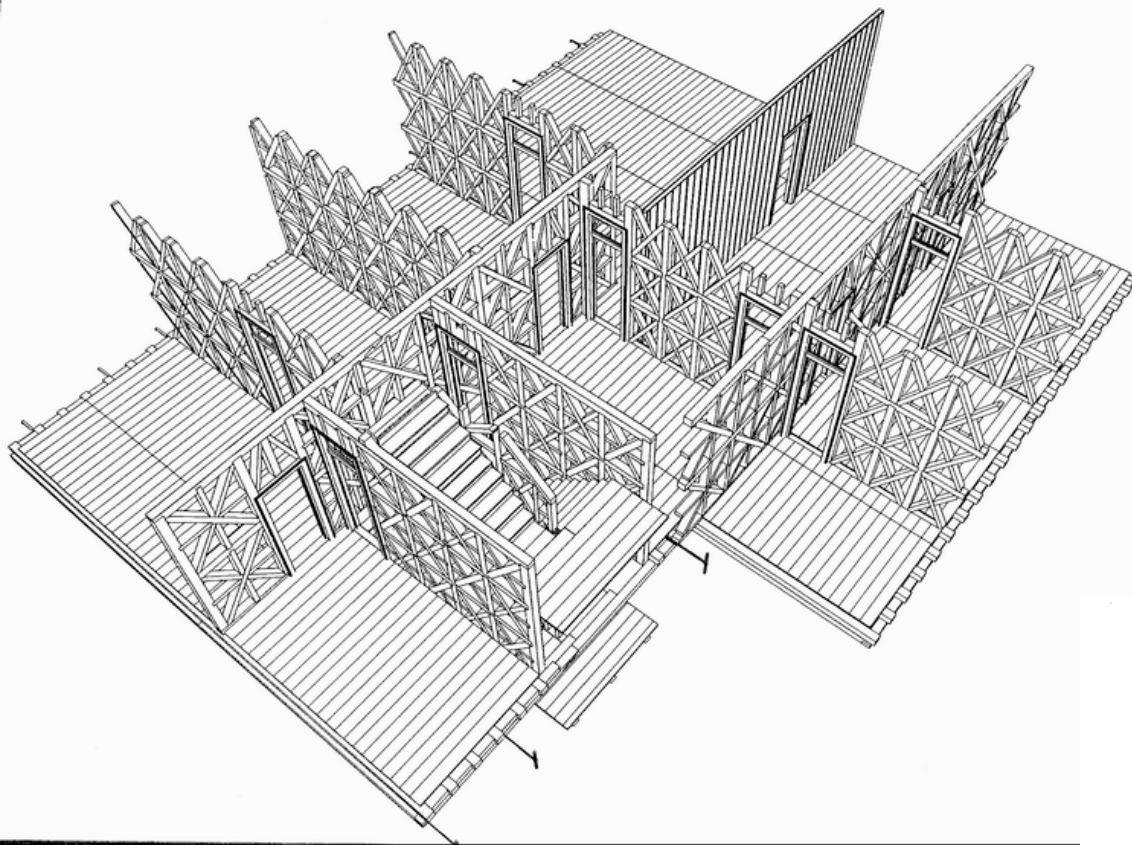
↑ Basic tri-dimensional
bracing unit: diaphragm
floor and bracing walls in
two directions.

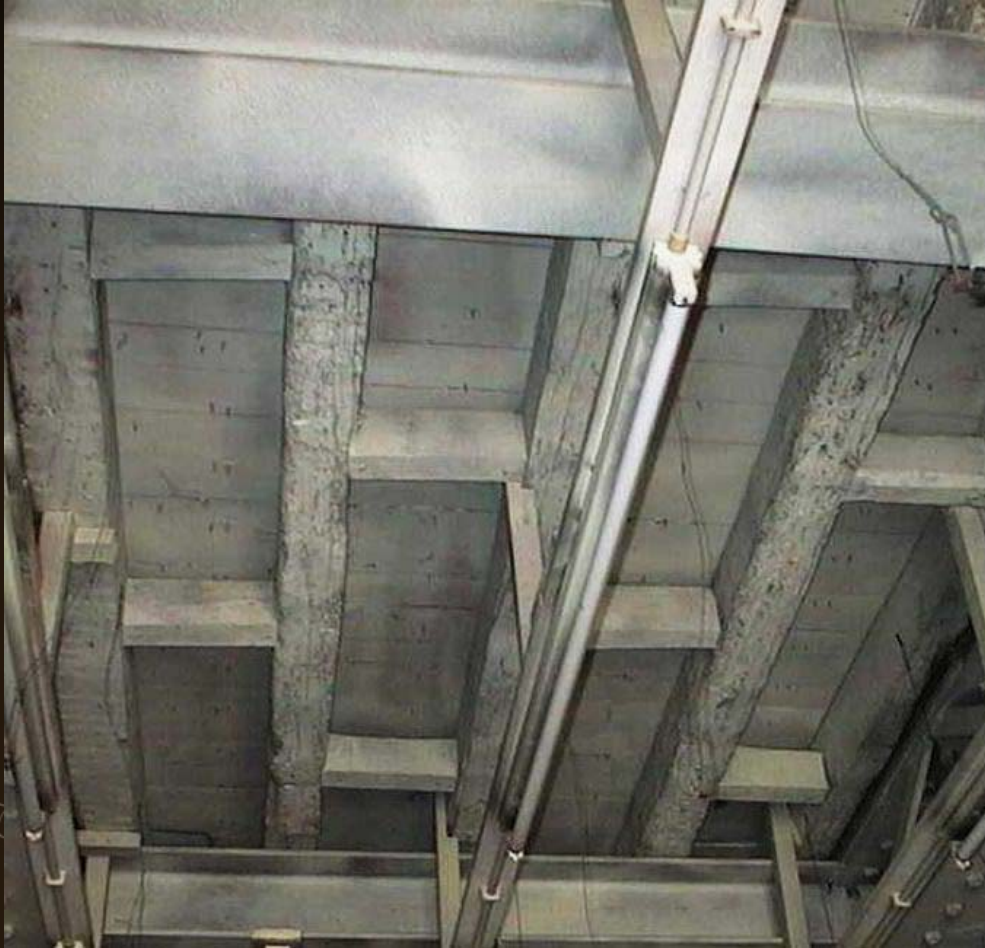
Sturdy bracing of floor joists to ensure diaphragm action. Steel members shown result from more recent alterations.

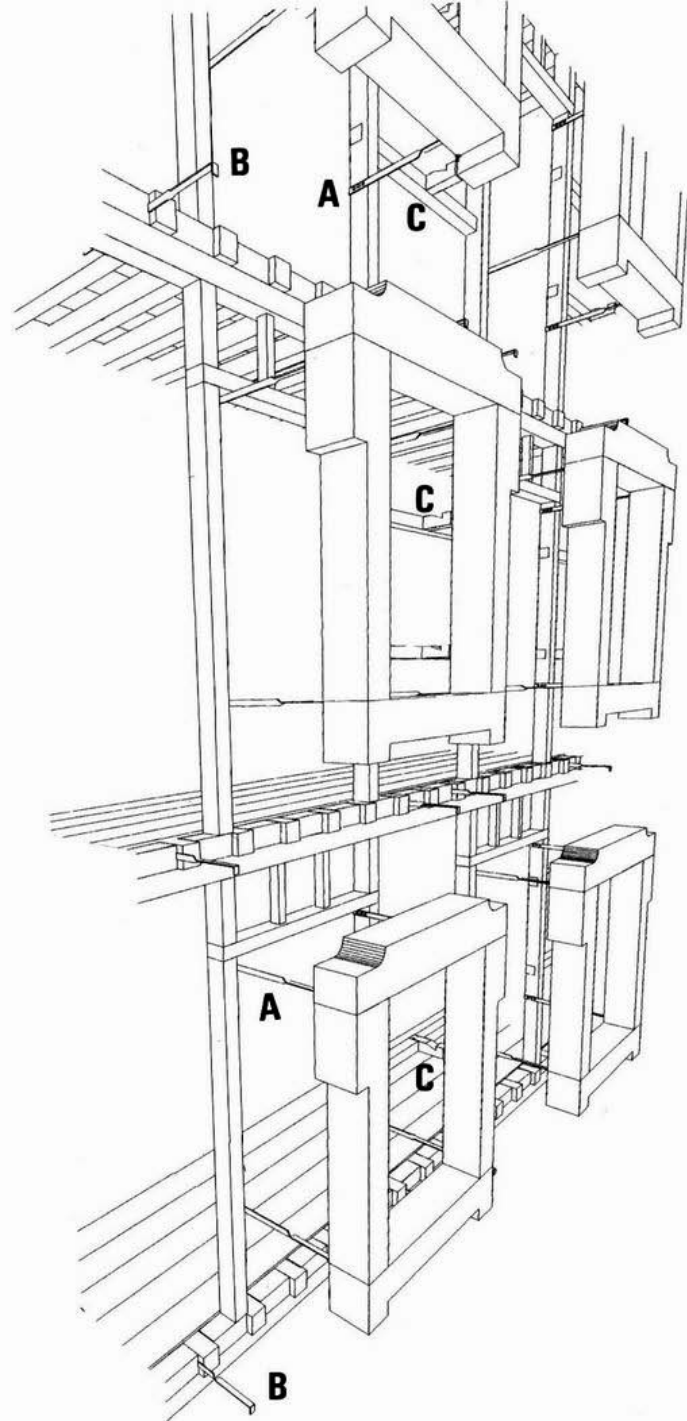
In this figure, where the masonry of the main façade wall was made invisible, several connectors are shown, both in iron (A, B), or timber (C). Masonry confinement between interior timber grid and exterior ashlars is also noted.

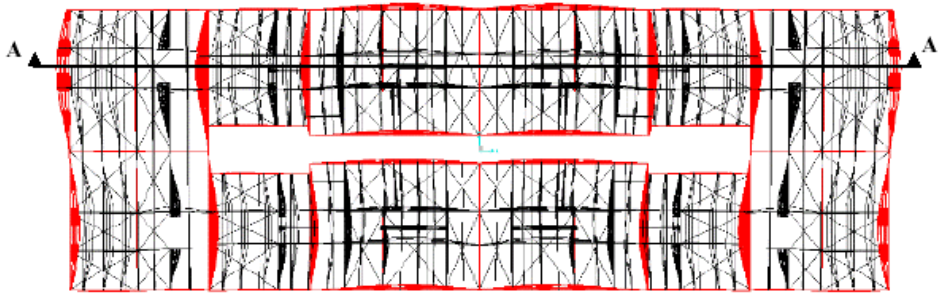
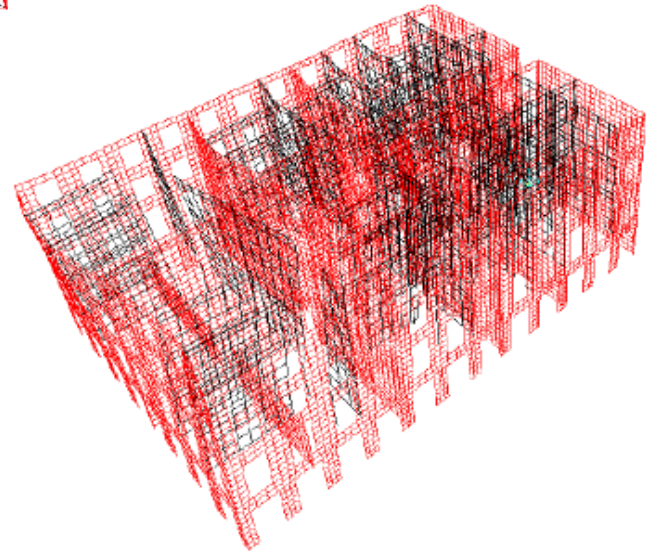
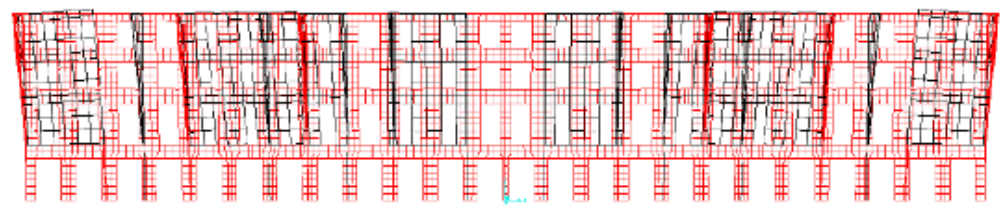
Elastic modelling
of a pombalino full
block.

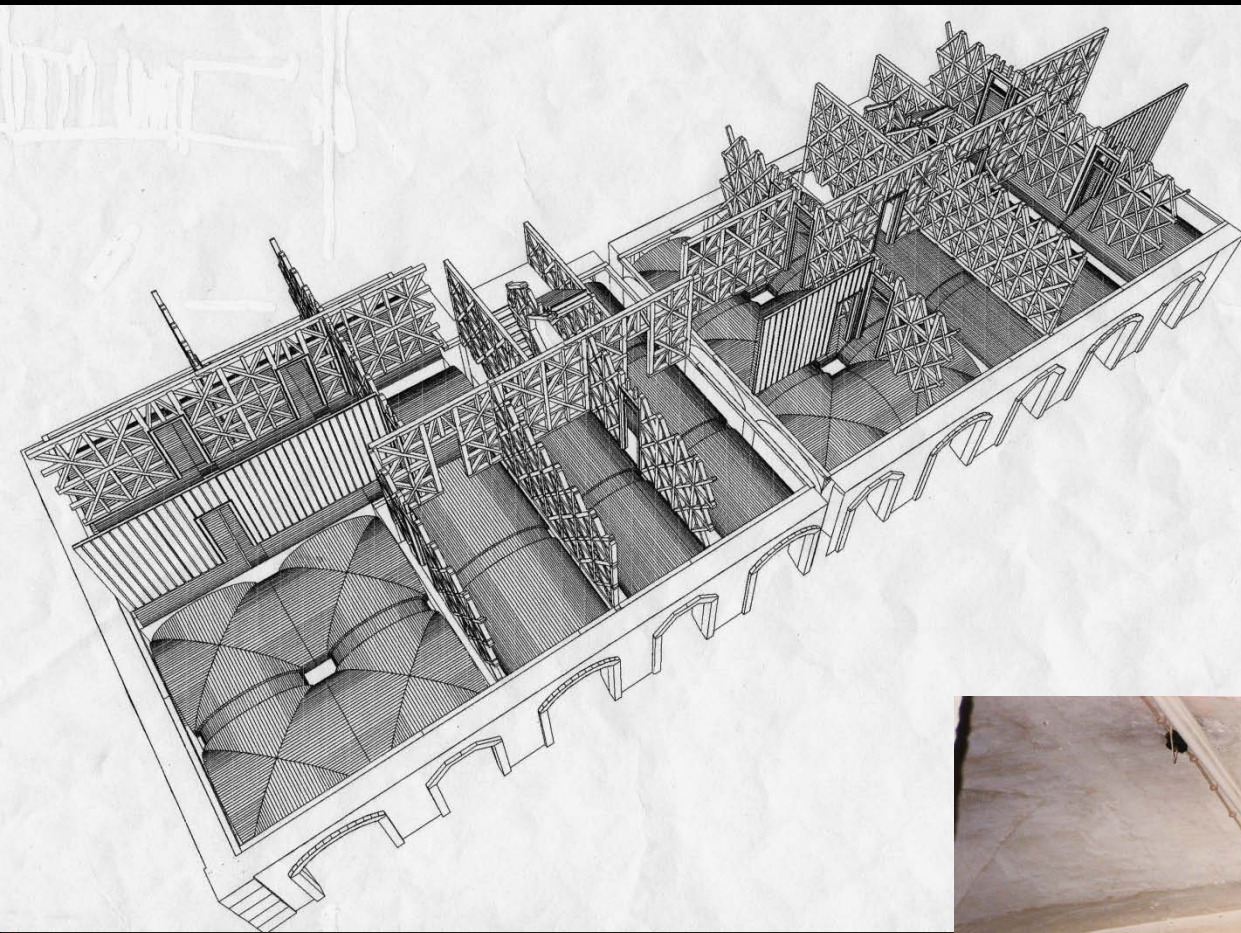
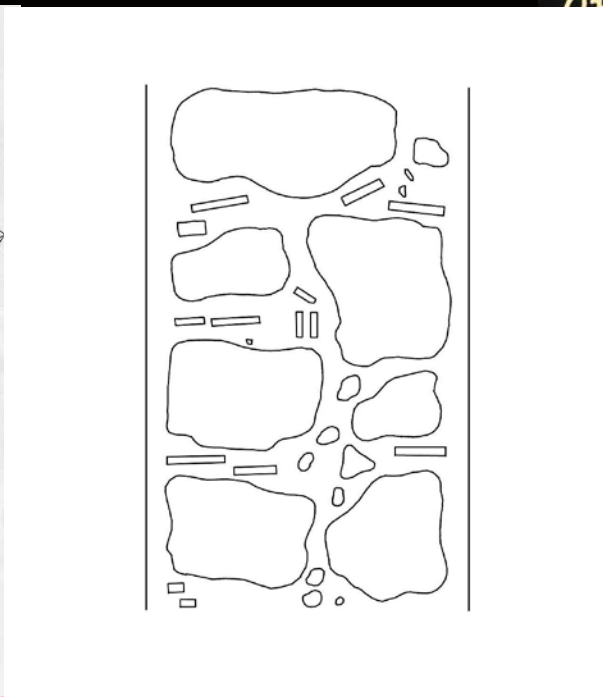
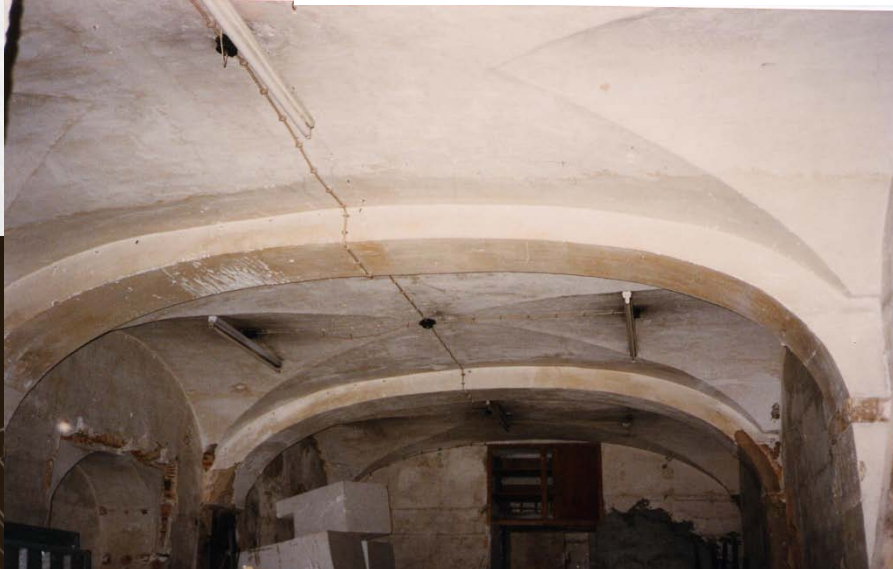
Structural irregularity of pombalino buildings. Low grade rubble masonry walls (above, right).

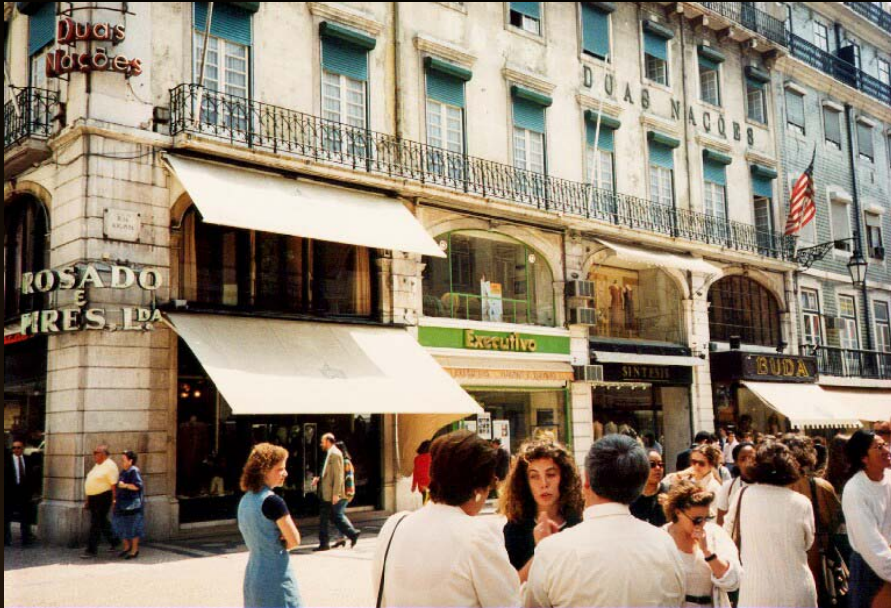
Removal of façade piers.

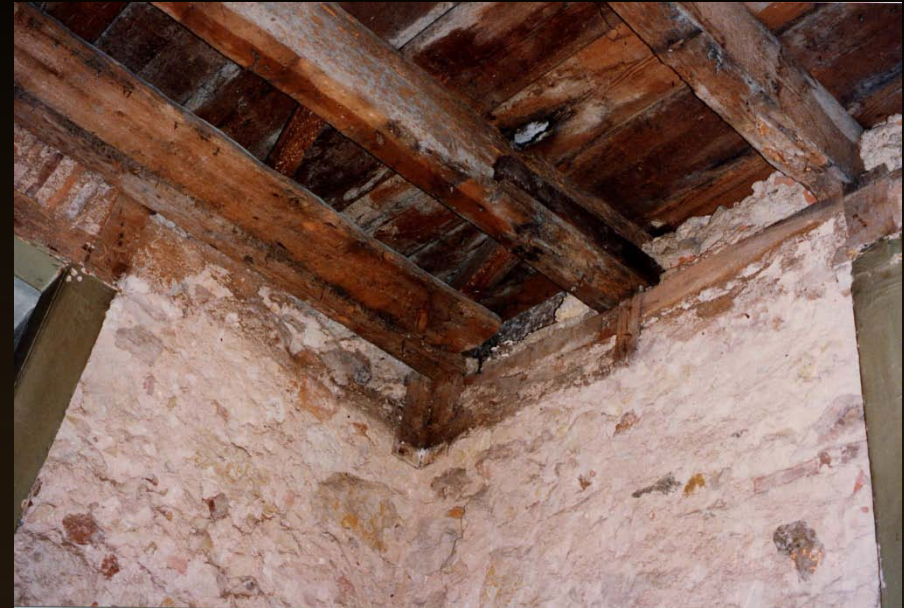
Wood degradation. Rot promoted by excess moisture.

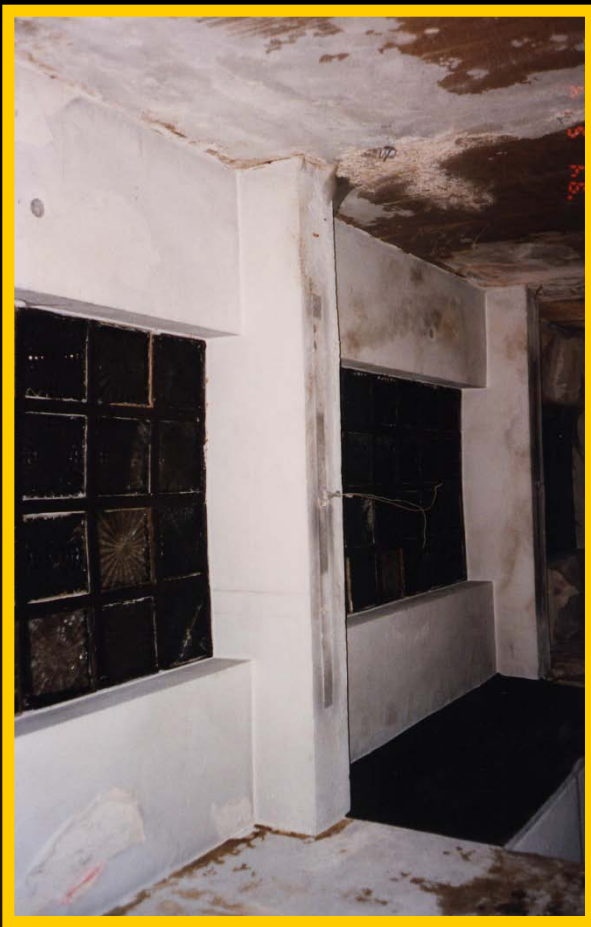
Alteration of the structural system with replacement of masonry components by reinforced concrete.

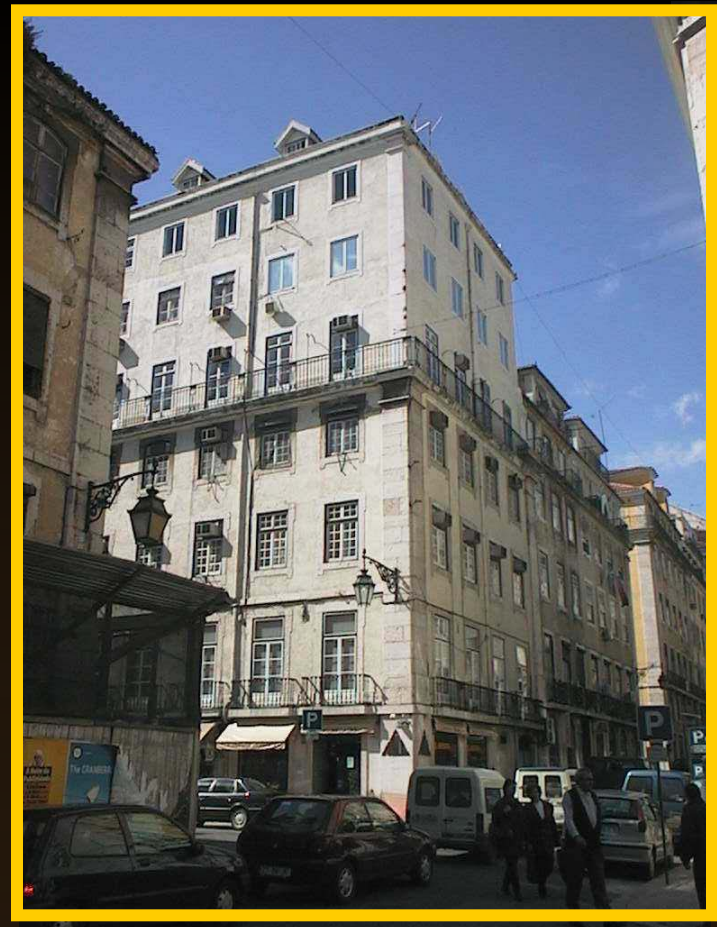
Addition of extra floors.

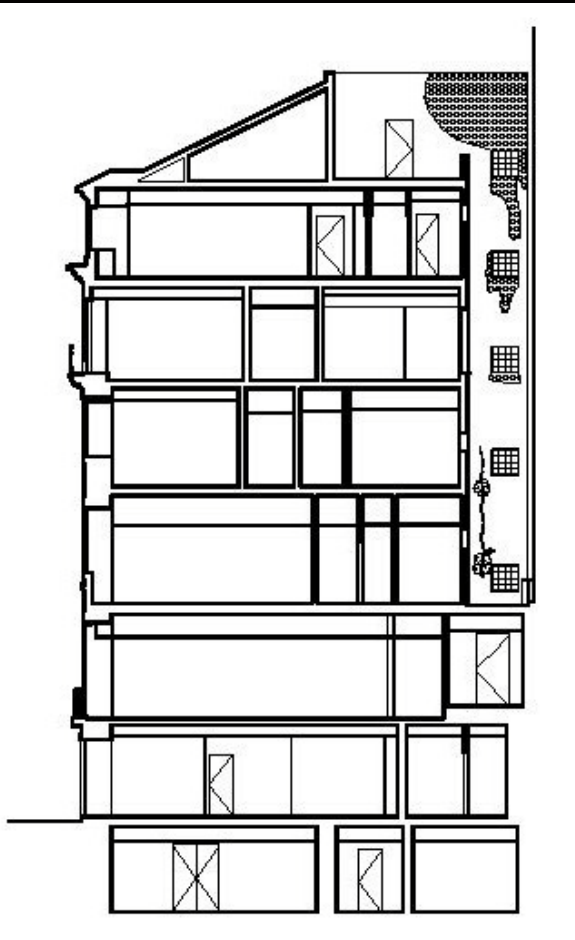
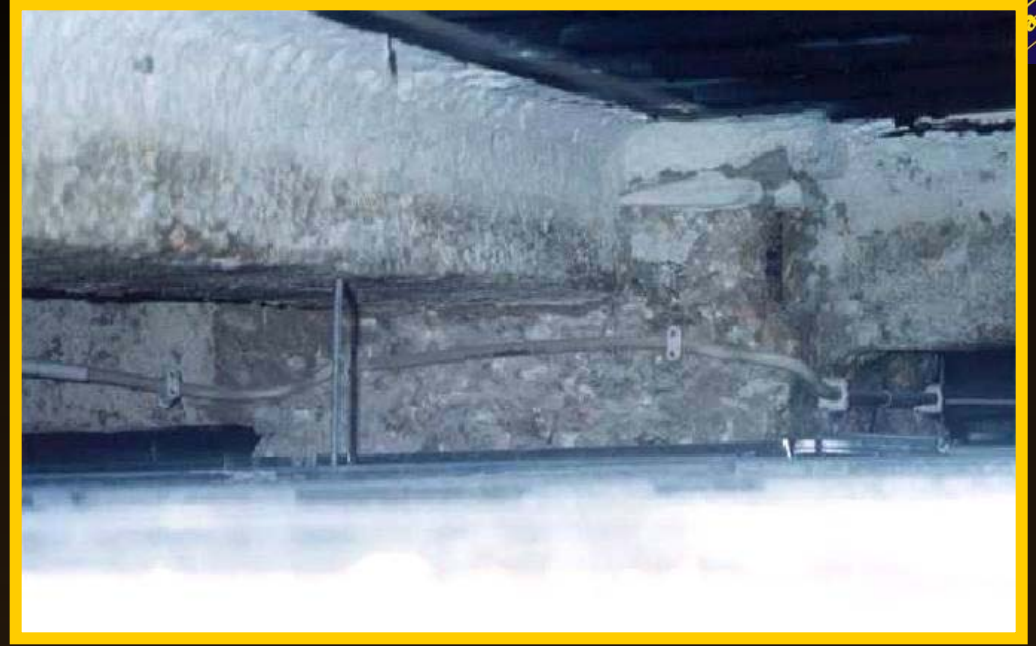
Execution of new RC slabs
at ground level.

Excavation of soil underlying the building,
with foundation deepening and basement
construction.

Main anomalies of pombalino buildings.

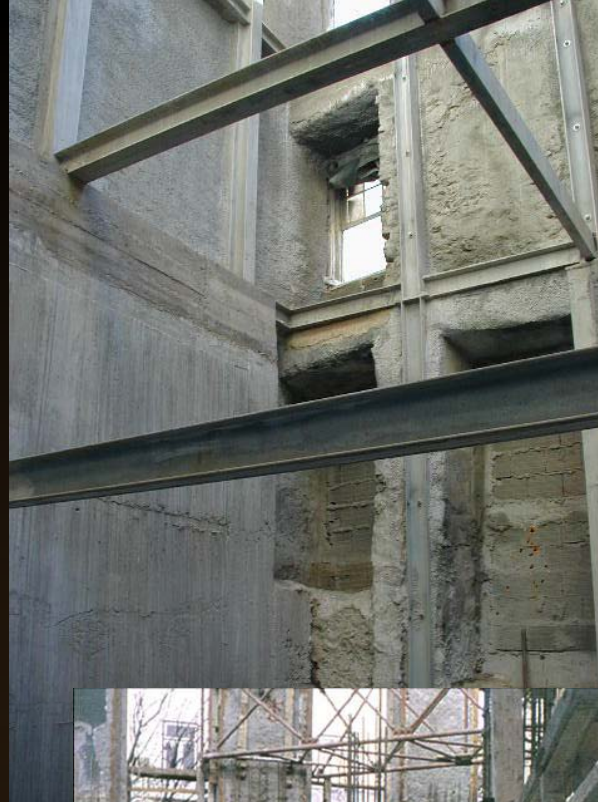
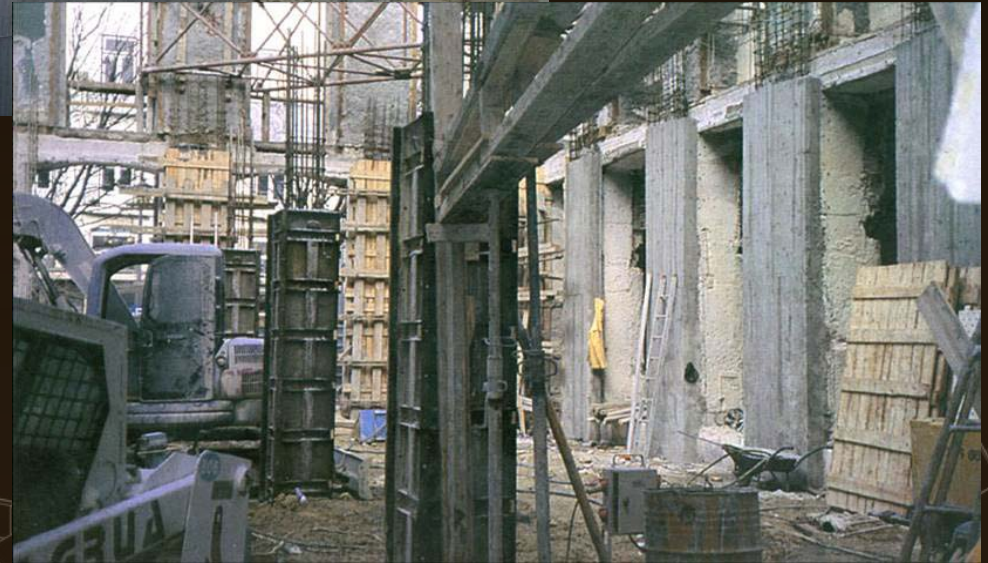
Total demolition of the building core and execution of a new steel or reinforced concrete structure.

Intrusive rehabilitation methods.

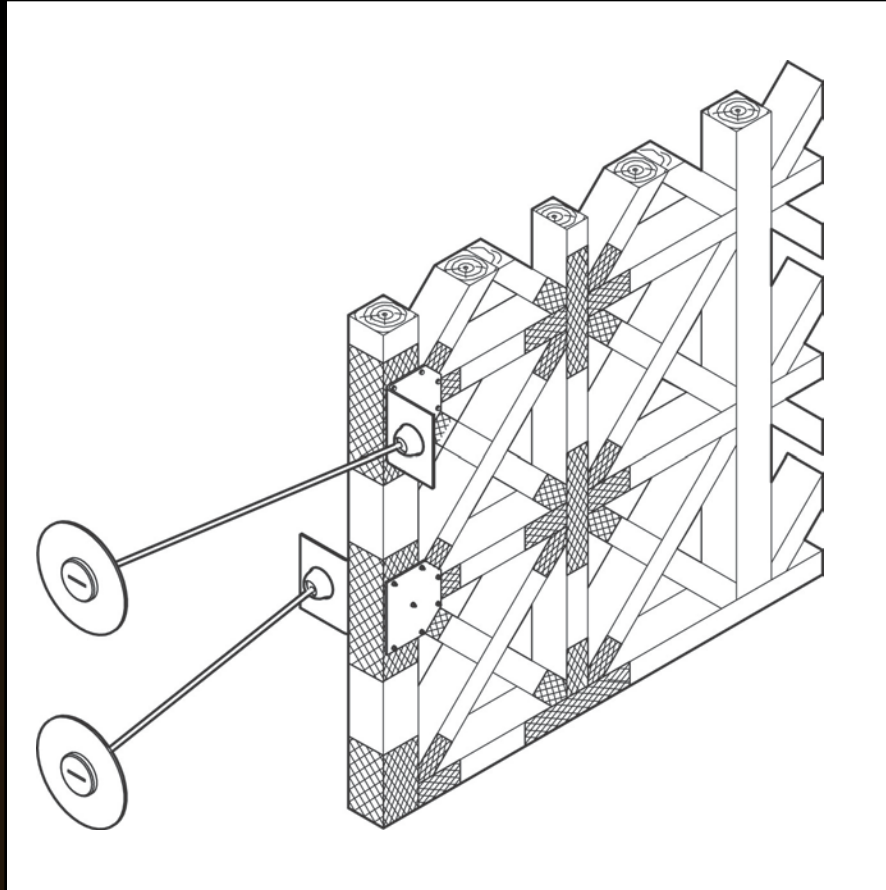
Strengthening the connection between timber bracing walls and main masonry walls. The ties cross the masonry wall. Note the FRP strengthening of the bracing walls.

Examples of techniques aiming at improving the global stability of the structure.

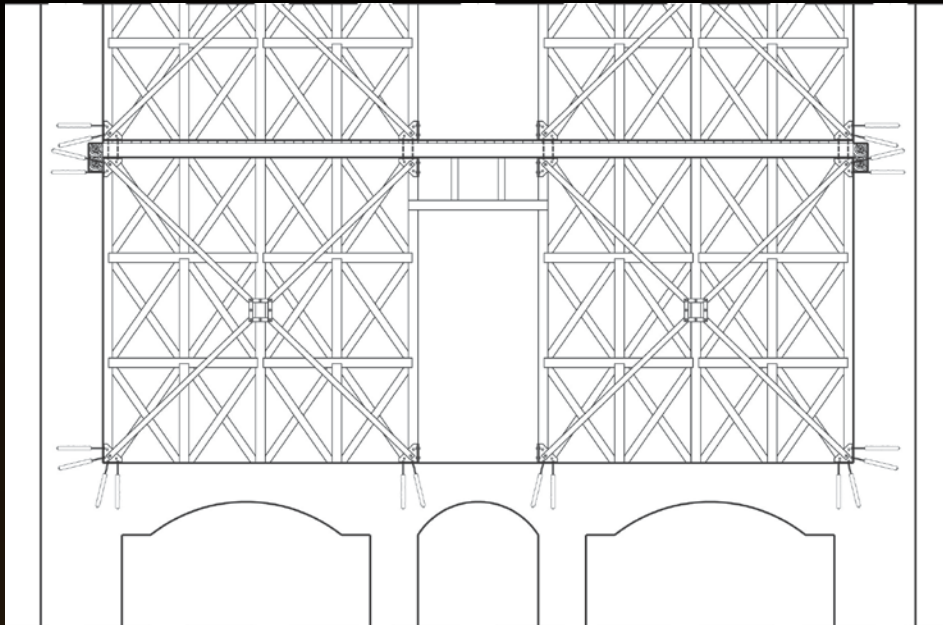
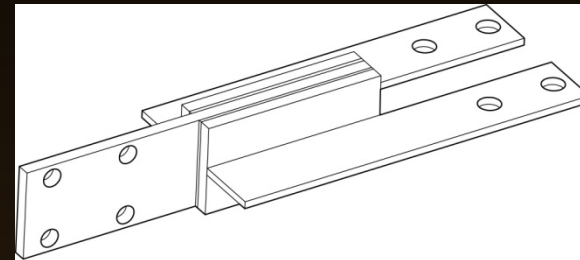
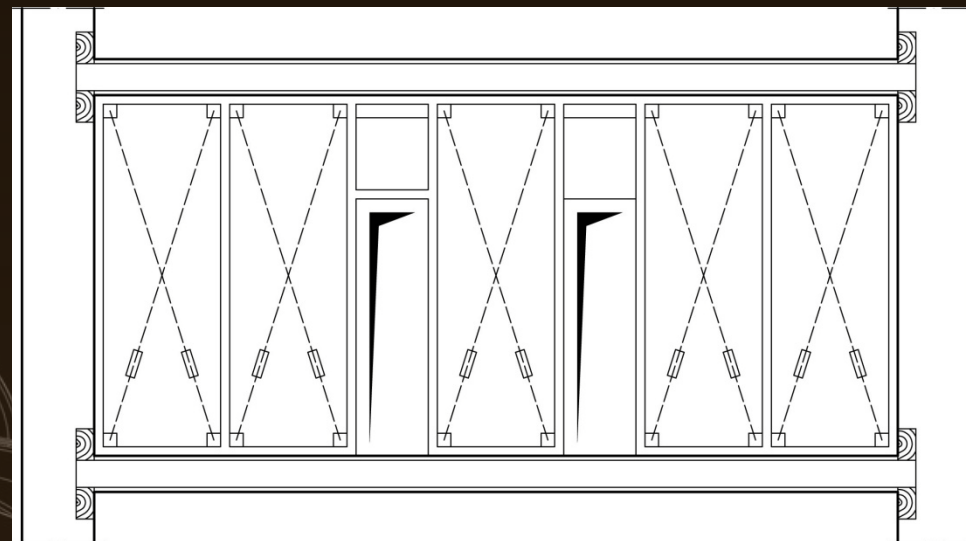
Installation of
damping devices.

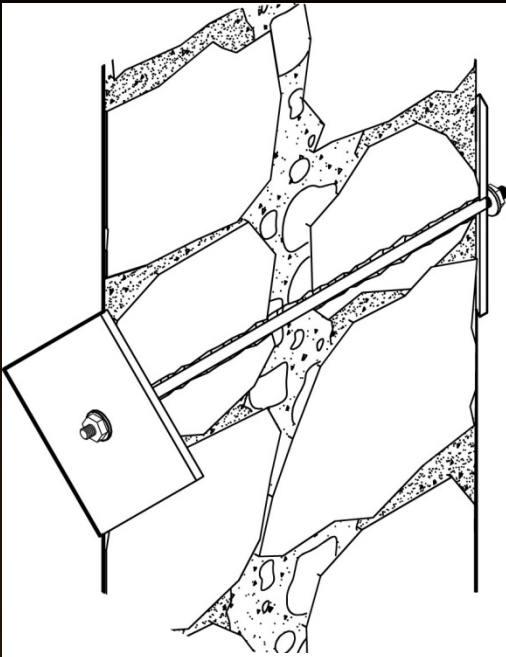
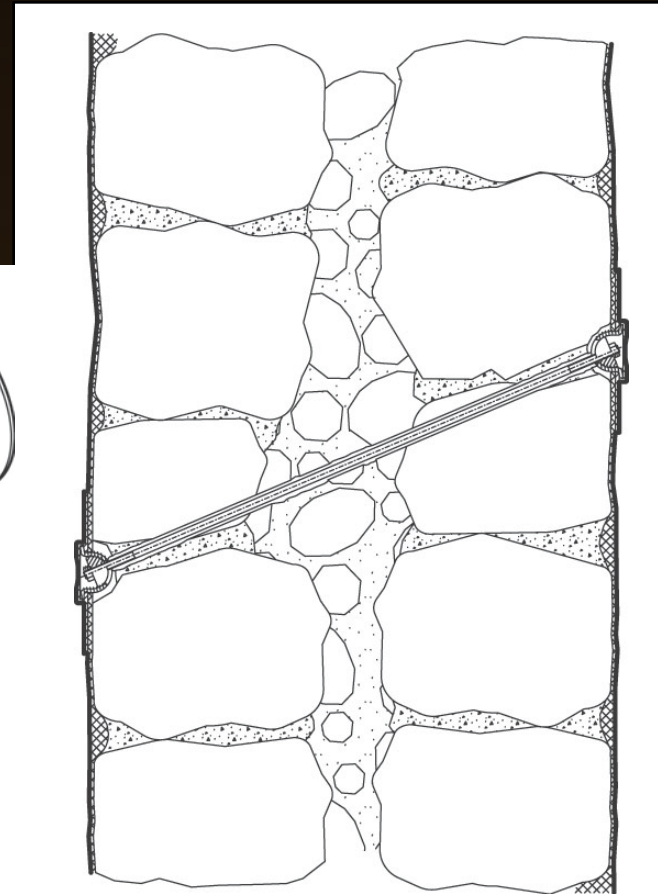
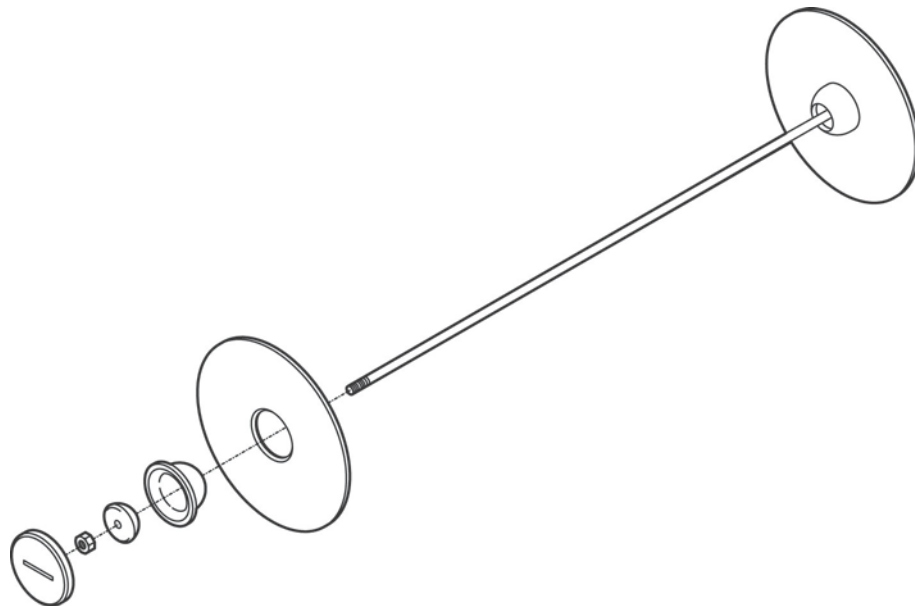
Installation of confining through ties.

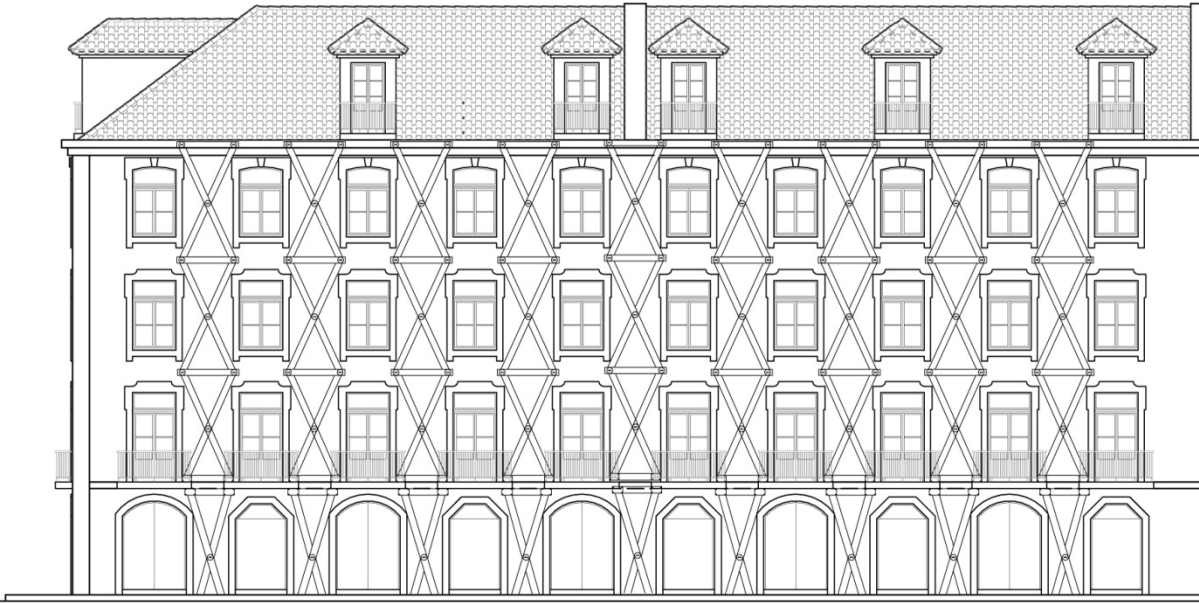
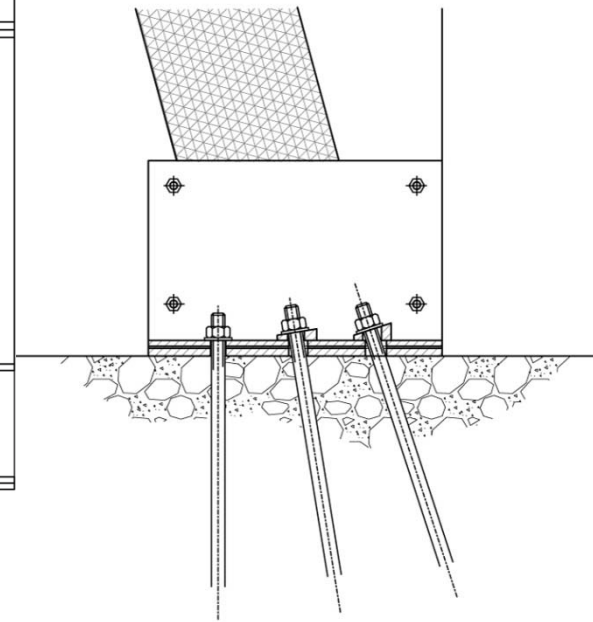
Increasing the strength of the component by adding a new material (FRP bands).

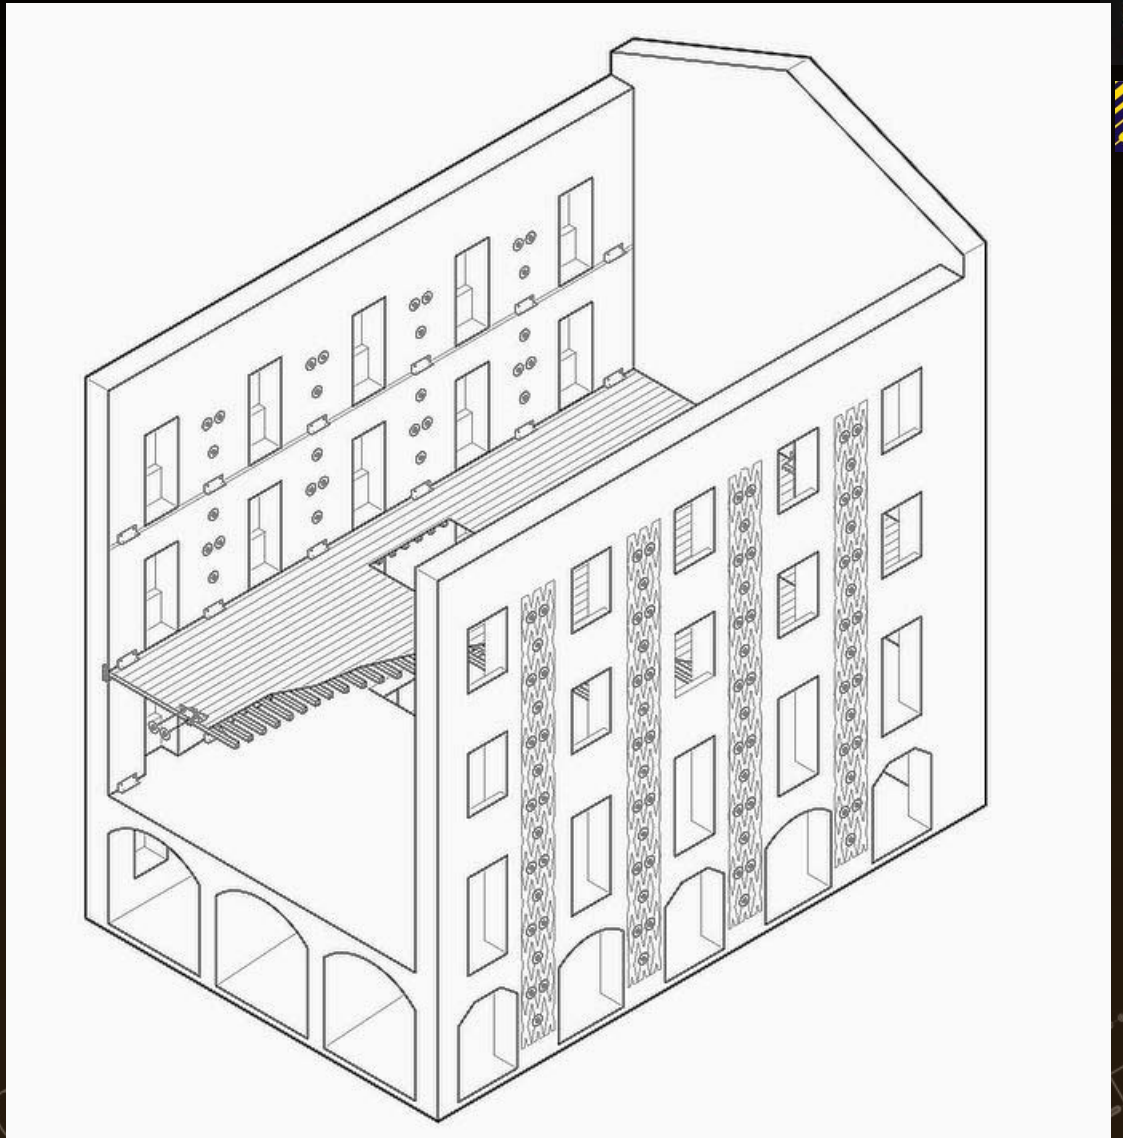
Strengthening the piers by adding a new material (FRP bands), coupled with trough ties.

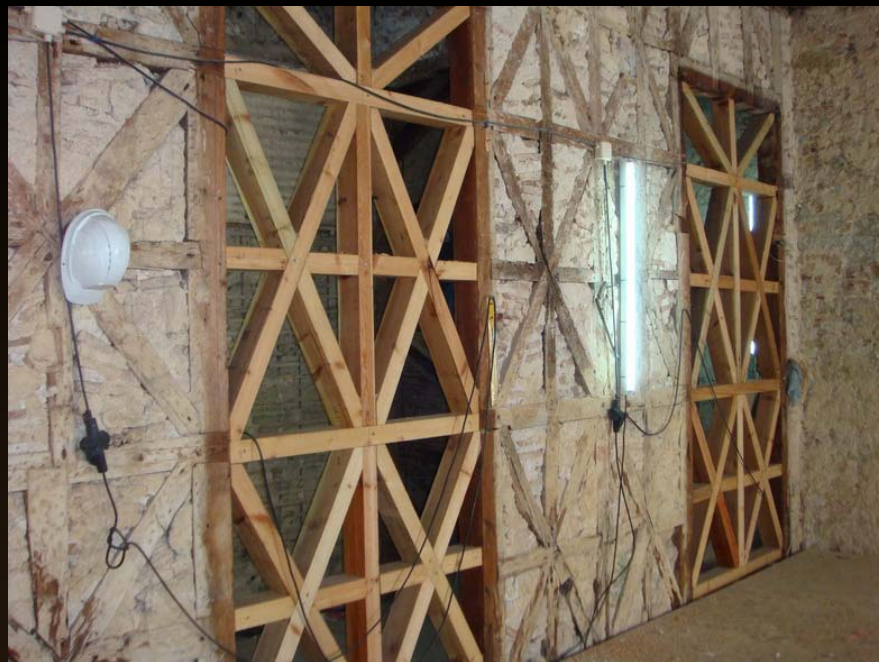
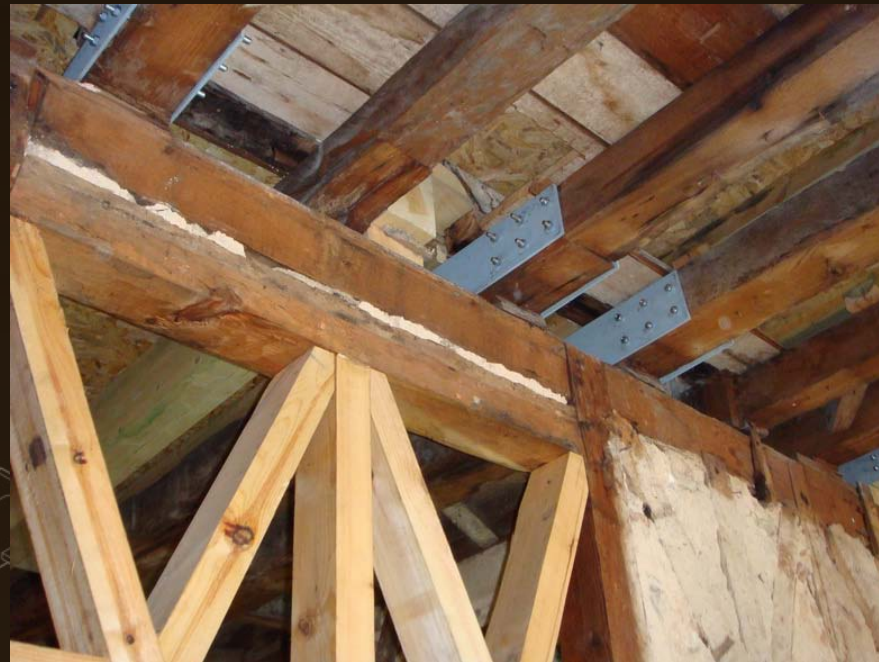
Make up of missing or deteriorated pannels of timber framed walls in a pombalino building, downtown Lisbon. Detail of local strengthening of floor beams.
