## Lessons learned from heritage structures conservation projects of Iscarsah Members

Prepared by the Examples Initiative Working Group

## Executive Summary

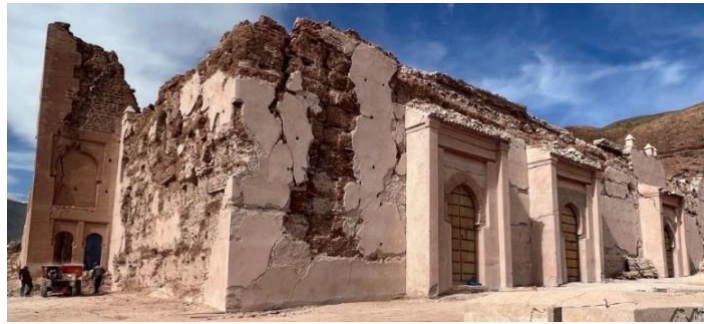
(a) (b)  
Figure 5: (a) Peak Ground Acceleration map, Al Haouz earthquake M6.8, Sep 8 2023 (USGS),  
(b) Tinnel Mosque after the earthquake showing severe wall damage

**Intervention during active restoration:** The Tinmel Mosque suffered damage while restoration was in progress, raising critical questions about temporary stabilization protocols and site safety in seismically active zones.

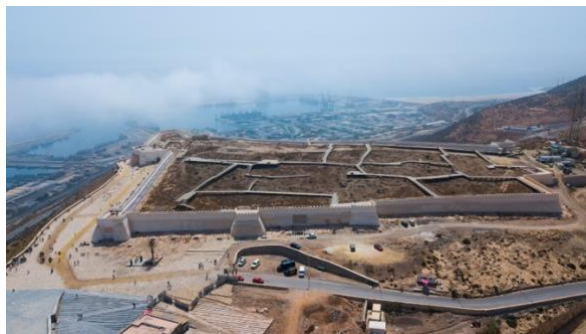
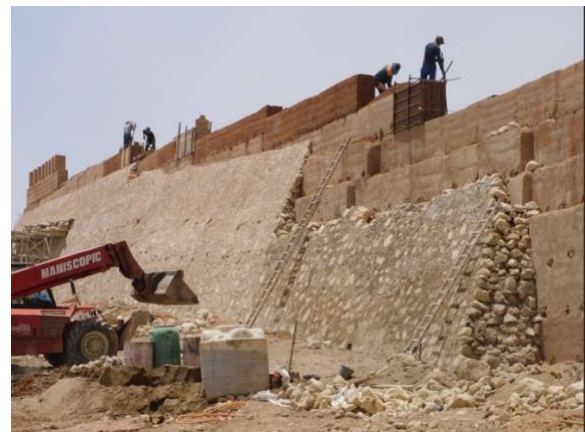
(a) (b)  
Figure 6: (a) Aerial view of the Kasbah Agadir Oufella rehabilitation (Salima Naji) (b) Wall  
construction and reinforcement technique, Kasbah Agadir Oufella (Salima)

**The Agadir Oufella model as a replicable blueprint:** The multidisciplinary, participatory, and digitally documented rehabilitation approach provides a transferable methodology for other earthen heritage sites in seismically active regions of the MENA and beyond.

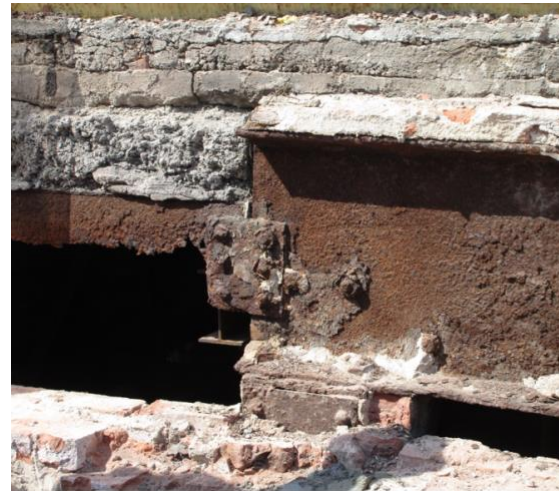
Figure 7: (a) An illustration of the building from 1910, shortly after completion, from *The Brickbuilder*. 19 (3), Match 1910. Public domain, (b) A photo of a condition found at the roof spandrel beam. Property of Old Structures Engineering.

The steel condition varied from mild rusting to near-complete loss of section in some columns. In the latter case, it was clear that the facade masonry in which the columns were embedded was carrying the structural load and was being damaged in the process. The other potential imminent hazard was the deterioration of the outriggers and tie-down hangers of the cornice.

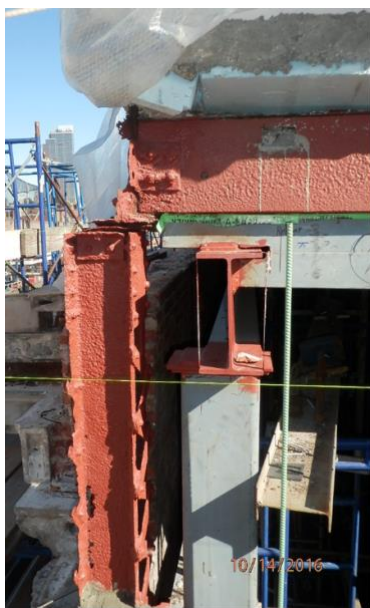
Figure 8: (a) A photo of a corner column showing deterioration and sister column (gray) during the repairs. Property of Old Structures Engineering., (b) Details for cornice stabilization. Property of Old Structures Engineering. Note the attached photos and drawings are all property of Old Structures Engineering

The Old Structures analysis of the building showed no evident damage from lateral loading or movement. The columns were sized adequately to carry gravity load but not the combined axial forces and moments that lateral-load analysis of the building frame would require. In the interest of promoting the rental, the developer had originally stated that the building should be entirely brought up to current-code standards, which would require either that the steel structure be reinforced to carry wind and seismic loading or that the masonry walls be reinforced to meet requirements for shear walls. Either form of reinforcing would have greatly increased the cost and intrusiveness of the repair work, without adding any obvious benefit. The decision was made by the entire team, based on the Old Structures recommendation, to rely on code grandfathering of the original structural design and on the demonstrated strength of the exterior walls to act as de facto shear walls. The damaged steel was repaired and sistered as required for gravity loads. The project was completed in that manner.

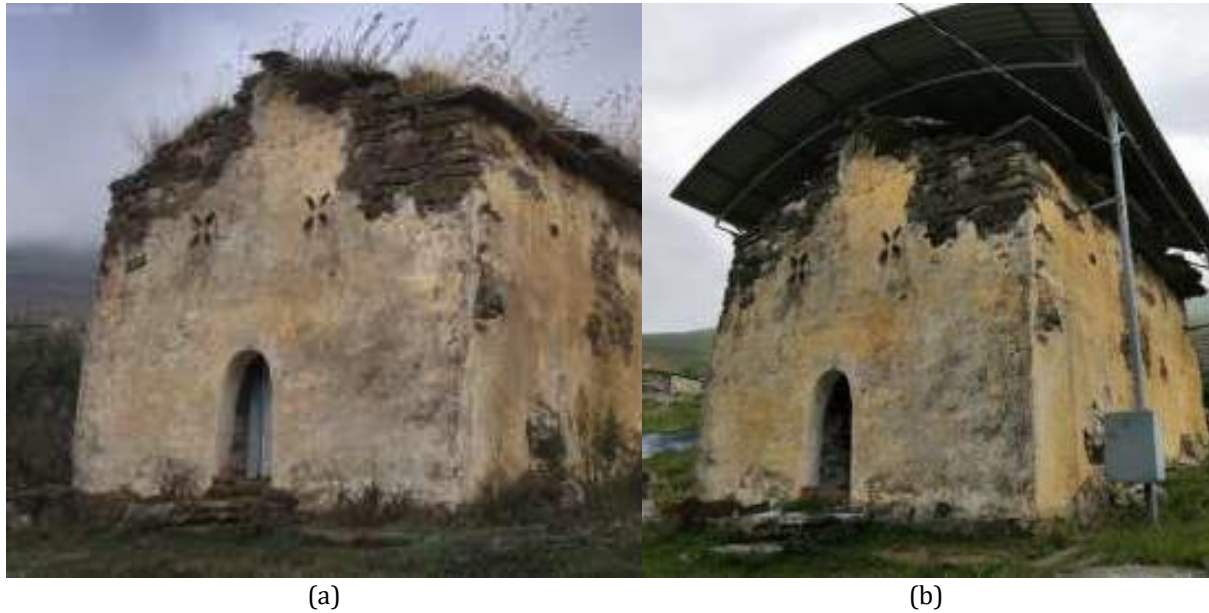
Figure 9: (a) The Faraskatta church before conservation, (b) Conservation roof installed in the 1990s

The slate roof slabs were deformed under the influence of moisture accumulation between the slabs under conditions of alternating temperatures. Biomass from grass and small bushes began to appear between individual slabs. In the 1990s, a metal conservation roof was installed on racks made of metal pipes.

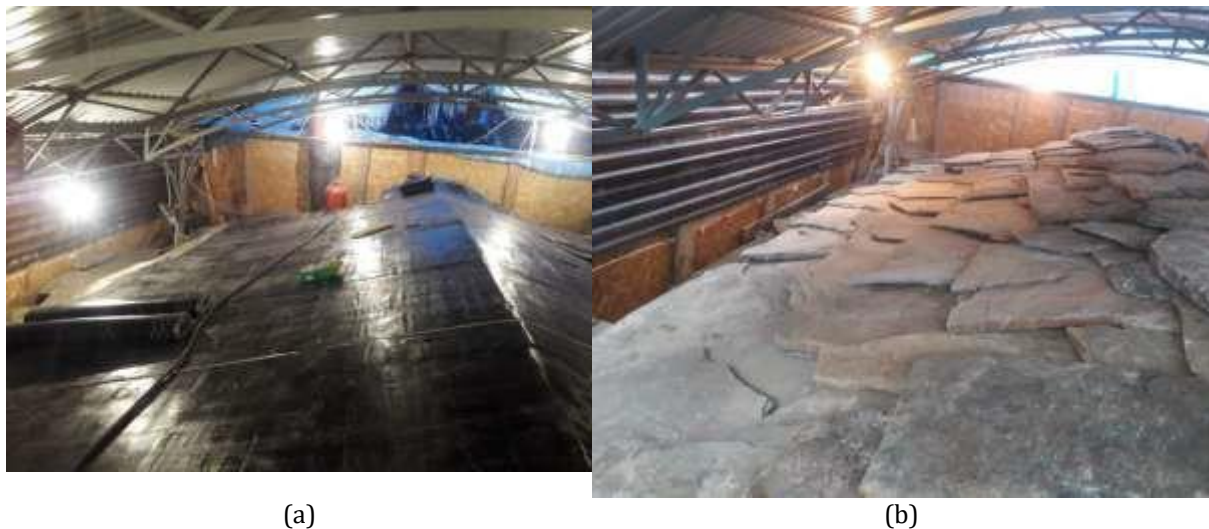
Figure 10: (a) Hidden insulation layer inside the roof, (b) Restoration of upper layer of the original slate roof

On top of the waterproofing layer, a top layer of slate roofing slabs was laid in mortar, keeping the original slabs in place with the addition of missing ones from new material. After checking the effectiveness of the waterproofing of the roof, the temporary conservation roof was dismantled.

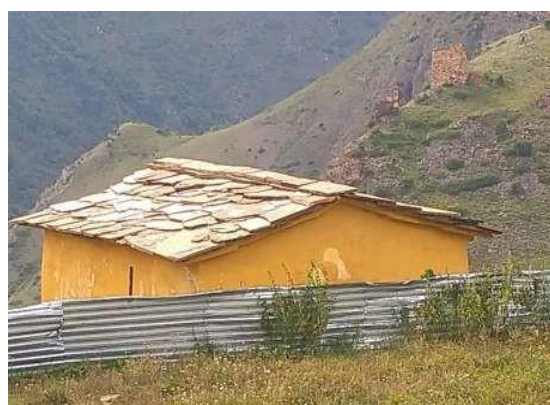
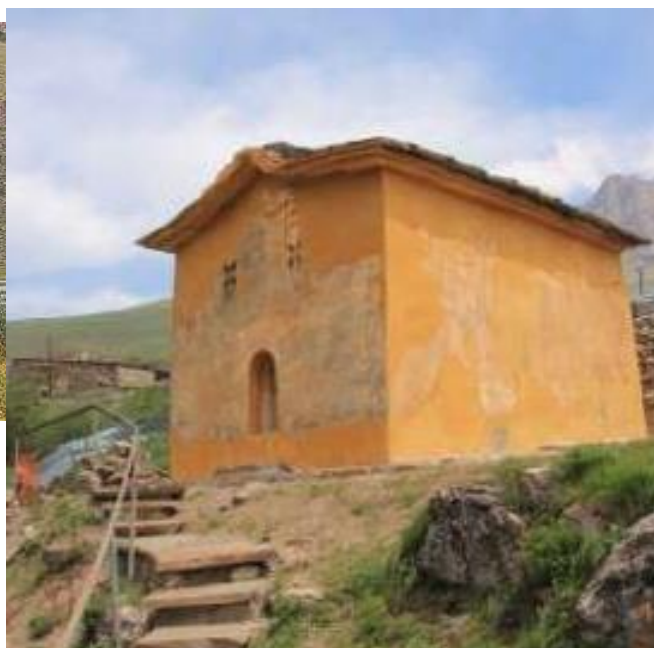
Figure 11: (a) Roof after the restoration, (b) The church after the restoration.

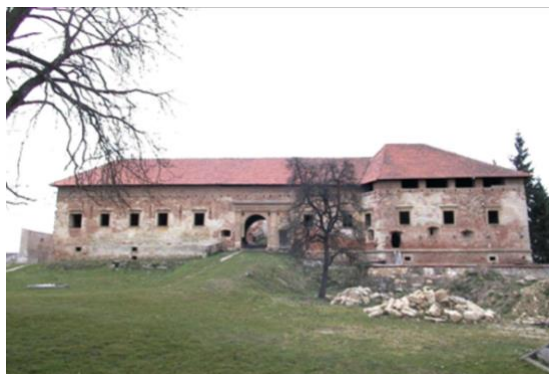
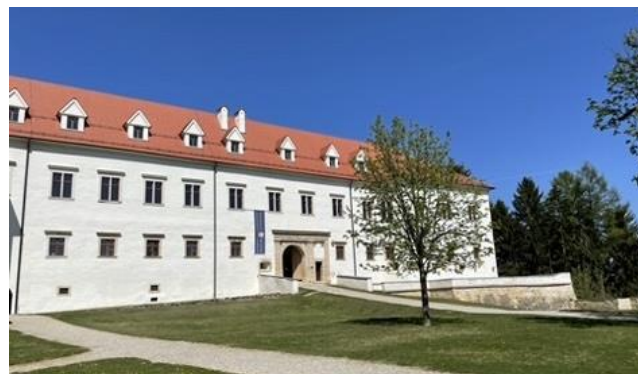
*Figure 14: (a) Reconstruction based approach - before, (b) Reconstruction based approach - after*

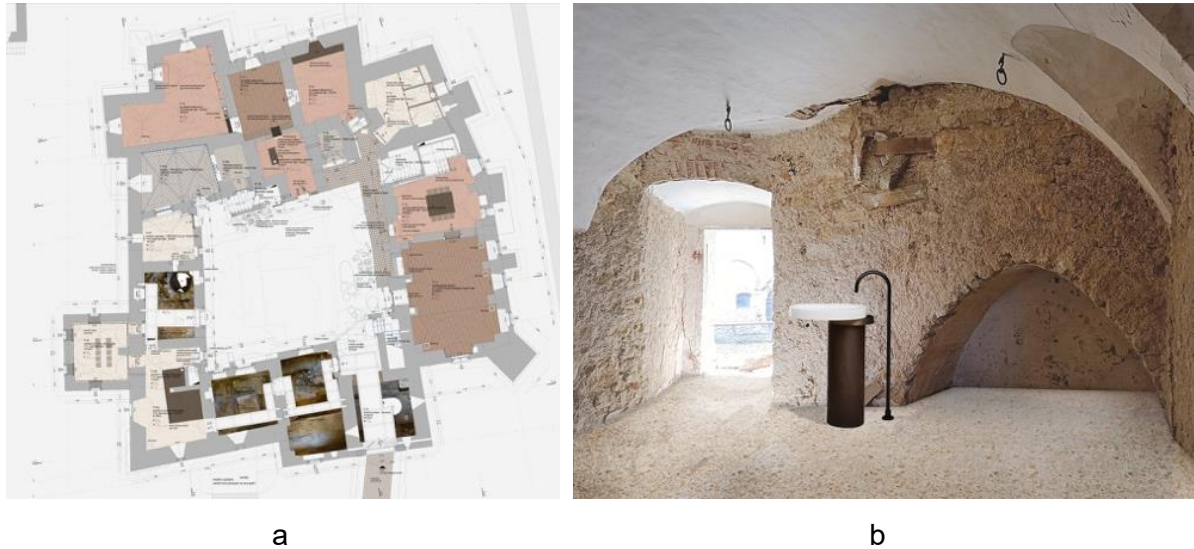
Figure 15: (a) Conservation based approach, (b) Conservation based approach

In contrast, the conservation-based approach, carried out from 2023, is being implemented in the old castle, where a significant portion of the original fabric has been preserved. This phase follows a different methodological framework, emphasizing minimal intervention and the retention of historic material. The works include consolidation of masonry through lime-based grouting and crack injection, stabilization and partial rehabilitation of foundations, improvement of drainage conditions to mitigate moisture-related deterioration, repair of plasters using compatible lime-based materials, and local structural strengthening where necessary. Additional measures include cleaning and protection of stone elements, repair of joints, and removal of incompatible later additions.

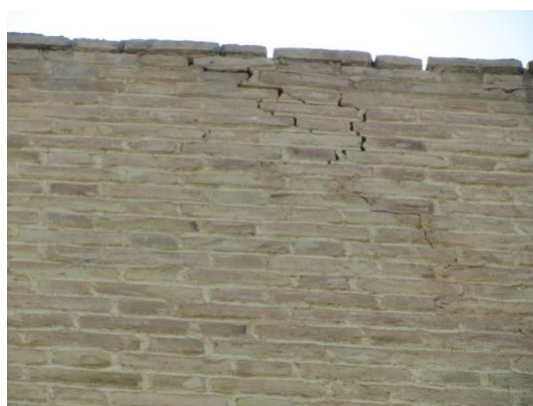
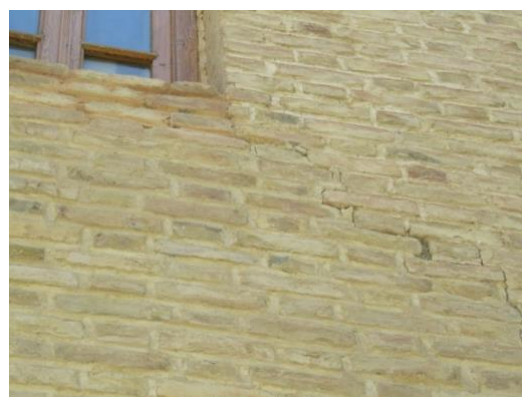
Figure 18: (a) and (b) Visible cracks

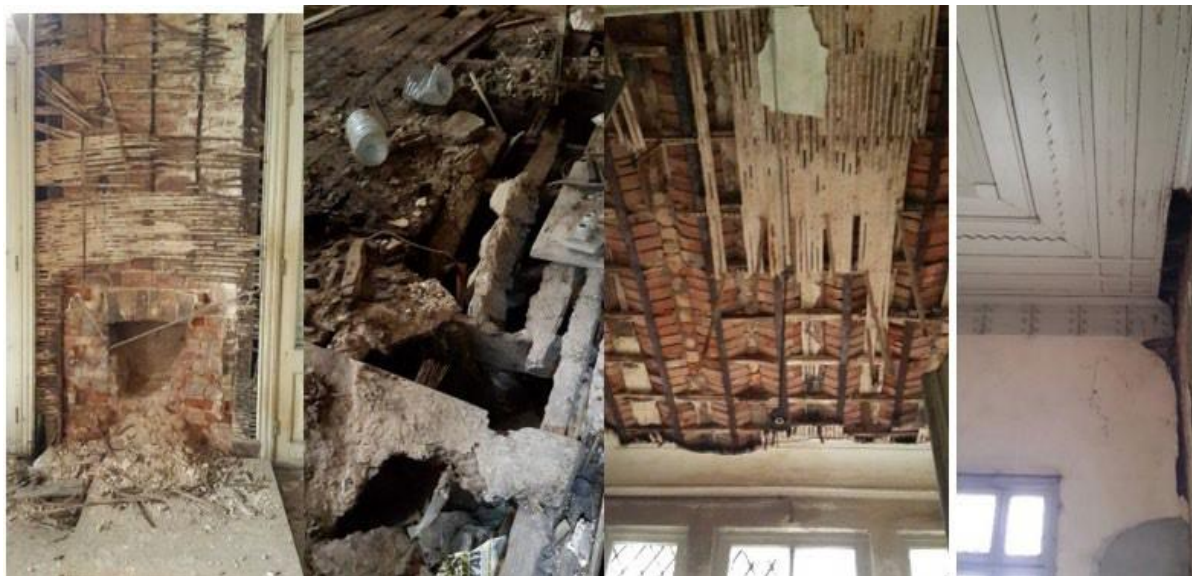
Figure 20: Damage to the masonry parts and floors – 2019.

Villa Tarabya has experienced extensive deterioration due to long-term neglect, lack of maintenance, and prolonged exposure to moisture. The most severe damage is concentrated in the structural timber elements, particularly in areas affected by roof failure and inadequate rainwater drainage. Water penetration accelerated the decay process, causing deformation, weakening, and deterioration of wooden components. Moisture infiltration through damaged roof sections and facade cavities continues to threaten the structural stability of the building. Timber elements exposed to persistent humidity show signs of biological degradation and advanced wear (Figure 3).

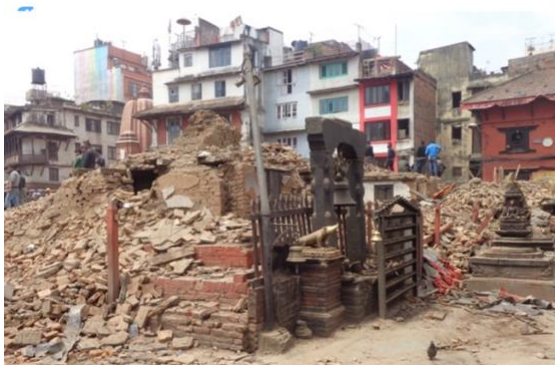
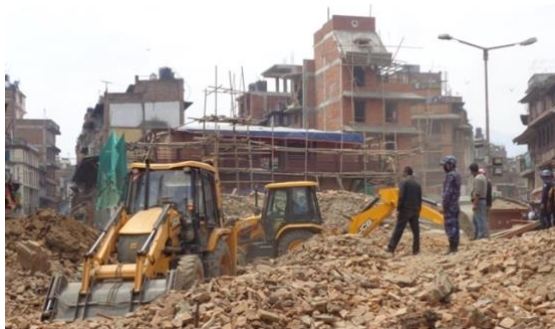
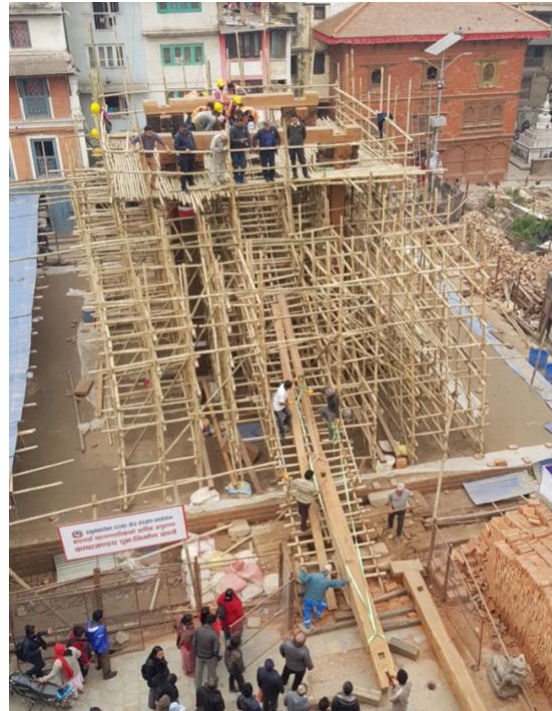
Figure 24: (a), (b), (c) View, the collapsed structure, reconstruction using bamboo scaffolds

The extent of damage to the monuments in the Kathmandu Valley indicated that without regular maintenance and the introduction of inappropriate interventions during restorations were the cause for these monuments to become vulnerable, as was the case of the Kasthamandap. There were examples of monuments in the Kathmandu Valley with major intervention carried out in the last 50 years using modern materials which were damaged during the 2015 earthquake. This was an opportunity to understand what intervention worked and what did not, but there was insufficient research done. To ensure protection of these historic monuments, a continuity plan is required which focuses on multidisciplinary research of the traditional techniques, providing support to the traditional craftspeople and regular maintenance, with appropriate interventions on the monuments.

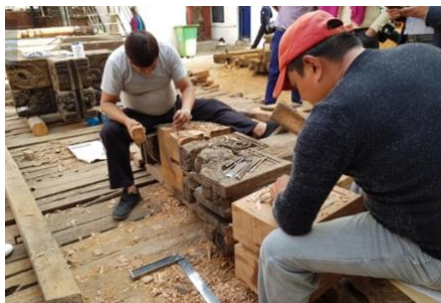
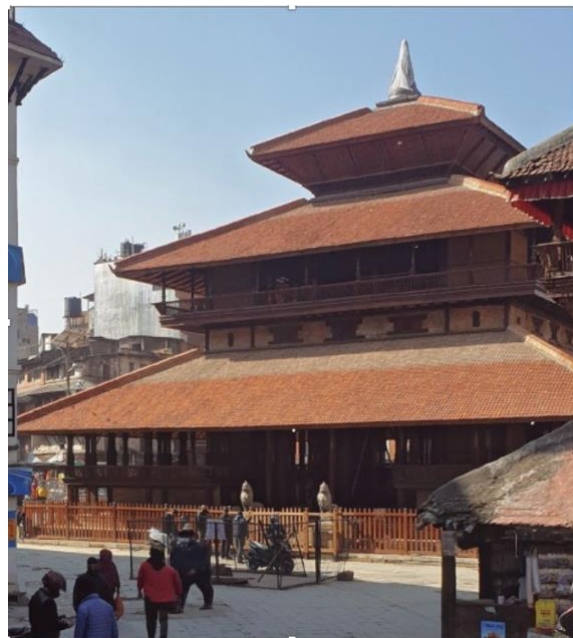
Figure 25: (a), (b), (c) Section, traditional carpenters are work, and the completed reconstruction
