## Message of the President of ISCARSAH Stephen Kelley

## La restauration du cloître de la cathédrale de Toul Ou un « écosystème » médiéval retrouvé

# Règlement parasismique des constructions en terre au Maroc (RPCT)

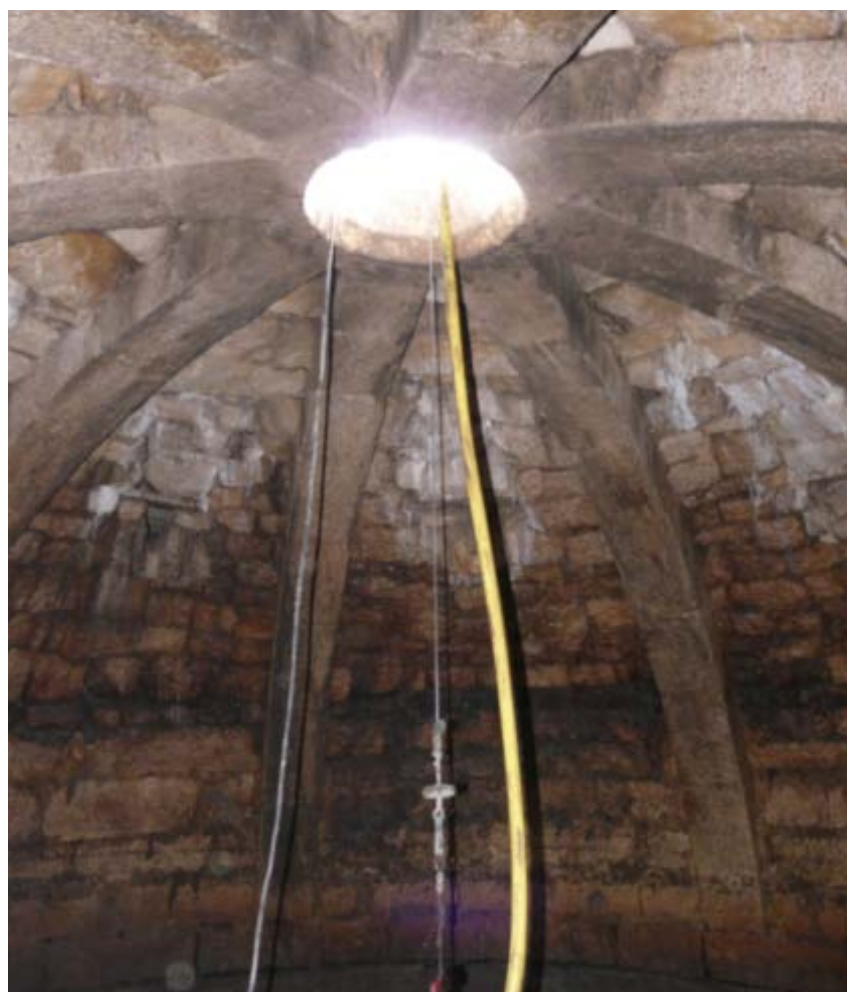
Vue de l'intérieur de la citerne.

d'impact de l'eau s'écoulant des gargouilles avec une construction enterrée, une citerne, située au centre du cloître. Explorant l'intérieur de cette citerne, nous avons découvert une construction en très bon état de conservation, constituée d'une coupole appareillée structurée par huit arcs rayonnants qui se rejoignent sur un oculus au-dessus duquel était posée la margelle d'un puits. Au centre de chacun des quartiers de voûte avait été ménagé un exutoire en pierre, contemporain de l'ouvrage. Il devenait évident que les exutoires correspondaient aux canalisations en pierre dont quelques fragments avaient été reconnus par sondages. Les auteurs des sondages archéologiques ont pu apprécier le bon état de conservation de la citerne et mettre en évidence la conception d'origine des [...] rigoles en pierre plates grossières [...] destinées à recueillir les eaux de pluie qui se déversent des gargouilles. Le rapport de l'INRAP est complété par l'observation suivante: «...ces rigoles sont aujourd'hui à l'état d'abandon et ne sauraient remplir leur fonction efficacement. Un large drain implanté postérieurement à l'est de la citerne, a manifestement pour fonction l'évacuation de l'eau qui viendrait la remplir. Cette structure marque l'abandon de la citerne et pourrait coïncider avec l'obturation de la margelle... ».

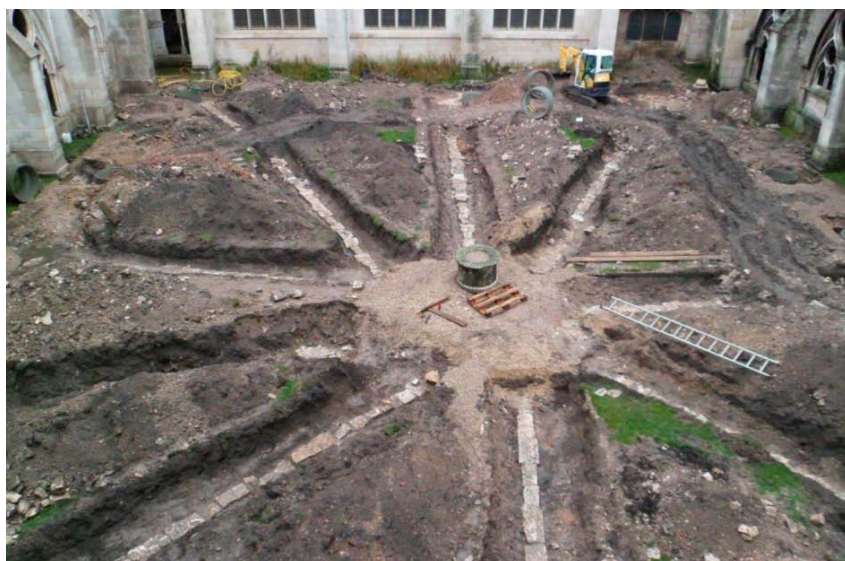
En cours de travaux, vue du réseau d'assainissement médiéval.

Le maître d'ouvrage fut rapidement acquis à notre nouveau projet consistant à reconnaître l'ensemble du réseau ancien, à le restaurer et à le compléter afin de retrouver l'équilibre qu'avaient mis au point les concepteurs du Moyen Âge. Nous décidions alors de mettre au jour l'ensemble du réseau enterré, tâche qui fut confiée à Cécile Travers, archéologue spécialiste des jardins historiques. La fouille systématique entreprise sous sa direction a permis de reconnaître un ouvrage en bien meilleur état que les sondages préalables ne laissaient espérer. En coordination avec les tailleurs de pierre, les canalisations reconnues ont été restaurées en conservation et les parties manquantes ont été complétées par des éléments en PVC afin de rétablir la continuité du système. Dans l'ouvrage médiéval, seules huit gargouilles étaient reliées à la « citerne » centrale (celles des quatre angles et du milieu de chaque côté du cloître). Nous avons partiellement conservé notre projet initial par la mise en œuvre de bacs enterrés au droit de chaque gargouille. Ces bacs reliés entre eux déversent l'eau récoltée dans les anciennes canalisations restaurées vers la citerne ; ceux qui ne sont pas directement situés au-devant d'un canal en pierre se déversent latéralement et alimentent les canaux situés de part et d'autre.

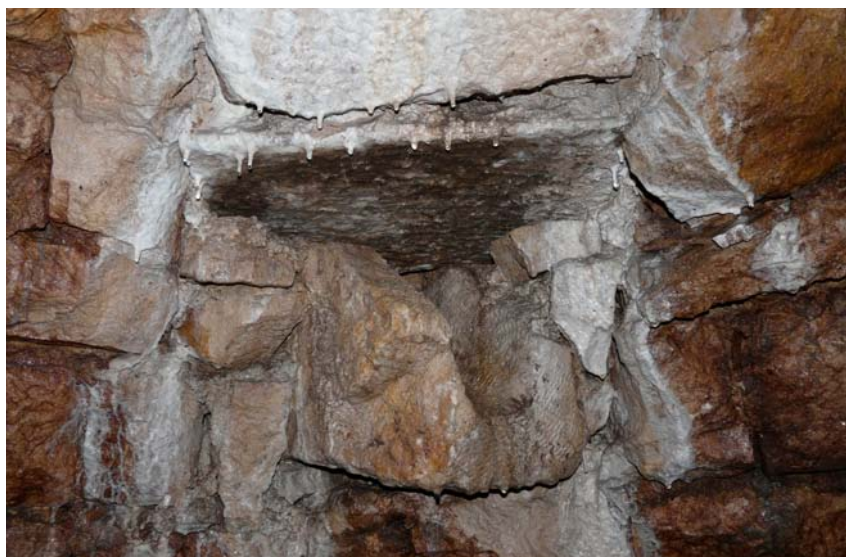
Intérieur de la citerne, détail d'un exutoire.

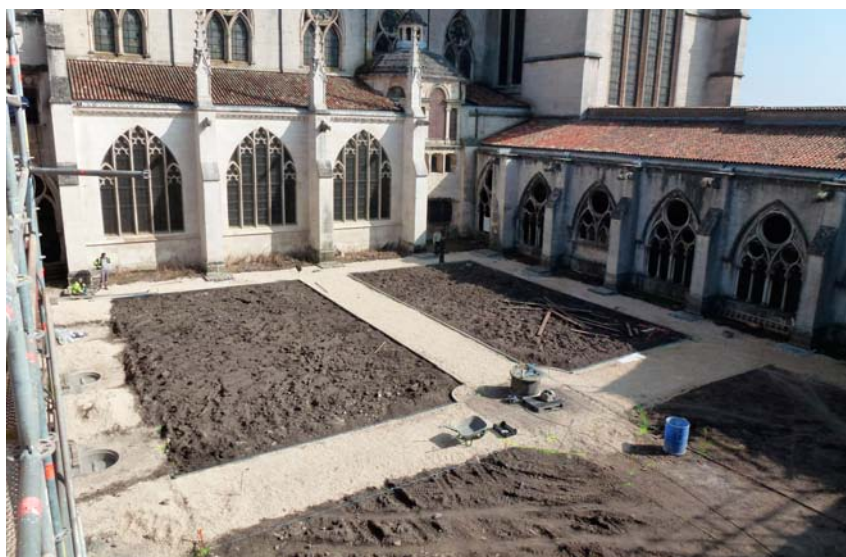
Vue du cloître après la remise en service du réseau d'assainissement.

Ainsi, le système médiéval a été amélioré permettant désormais de récolter l'eau issue de toutes les gargouilles et les bacs enterrés reliés deux à deux préviennent l'éventuelle surcharge de l'un d'entre eux.

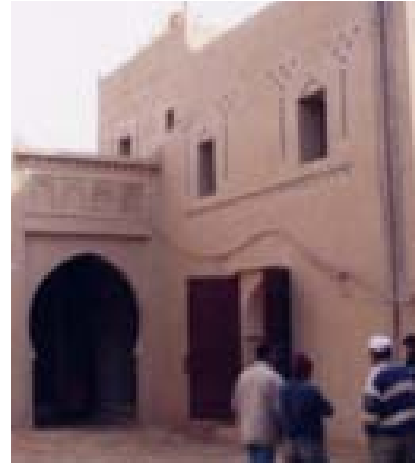
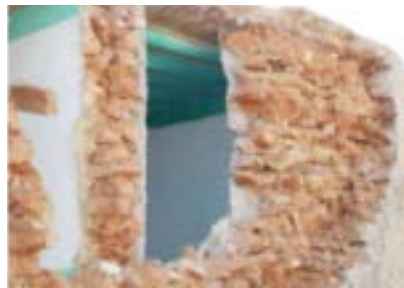
*Séisme Al Hoceima (Nord du Maroc) en 2004, milieu rural.*

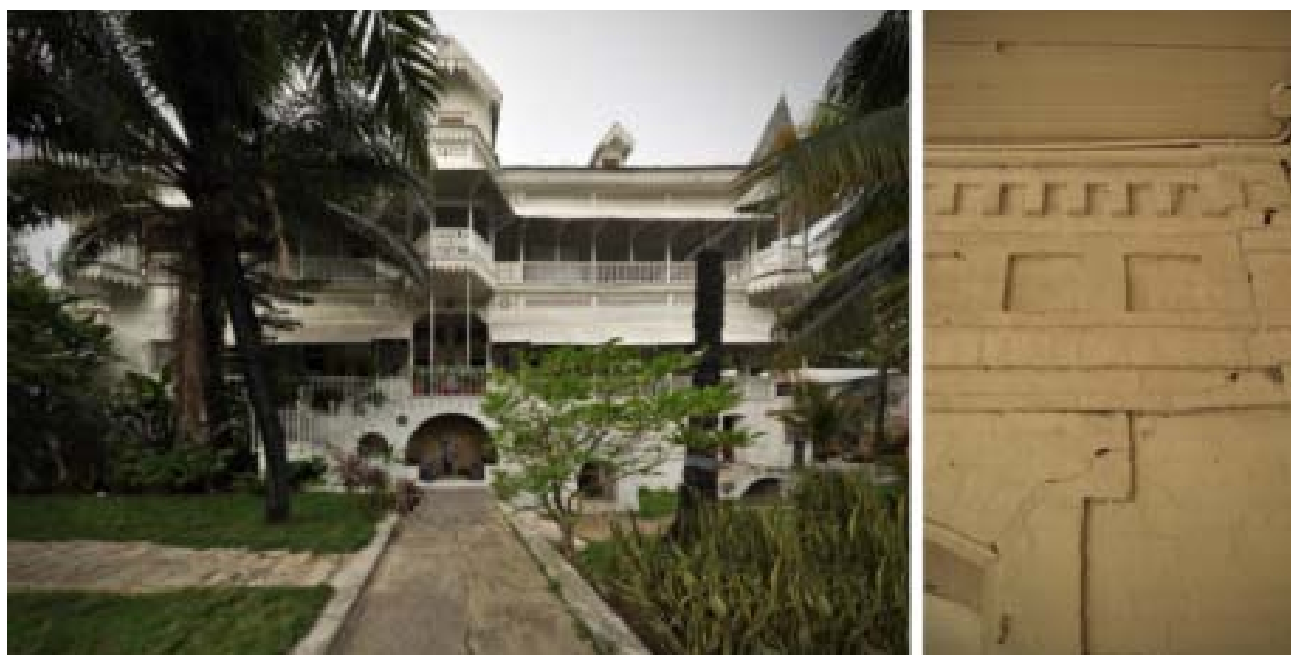
Figure 3. The unreinforced brick masonry Hotel Oloffson, Port-au-Prince after the earthquake.

When our team arrived in Port-au-Prince in April of 2010, four months after the earthquake, we had seen the imagery in the news and early reconnaissance reports. We were first taken to the Oloffson Hotel where we found ourselves in a 120 year old three story unreinforced brick masonry building in excellent condition that had never closed after the earthquake. The only marks on it left by the earthquake were cracks so small that to show them in slide shows later, arrows and circles were needed to point them out, even though a new 9 story hotel lay completely pancaked behind it. In fact, the largest crack found in the walls of this building turned out to be from a rusty bolt embedded in the brick wall!

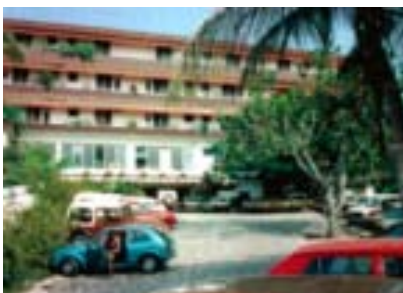
Figure 4. Five star collapses in Petionville: left: Hotel Montana before, and center after the earthquake (Google images).

Two buildings that may have influenced the setting of a high MMI were the pancake collapses of the five star Hotel Montana, and the former five star hotel used by the UN to house its staff in Haiti (Figures 4 & 5). The Hotel Montana had been heavily used by visiting US governmental officials. These two collapses alone killed the head of the UN mission together with much of its staff, as well as a number of US and European dignitaries. Knowledge of these events spread fast, including to the US Geological Survey (USGS) which within hours of the earthquake began publishing their famous shakemaps that, in addition to instrument data where it existed, included subjective data based on analysis of the initial news reports and over the phone interviews.

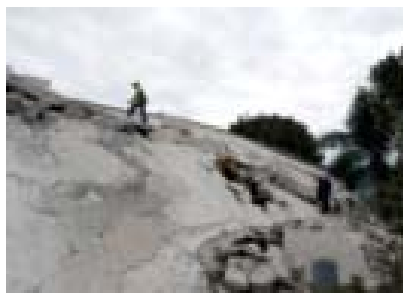
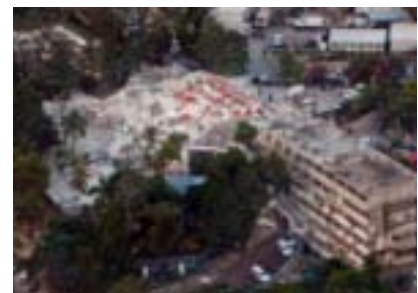
Figure 5. UN Headquarters after the earthquake (Google images).

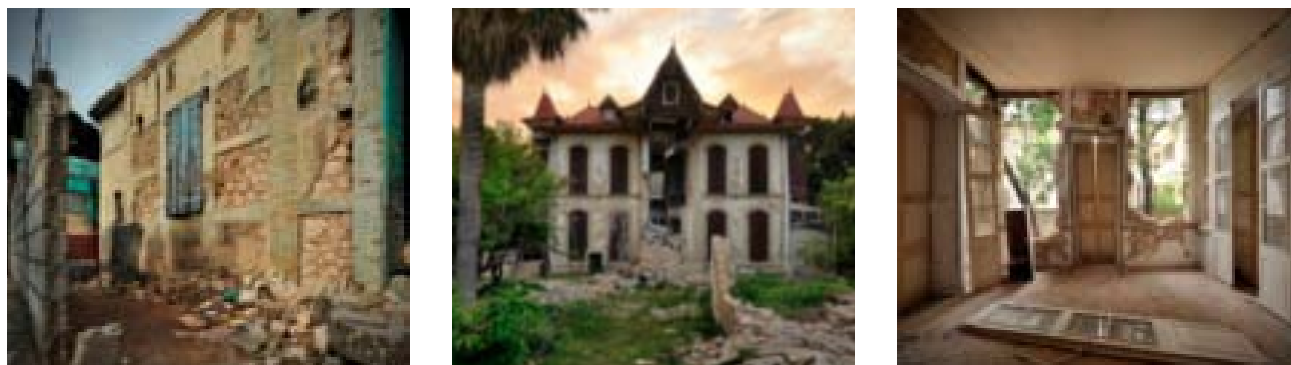
Figure 6. Brick and empanelled round-rock rubble stone construction, as is typically found in many of the Port-au-Prince "Gingerbread" Houses from the late 19th century, showing different levels of damage from onset, to collapse of the rubble panels. Center: The 2 1/2 story Villa Castel Fleuri Mansion was of rubble stone between brick piers and window surrounds, and only the staircase projection collapsed. The onset of inelastic deformation of the rubble stone panels is visible where the surface stucco has come off. Right: The Dufort House still standing on its brick piers after the collapse of the rubble stone panels. This house is now being restored by FOKAL. Many reinforced concrete buildings nearby collapsed.

In almost all cases, the timber framing elements were compromised by termite damage and/or fungal decay – which was in a few cases very extensive. Despite the almost universal lack of maintenance and commonly found decay, it was rare to find even a partial collapse at any of these houses, regardless of construction type. In the buildings with rubble stone, in quite a few instances, the rubble stone sections of the walls showed different gradations of damage from the shedding of exterior stucco to the partial or total falling out of a stone panel – leaving the building still standing on the brick piers which surrounded the rubble sections of the walls.

century, he developed the scale that bears his name. An earthquake classified as a IX on the MMI scale would be expected to cause "*Damage to masonry buildings... from collapse to serious damage*" whereas what was found in the WMF survey seems closer to the description for an MMI-IV: "*...damage to some poorly built unreinforced masonry buildings [and] some cracks even in better built masonry buildings if not reinforced.*" Thus the Oloffson Hotel would qualify as a "*better built masonry buildings,*" while the brick and rubble stone mixed construction houses, because of the existence of the rubble stone in clay mortar, inarguably can serve as examples of "*poorly built masonry buildings.*" So, using these examples, it would seem that this earthquake is more accurately classified as an MMI-VII, rather than an MMI-IX or X, as has been often cited.

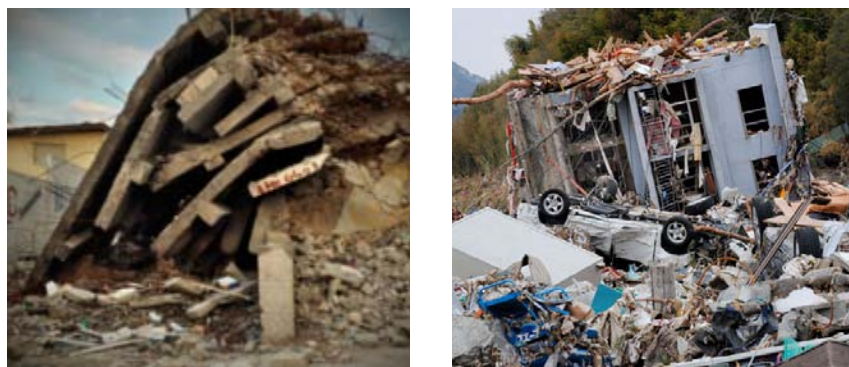
Figure 7. Left: Pancake collapse of a reinforced concrete building that was located in the Gingerbread District of Port-au-Prince. Right: As a remarkable example of the inherent strength and resilience of a well-constructed reinforced concrete building, this one in Rikuzentakata, Japan was swept onto its side and carried upstream by the March 10, 2011 earthquake and tsunami without being crushed or collapsed (AFP/Getty).

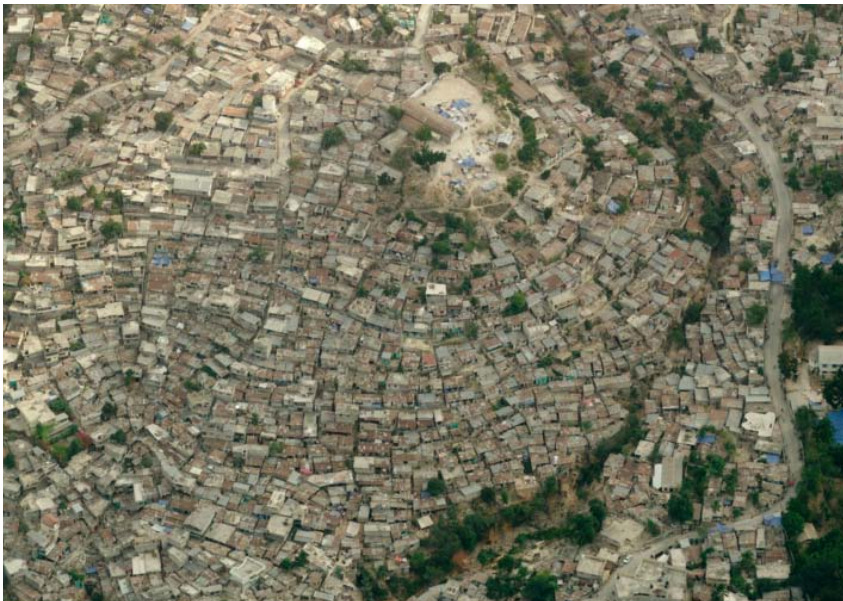
Figure 8. View of 4 Carrefour Feuilles area bidonville, close to the city center, Port-au-Prince (© Pictometry).

ance of the tightly packed cluster of homes that spread over the hills showed little damage visible from the air within the high resolution of the Pictometry images (Figures 8 & 9).

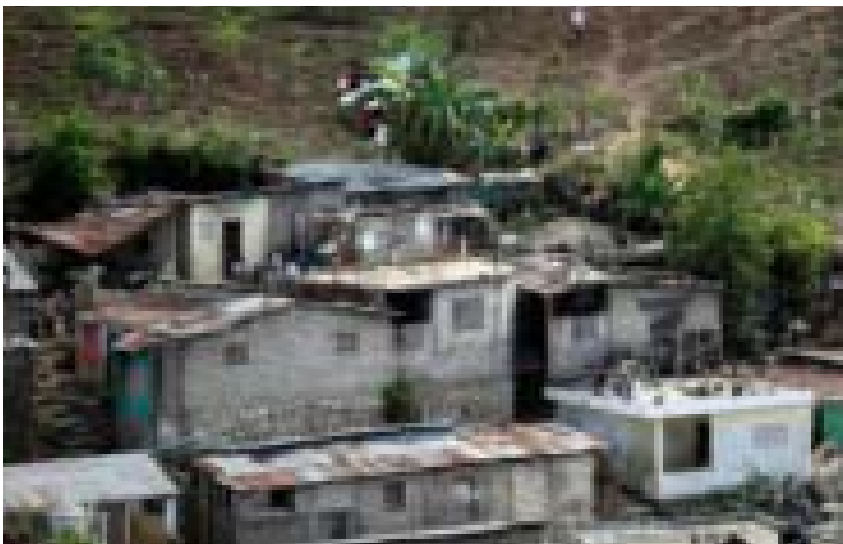
Figure 9. View of 4 Carrefour Feuilles area bidonville, close to the city center, Port-au-Prince showing the unsophisticated rough construction of informal settlement dwellings, with incomplete frames, round-rock rubble stone retaining walls, and unreinforced concrete block construction – that nevertheless did not collapse (Source: Carlos Barria-Reuters).

Does this defy the improbability that poor people without training on land they do not own would use higher quality materials, better engineering, and better construction quality control than that found in the formal, contractor-built, and even sometimes engineered structures downtown and in Pétionville? The answer to this question is *no*. The quality of the design, construction and even the materials used in the informal settlements was in fact quite poor as one would expect – they just did not often collapse (Figure 9).

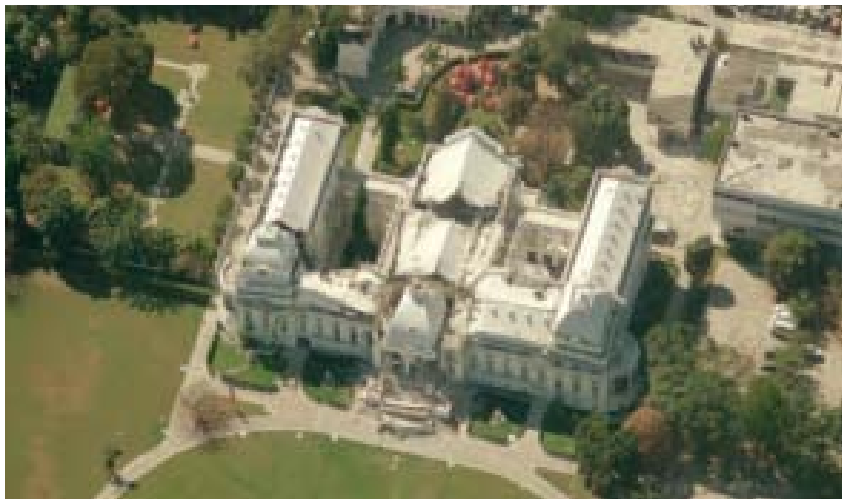
Figure 11. National Palace in Port-au-Prince after the earthquake and partial demolition, revealing the reinforced concrete frame infilled with rubble stone (© Pictometry).

In Haiti, the two iconic symbols of the destruction wrought by this earthquake were the National Palace (Figure 11, 12) and the National Cathedral. Both were reinforced concrete. The cause of the collapse of these two structures, as well as many other 100+ year old churches, was the corrosion of the rebars after a century of exposure to moisture in the tropical environment. Yet only a few blocks away from both, and resting on the very soil identified as subject to the highest shaking, is another structure that few have seen and which has rarely been in the news, but which stands as a remarkable monument to resilience when almost every building around it collapsed – the Saint Louis de Gonzague Chapel (Figure 13). It was as high and about half the length of the cathedral, and about 20 years older – but little damage was visible on the exterior. The structure was of brick masonry with an iron or steel frame. Not only has it not rusted out, despite its age, it has remained standing, even as all of the school buildings around it, some of concrete, and others of timber, collapsed. Much still needs to be known about this church, but perhaps when we are looking at this structure we are looking at the future, and not just at the past. Embodied in this magnificent survivor may be at least one idea of how we can build durable and safe buildings in earthquake areas that can remain standing after an earthquake a century later.

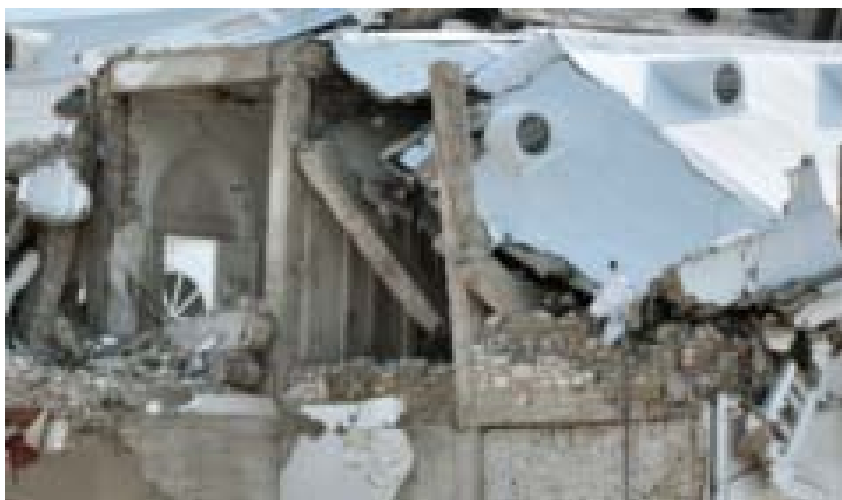
Figure 12. Detail view showing the reinforced concrete frame with round rock rubble stone infill of the 1916 structure exposed during the demolition of the ruins of the National Palace.

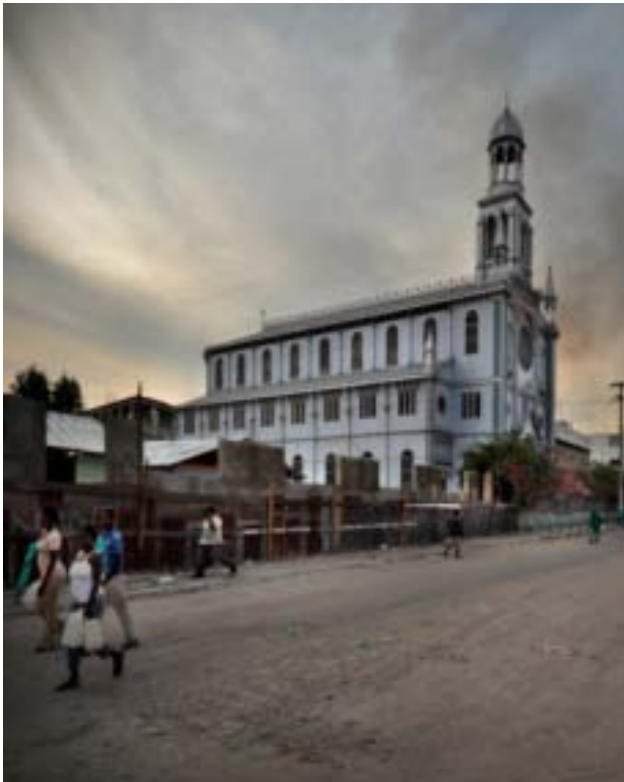
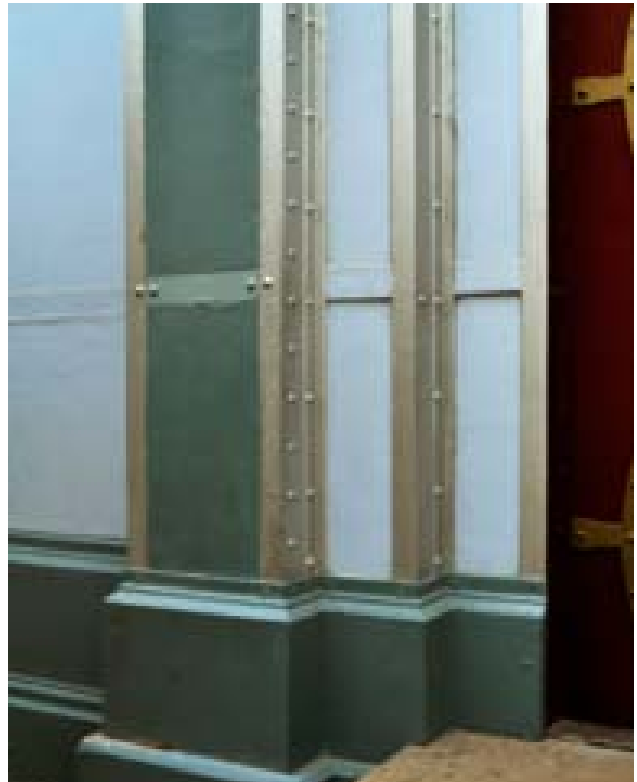
Figure 13. Saint Louis de Gonzague Chapel ca. 1890 in central Port-au-Prince showing external lightweight steel frame on masonry walls.

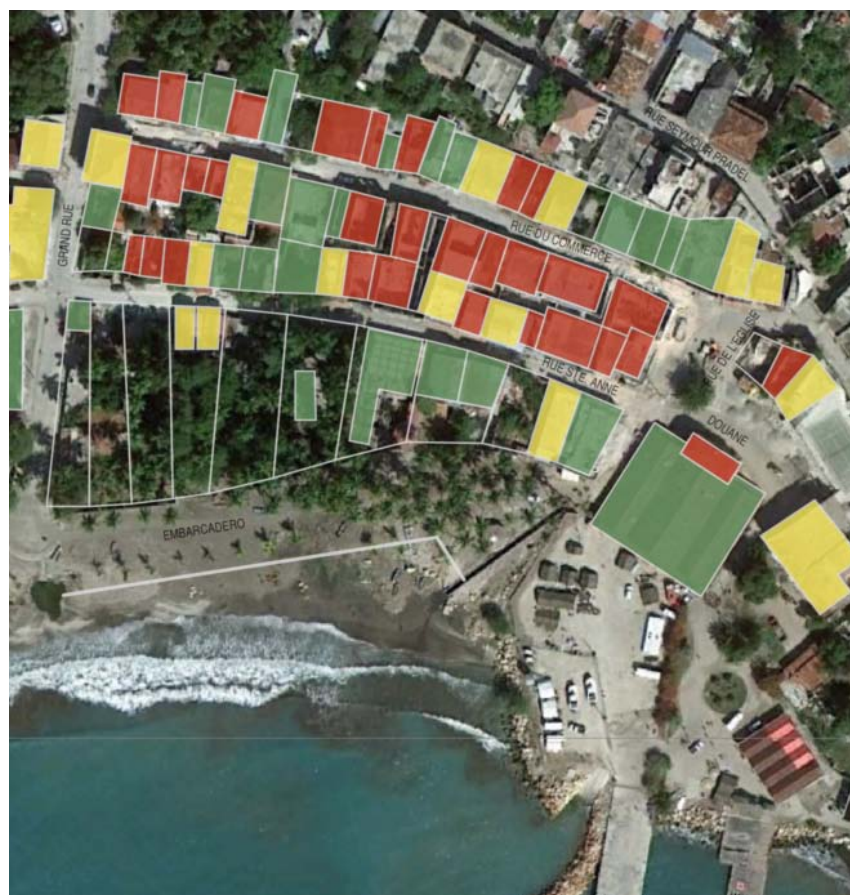
Assessment of Buildings & Sites for Development in the Historic Port District.

MTPTC Designation RED: UNSAFE. The building is not reusable with out major structural repairs. MTPTC Designation YELLOW: RESTRICTED USE. The building is temporarily unserviceable, with significant structural damage.

MTPTC Designation GREEN: SAFE. The building is serviceable, with no or minor structural damage.

VACANT PROPERTY: Suitable for Development.

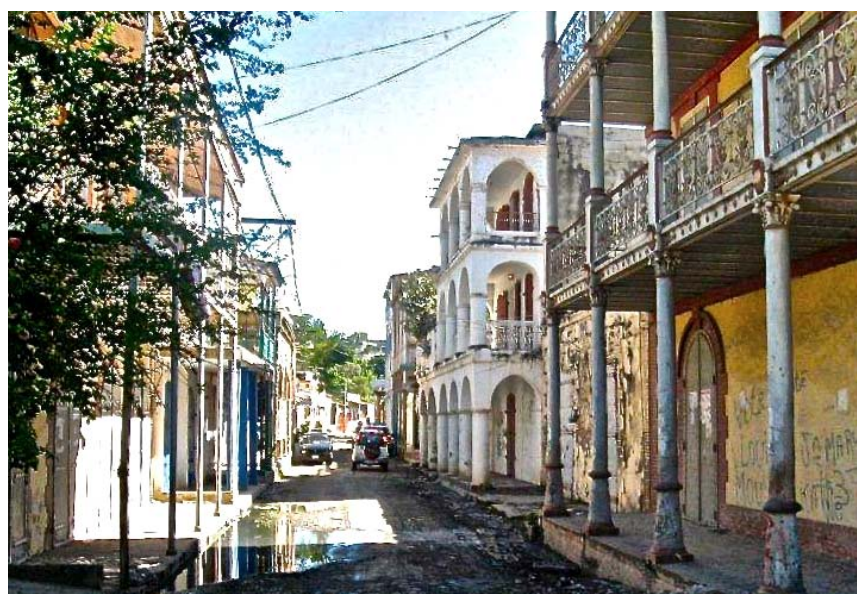
ures during ground movement events. "X" shaped wall cracking and failures are classic indications of structures lacking sufficient strength to resist even minor seismic events.

The Plantain Garden Zone Fault, active in 2010 is a major threat to strike again. In Jacmel, the typical mode of wall failure expresses this condition; and indicates a need for customized preservation and restoration techniques for walls built in this fashion. Failure to address this threat will lead to further damage, destruction and loss of life. Such damage will continue to set Jacmel back and will create a real and perceived danger to visitors and investors. The risk to investment in Jacmel's future development will be extremely limiting without establishing and enforcing proper standards for repair.

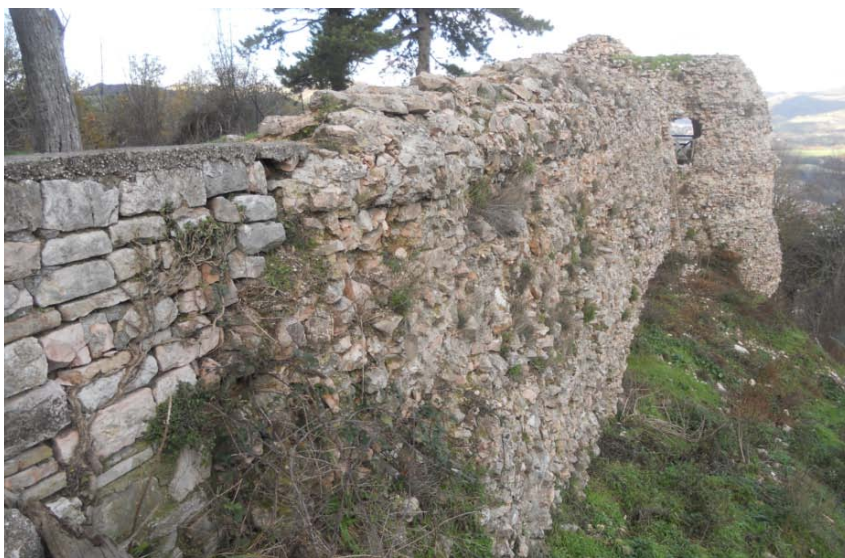
Porción del sistema defensivo superior y su estado de deterioro.

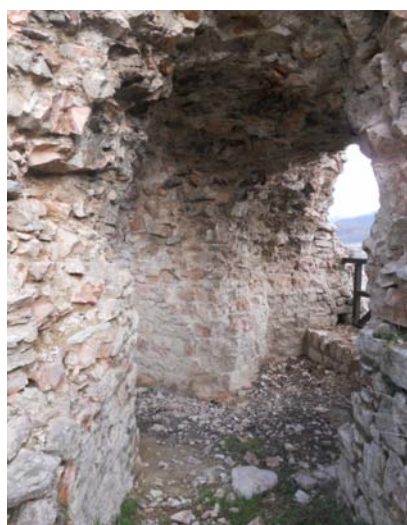
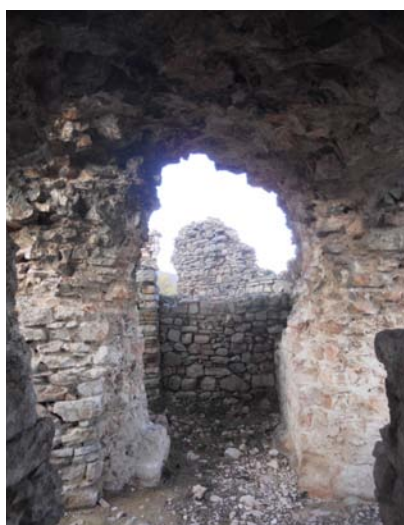
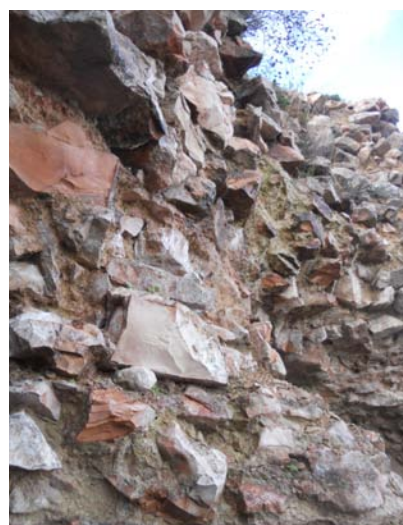
A la izquierda y al centro, ambientes interiores abovedados; a la derecha, detalle del núcleo de mampostería, con inserciones de la piedra llamada *marmarone rosado*, presente en otros edificios militares de Francesco di Giorgio Martini.

Los muros de la torre superior de Cagli están constituidos por un relleno de mampostería realizado en piedra caliza, mezclada con fragmentos de piedra y de ladrillo. La piedra caliza es la llamada *marmarone* rosado de Cagli, diferente del *marmarone* almendrado, presente en las fachadas de los palacios monumentales de la zona. Se trata de una piedra compacta y dura, que se encuentra en otros edificios atribuidos a Francesco di Giorgio Martini, existentes en el territorio de las Marcas<sup>4</sup>. El paramento original, del que se conserva sólo una parte muy limitada, está también realizado en piedra caliza y en piedra rosada de Cagli, dispuesta en hiladas regulares, mientras que en algunas partes, probablemente de épocas posteriores, se presenta como un *opus listatum*. En otros puntos del edificio se reconocen diferentes intervenciones efectuadas a partir del siglo XVI; sin embargo las más incongruentes parecen ser las ejecutadas en épocas más cercanas a la nuestra, de las que desafortunadamente no se conserva documentación alguna. El acabado final de las torres, tanto de la superior como de la inferior, consistía en una fina capa de revoco, de la cual se han encontrado algunos restos bajo la cornisa de la torre inferior, que, al contrario de la superior, se encuentra muy bien conservada y ha sido restaurada recientemente.

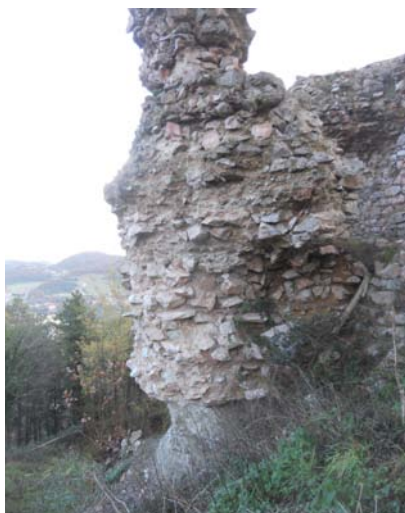
Estado de deterioro de la base del muro de la torre.

Desde el punto de vista estructural, uno de los temas preocupantes concierne el acentuado debilitamiento de la base de los muros de mampostería de la torre. A primera vista, la intención sería la de reconstruir intensivamente las partes faltantes; sin embargo, es importante señalar cómo ya, en proyectos anteriores lamentablemente no financiados, la Soprintendenza había adoptado el criterio de la mínima intervención (según la acepción acuñada por Gustavo Giovannoni), es decir limitando lo más posible la transformación de la imagen del edificio. Por lo tanto, el proyecto se concentra sobre todo en la reintegración del núcleo de mampostería, en línea con otras intervenciones efectuadas en Italia sobre todo en contextos arqueológicos, como el Templo de Venus Cnidia en la Villa Adriana, la tumba de los Horacios y Curiacios en Albano o los diversos sepulcros de la época romana existentes en la via Appia Antigua.

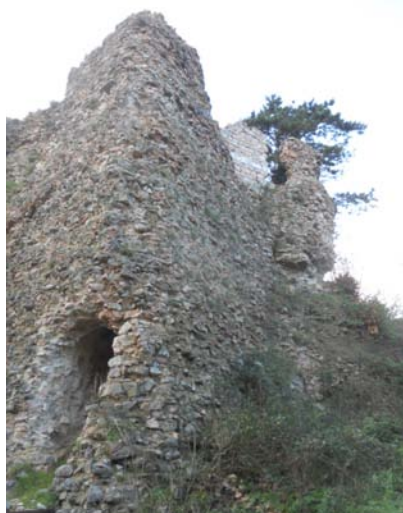
La torre superior, reducida a núcleo, con fragmentos en *opus listatum*.

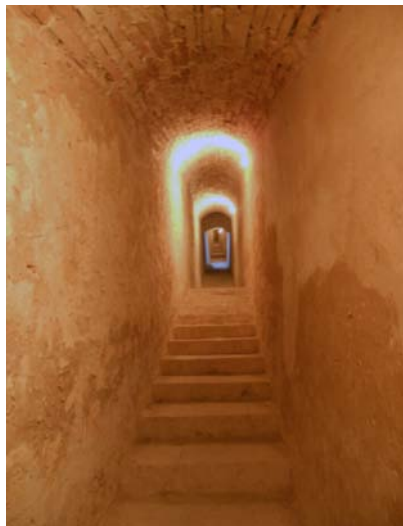
Interior del pasaje de conexión entre las torres superior e inferior.

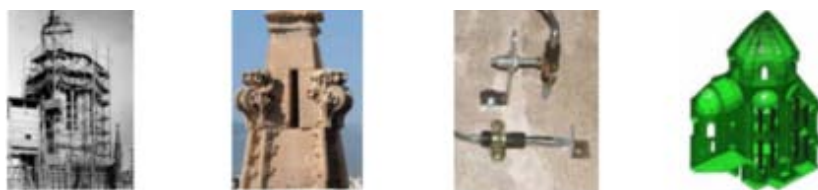
Figure 2. ISCARSAH Recommendations (2001): History; Present condition; Monitoring; Structural Modeling.

The Vratislav II's Kostel Sv Petra a Pavla (Church of Sts Peter and Paul) is located in Vyšehrad, in Prague, Czech Republic. According to the ISCARSAH (International Scientific Committee For Analysis and Restoration Of Structures of Architectural Heritage) Recommendations (2001), it is very important to recognize that conventional calculation techniques and legal codes or standards oriented to the design of modern constructions may be difficult to apply, or even inapplicable, to ancient structures. And because of that, it states the importance of a scientific, multidisciplinary approach involving historical investigation, inspection, monitoring and structural modeling and analysis (Figure 2).

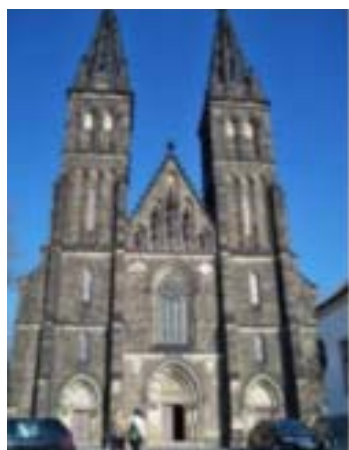
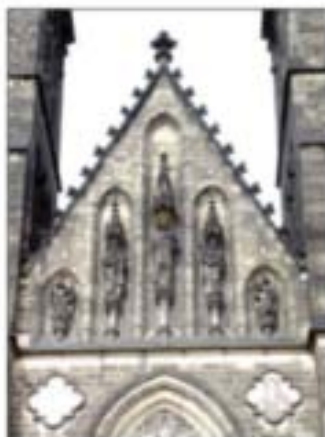
Figure 8. Main facade and detail of the gable.

In the Church Sts Peter and Paul, the triangular gable wall over the main entrance starts at the height of 19.60 m above the church floor, its width between both church towers is 9.0 m and the height of its rectangular part fixed into the towers is 2.60 m. The height of the free-standing triangular part is 8.70 m and the cross on its top reaches the height 30 m. The gable wall does not lean against the wooden construction of the roof covering the main nave of the church. The thickness of the masonry of the gable is 0.57 m, but the niches containing statues reduce it to 0.27 m. (Figure 8).

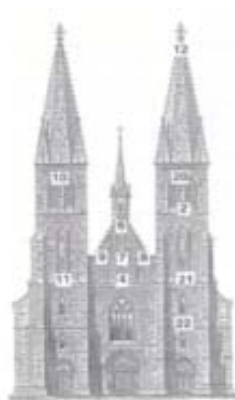
Figure 14 Measuring points in the façade Points 4 (2002). (ITAM, 2002).

So for instance, due to the dynamic excitation of the ringing of the bell J1, in 2002, it was possible to recover in the point 6 the graph that is presented in the Figure 14. In those graphs is possible to determine according to the spectral density (mm<sup>2</sup>/s) the peak that correspond to the frequency related with the modes of structure.

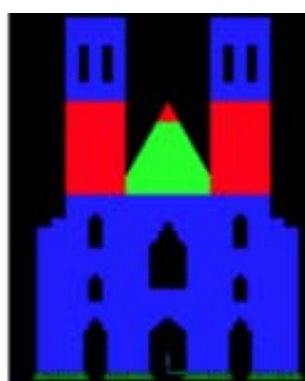
Figure 17. Thickness of the Shell Elements in the Structural Model.

In the model different colors were assigned to a specific thickness, according to that selection, in the Figure 17 is presented the façade of the model. The four values of thickness that were determined were 30 cm, 60 cm, 100 cm and 120 cm, and respectively the colors that were assigned were green, red, yellow and blue.

In the façade presented in Figure 17, is possible to see that the thickness of the gable is 30 cm, and in its top is 60 cm, in order to consider the fact that in this part has a spire. The sculptures that are in this area were not included because they are not linked to the gable.

For the tower there is a section where the masonry is thicker, it is between the height of 19 m and 29 m. Because of that reason in the model is possible to see that in this section of the tower the color of the elements is red (60 cm)

For the model of 2002, three eigen values were obtained. The first mode is related specifically with the gable. It consists in the oscillatory movement of the gable out of its plane, the value of the eigen frequency is 0.83 Hz, in the Figure 57 is presented the modal shape. As it could be seen, in Figure 17, the movement is related with the gable out of its plain. Just in order to take into account, the excitation due to the bells was 0.44 Hz, so the value of this mode corresponds to a harmonic of that value, so clearly the gable is in resonance.

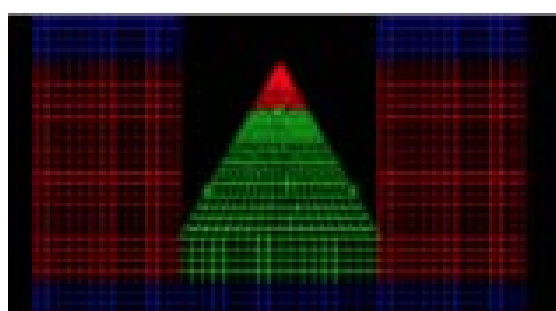
Figure 20. Model of the Structure for 2007 (after the retrofit).

For the model of the year 2007, in order to consider the retrofit of the gable, some restriction were placed for the gable, in the Figure 20, is presented the restrictions out of the plane that were assumed in the model.

due to the restriction out of the plane of the gable, as it was expected, the mode related with it, disappeared. So for the model for 2007, only two eigen values were obtained.
