## Message of the President Görün Arun

### Disasters and Heritage

# Iscarsah

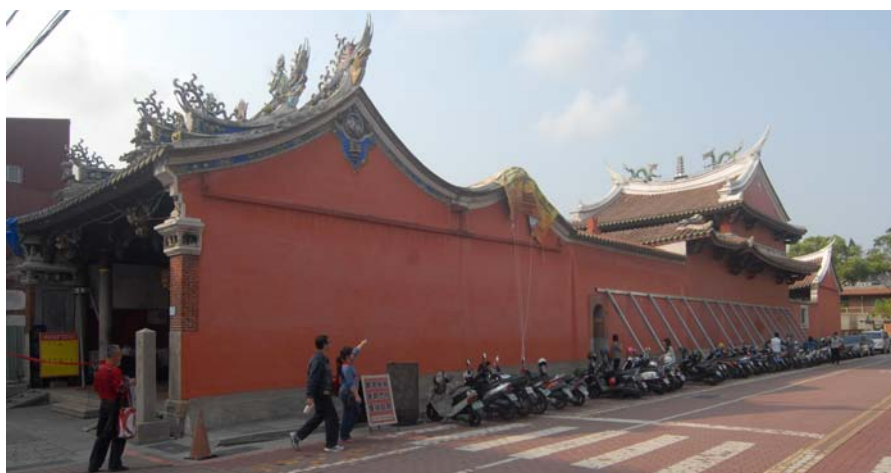
Figure 7: Official God of War Temple. Far, on the right side: Fort Provintia (Chihkan Tower): undamaged by the earthquake (Photo: P. Smars, 2016).

walls. In the Official God of War Temple significant displacements of columns were observed, in the entrance (figure 6) and inside the temple complex. Provisional strengthening structures were installed there, in the courtyard (figure 8) and on the outside wall of the temple (figure 7). Cracks in between structural elements are also observed in the Singi Temple (figure 10) and in the Confucius Temple (figures 9-left).

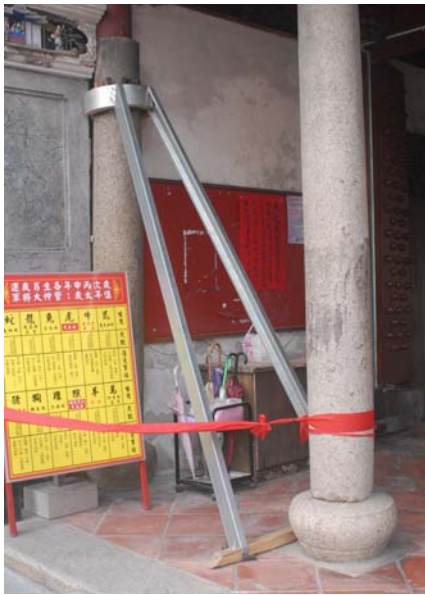
Figure 11: Temple of Confucius (Photos: P. Smars, 2016).

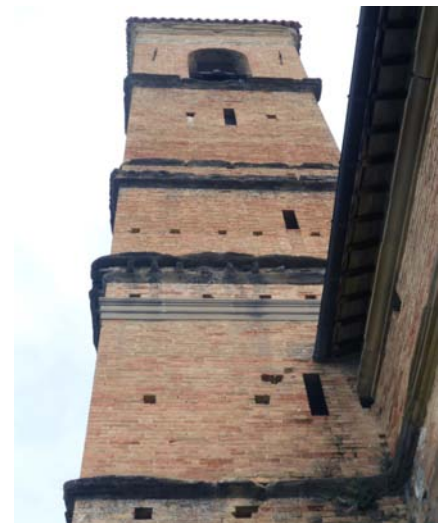
Torre campanaria con cornisas originales y de restauración (Foto S. Gizzi, 2012).

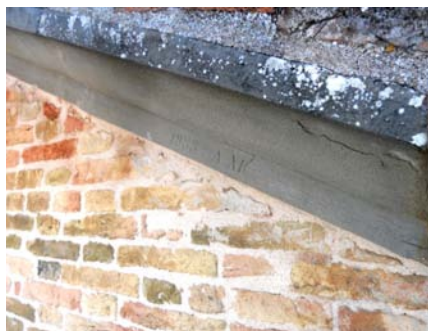
Una cornisa de reintegración con la fecha grabada: 1933 (Foto S. Gizzi, 2015).

Sólo en algunos de estos bloques de reintegración se ha anotado la fecha de la restauración. En una cornisa en piedra arenisca del tímpano se lee la fecha de una de esas sustituciones: 1933. En la fachada principal y en las laterales se perciben numerosos fenómenos de deterioro tanto de los materiales pétreos como del ladrillo. En el portal, tan admirado y citado por Rafael Sanzio,

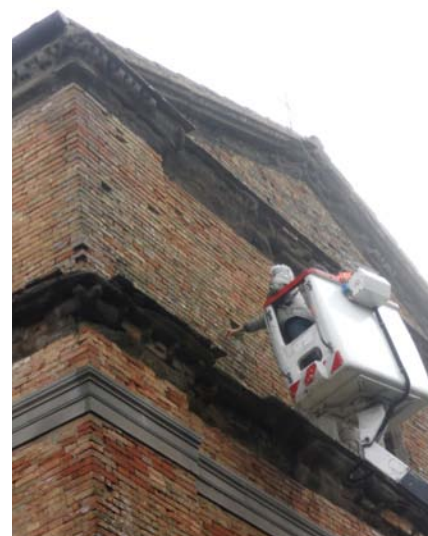
Monitoreo del frente principal (Foto S. Gizzi, 2013).

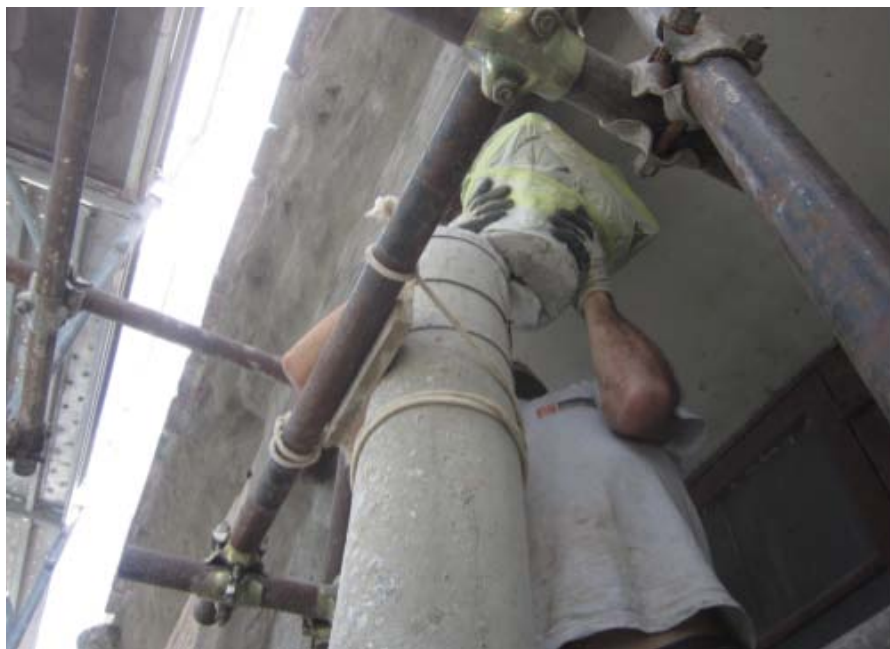
Desmontaje del capitel de la columnilla de la ventana bifora del frente principal (Foto Gamma s.r.l. Fano, 2015).

En la intervención actual, efectuada a partir de 2012, la columnilla en piedra arenisca de la ventana principal de la fachada de la iglesia – fisurada por una errada restauración precedente en la que se utilizó un núcleo de hierro – se ha consolidado de acuerdo al siguiente *iter*: pre-consolidación de las lagunas lenticulares través de microinyecciones de resina acrílica; desmontaje y montaje de las

piezas desprendidas con un sellador especial; inserción de micropernos en acero inoxidable con rosca antes del desmontaje y de la eliminación de los refuerzos inadecuados (realizados anteriormente con un simple alambre); corte y remoción del capitel; eliminación de elementos en hierro oxidado del fuste de la columna; protección del fuste con policloruro de vinil durante el desmontaje; montaje del basamento; consolidación por aspersión hasta rechazo de silicato de etilo; preparación de un soporte adecuado al sucesivo montaje de la columna; reposicionamiento de la base e inserción de una barra de acero inoxidable con rosca en lugar del hierro oxidado; montaje del capitel con mortero a base de cal, polvo de piedra arenisca gris y puzolana adicionada con filamentos de fibra de vidrio<sup>56</sup>. Las restauraciones anteriores pueden identificarse – no sin cierta dificultad – comparando los diversos tipos de materiales; en la fachada se notan, en efecto, morteros diferentes de los originales, aplicados a través del tiempo para efectuar reparaciones y reintegraciones. Son, en especial, de dos tipos: *mortero rosado o de color cemento* aplicado para sellar lagunas de diferentes tamaños, como la cúspide del tímpano o el paramento del tambor de la cúpula; *mortero de cemento*, aplicado como una espesa lechada sobre

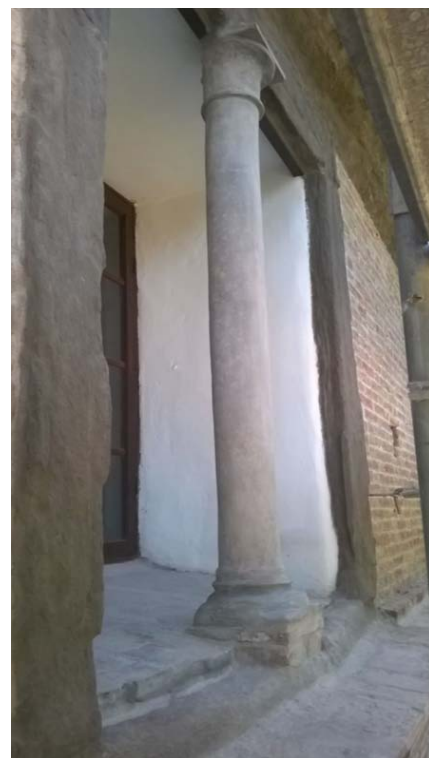
La columna después de la restauración (Foto Gamma s.r.l. Fano, 2015).
